Property Inspection Report

Report Number: 24175

5407 Eastern Shores Dr
Greensboro, North Carolina 27455

Date of Inspection: Monday, July 29, 2024

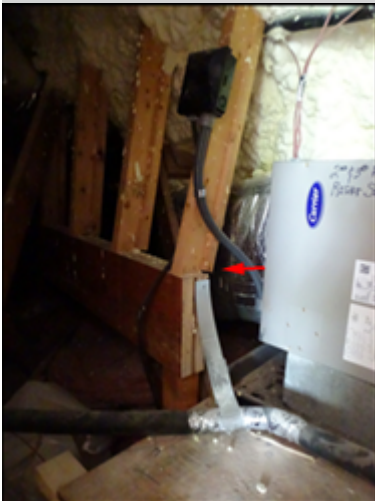
(A6 - 1.1) Main House

There is an LVL beam installed just inside the HVAC access on the 3rd level that needs further evaluation. Because the 2"x 4" braces resting on the beam are installed on an angle additional bracing is recommended to avoid the potential to tilt or fail. A licensed general contractor should be contacted for further evaluation and repair as needed.

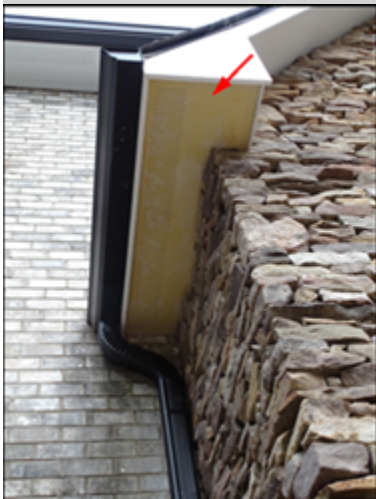
(B1 - 1.1) Main House

When inspecting the exterior trim the following was noted:
1 - Some soffit areas are missing paint - photo to the left is at the left side of the front entrance.
2 - Evidence suggest a single coat of paint - poor coverage.
3 - Fit and finish is incomplete - nail heads exposed.
A general contractor should be contacted to evaluate and complete the exterior trim installation and painting as needed.

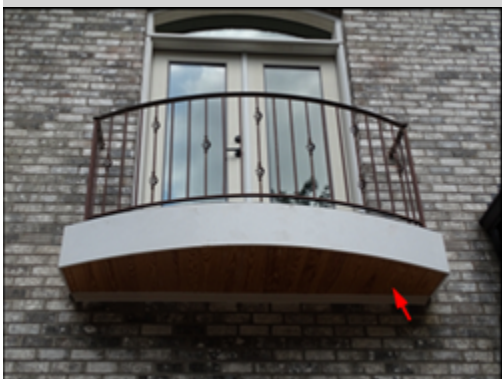
(B1 - 1.2) Main House

See item #1 in the comment above

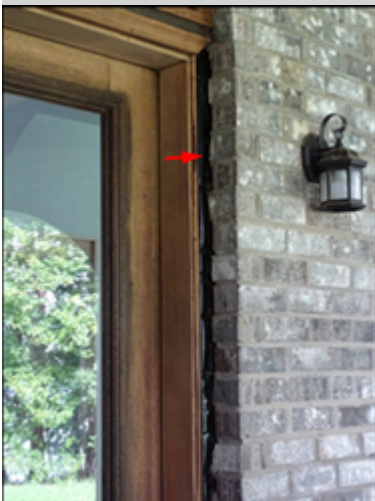
(B2 - 1.15) Doors

See item #3 in the comment above - exterior trim missing

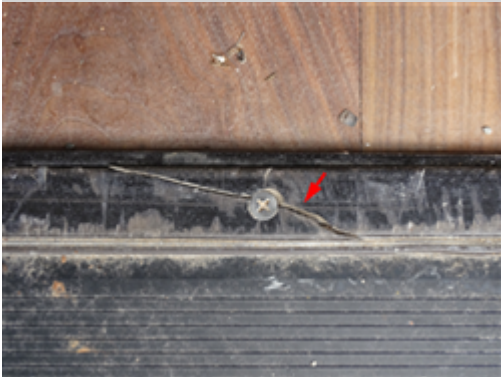
(B2 - 1.20) Doors

See item #5 in the comment above - cracked threshold

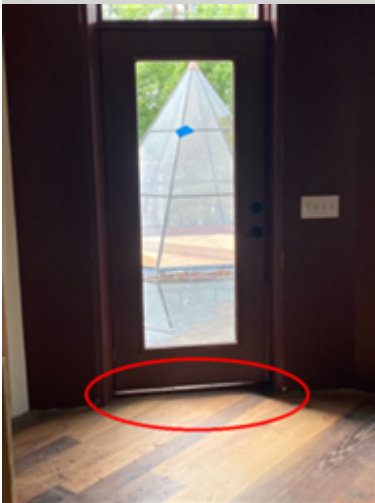
(B2 - 1.21) Doors

See item #6 in the comment above - 2nd level office

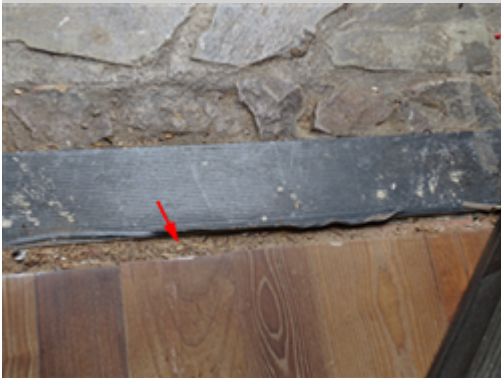
(B2 - 1.26) Doors

9 - The front door threshold is damaged - can allow storm water to cause damage to the flooring.

See item #9 in the comment above - front door threshold damaged

A licensed general contractor should be contacted for further evaluation and repair to ensure that the doors function as intended.

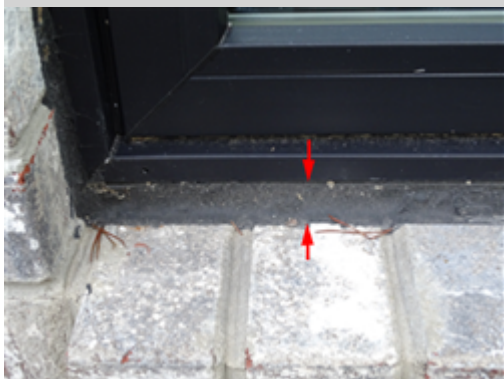
(B2 - 2.2) Windows

See general comment above - heavy caulking at bottom of windows

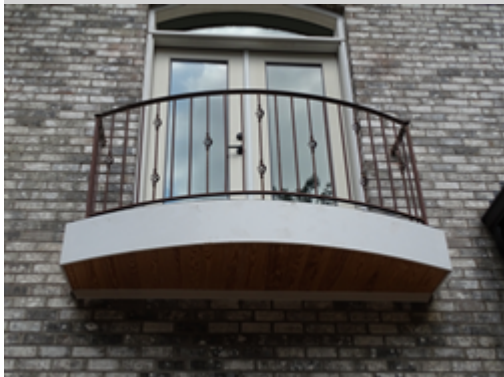
(B4 - 1.1) Balcony - 2nd Level - Front

At the 2nd level front balcony the following was noted:

1 - Evidence suggest that the surface is not properly sloped to direct storm water to the outer edge, and the water proofing material installation is not complete - has a gap under the door threshold where moisture could enter.

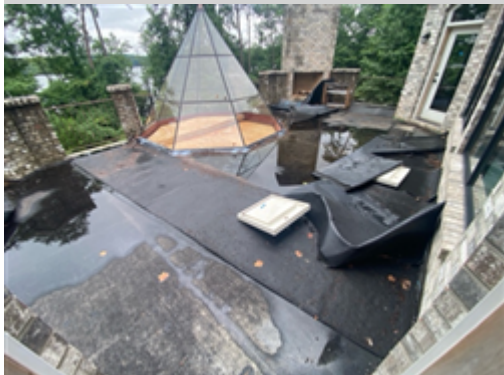
(B4 - 2.1) Patio - 2nd Level - Rear

At the 2nd level rear patio the following was noted:

1 - Evidence suggest that the surface is not properly sloped to direct storm water to the outer edge. Standing water was observed at the time of the inspection.

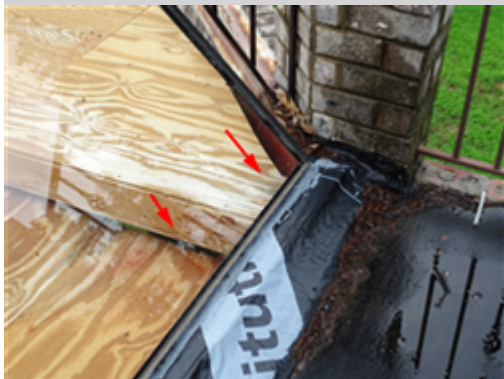
(B4 - 2.2) Patio - 2nd Level - Rear

3 - Evidence of leaking at right side of glass dome and at inside corner next to house.

See item #3 in the comment above - leaking next to dome

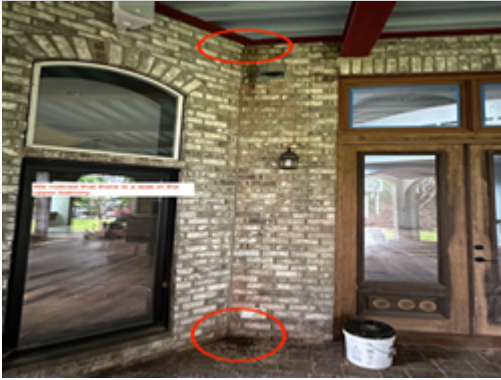
(B4 - 2.3) Patio - 2nd Level - Rear

See item #3 in the comment above - leaking next to house (from below)

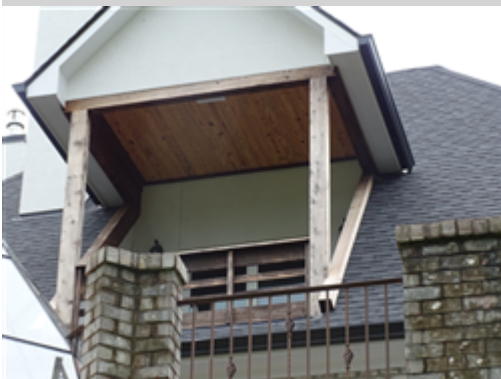
(B4 - 3.1) Patio - 3rd Level

At the 3rd level patio the following was noted:

- 1 - The slope of the surface is greater than what is comfortable to walk on.
- 2 - The surface materials have not yet been installed - installation incomplete.
- 3 - Some of the underlayment moves when walked on - needs to be secured.
- 4 - Water stands on the floor surface around both post.
- 5 - There are cracks in the stucco wall finish.

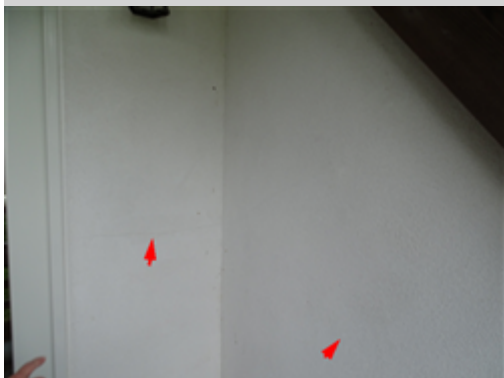
(B4 - 3.4) Patio - 3rd Level

See item #5 in the comment above - cracks in stucco

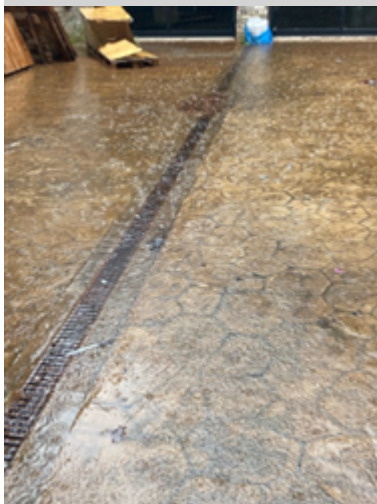
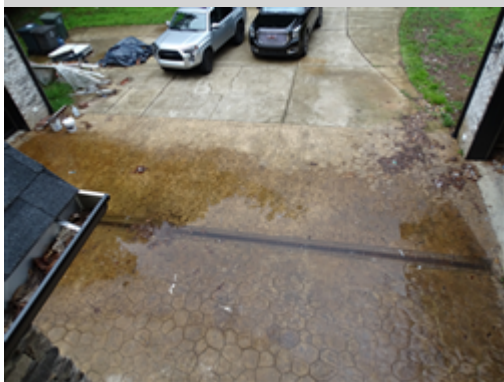
(B4 - 4.1) Driveway

The drain for the concrete pad at the front of the home was not functioning to direct water away from the home at the time of the inspection. A licensed general contractor should be contacted for further evaluation and repair to avoid damage to the home.

See comment above - additional photo

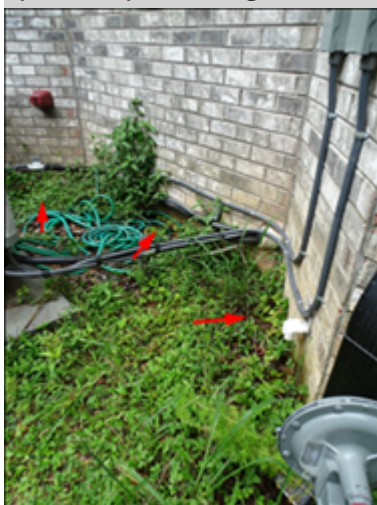
(B5 - 1.1) Grading

At the left side of the home, behind the HVAC units, the grade is lower than the adjacent yard and will not allow storm water to drain away from the foundation. The standing water can damage the foundation over time if not repaired. A landscape contractor should be contacted to repair as needed.

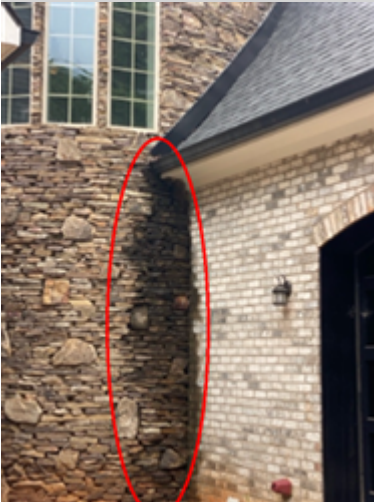
(C2 - 1.1) Main House

When inspecting the roof drainage system (6" Gutters with 3"x 4" Downspouts) the following concerns were observed:

- 1 - Evidence suggest that the gutters are leaking (kick-out flashing not visible) in several locations across the front of the home.
- 2 - Evidence suggest that the drainpipe attached to the downspouts across the front of the home are clogged and not functional. It was raining during the inspection - water was overflowing at the connection at the base of the downspout.
- 3 - At the left side of the home, a downspout is not piped away allowing storm water to drain next to the foundation.
- 4 - The gutters are full of leaves and debris that is keeping them from functioning as intended. Cleaning is needed.

A general contractor should be contacted for further evaluation and repair to avoid further damage.

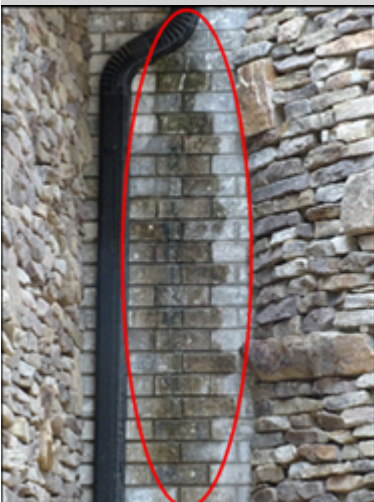
(C2 - 1.2) Main House

See item #1 in the comment above - right side of front entrance

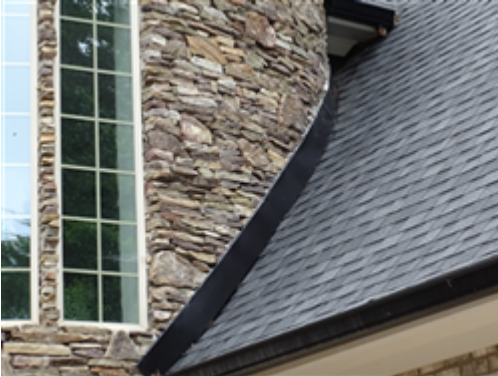
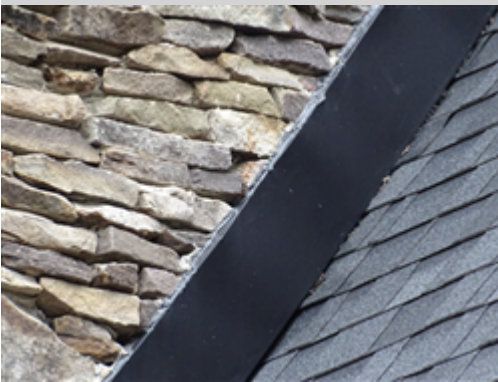
(C3 - 1.1) Main House

The transition between the stone veneer and roofing has metal flashing installed over the stone, which is unconventional and not recommended. The gap at the top of the flashing between the stone is heavily caulked. Heavy caulking will require regular maintenance and should only be considered a temporary repair. A qualified roofing contractor should be consulted for evaluation and repair to ensure the long term weathertightness of the roof covering system.

See comment above - additional photo

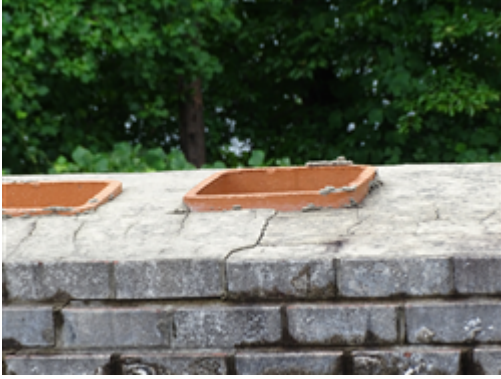
(C4 - 1.2) Outdoor Fireplace - Rear Patio

When inspecting the exterior fireplaces and chimney the following was noted:
1 - The mortar crown is deteriorated and cracked. When the mortar crown is damaged water can enter between the chimney body and the flue liner resulting in leaks and deterioration.
2 - At the lower level fireplace, evidence suggest that moisture is entering the chimney from the top.
A chimney specialist should be consulted for a complete evaluation of the chimney, the flue liner and the masonry crown and to make necessary repairs.

See item #1 in the comment above

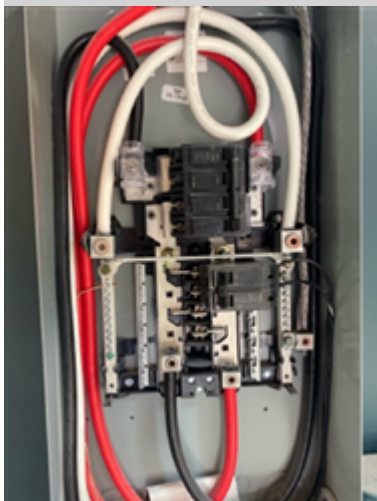
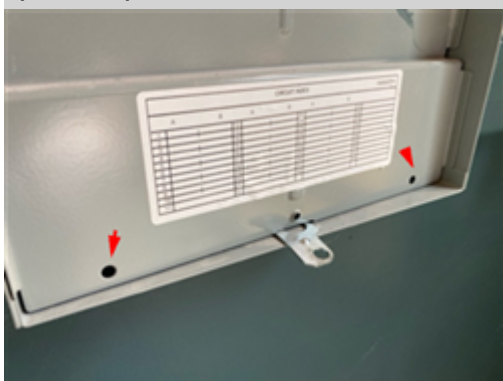
(E2 - 1.1) Main Panel #1

The main electrical service panel cover is missing fasteners that secure the cover to the enclosure. The door/cover prevents direct contact with hot electrical circuits and contains the electrical energy of the electrical system in the event of a short or electrical explosion; therefore the cover must be secured with the correct type, size and number of fasteners. This condition presents a safety hazard that could result in serious personal injury or death. A licensed electrical contractor should be consulted for a complete inspection of the electrical system and for repair/replacement of the panel to ensure that it is safe and functioning properly.

See comment above

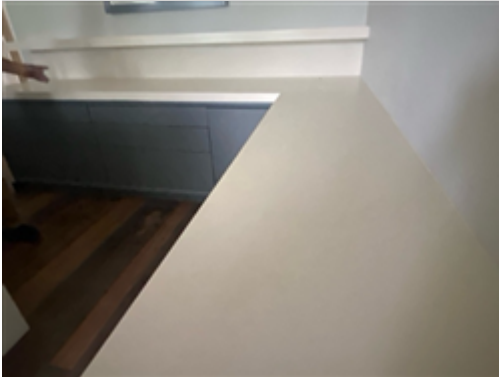
(E5 - 1.1) Miscellaneous Electrical

The following electrical concerns were noted:
Main Level
1 - The receptacles are missing in the kitchen.
2 - The electrical light switches for all of the main level were not functional - did not operate any of the overhead lights.
3 - A receptacle under the sink cabinet is missing the cover plate.
4 - A receptacle at the bar sink in the kitchen installation incomplete.
2nd Level
5 - A receptacle in the left front bedroom tested as reversed polarity. Polarization provides an extra safety feature to prevent electrical shock hazards and property damage.
6 - A switch in the left rear bedroom controls a downstairs hall light.
7 - A receptacle at the top of the right side stairwell did not have power.
8 - A hall bathroom GFCI receptacle did not test to be functional.
9 - A number of overhead lights are missing.
3rd Level
10 - A group of recessed lights are controlled by multiple switches. The switches do not operate properly together and random positions disable one or both switches.

The following electrical concerns were noted:

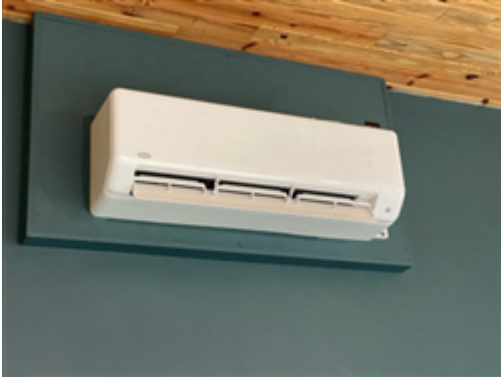
(F1 - 5.1) Heating and Cooling Unit #5

Limitation: unable to operate, no remote

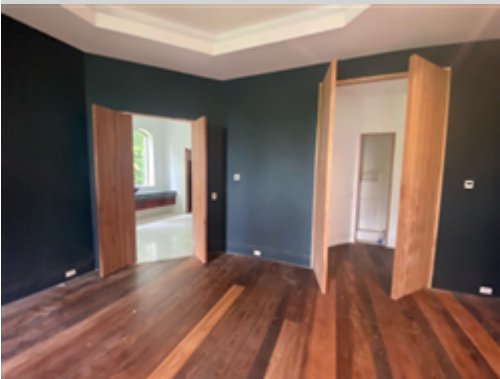
(H1 - 1.1) Interior Doors

All interior doors are missing hardware and need adjustment. The following addition concerns were noted:

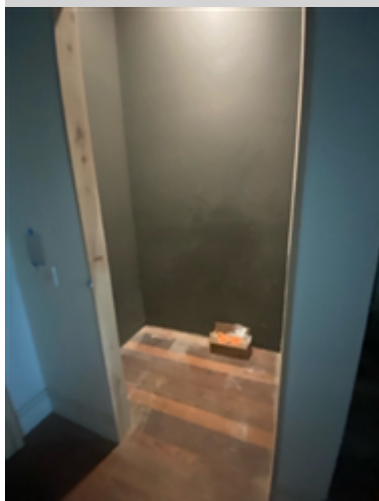
(H1 - 1.2) Interior Doors

See item #1 in the comment above - hall closet

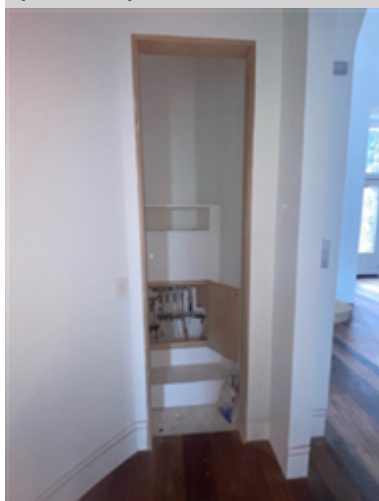
(H1 - 1.3) Interior Doors

See item #2 in the comment above - Missing pivot door on closet

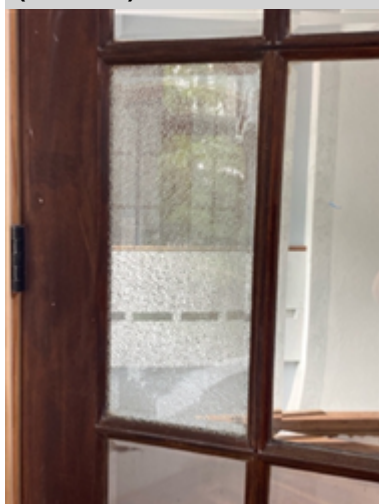
(H1 - 1.4) Interior Doors

See item #3 in the comment above - left rear bedroom

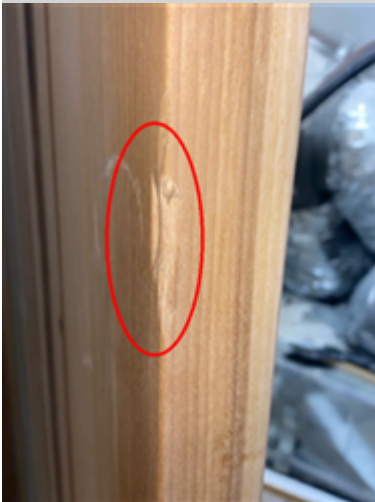
(H1 - 1.7) Interior Doors

See item #6 in the comment above - Damaged door, 2nd floor utility closet

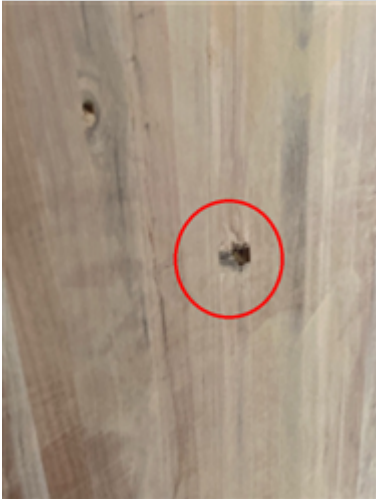
(H1 - 1.8) Interior Doors

See item #7 in the comment above - right side office

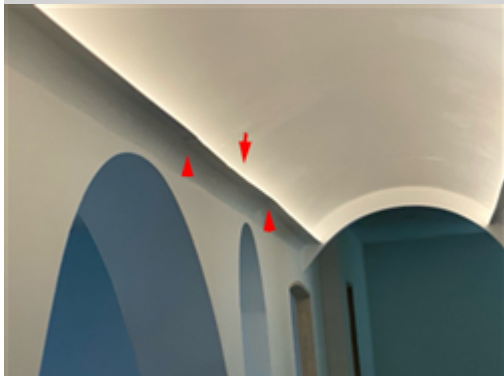
(H1 - 2.1) Miscellaneous

Trim on 2nd level barrel ceiling is wavy and needs repair...

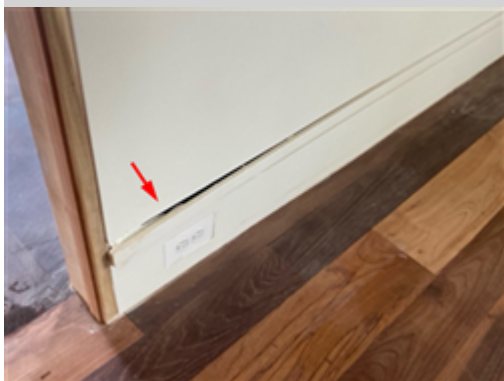
(H1 - 2.2) Miscellaneous

Displaced baseboard right side second level hall

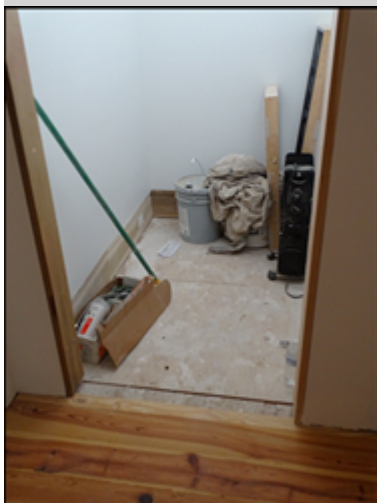
(H1 - 2.7) Miscellaneous

A 3rd level closet is missing flooring

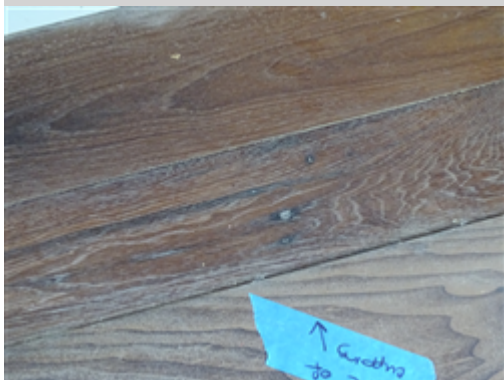
(H1 - 2.8) Miscellaneous

The photo to the left is an example of the hardwood flooring cupping... to be addressed by others.

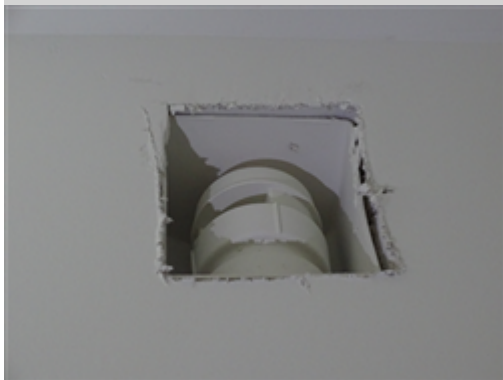
(H1 - 2.9) Miscellaneous

A plumbing vent at the 2nd level right side cubby, is missing a cover...

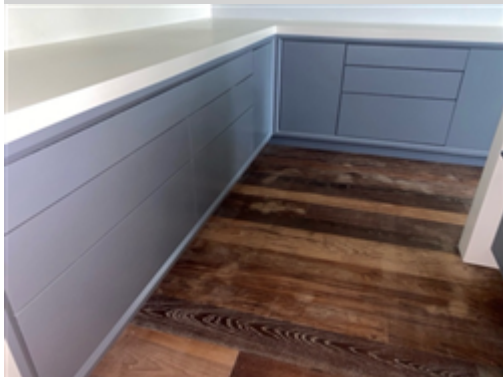
(H2 - 1.1) Kitchen

At the kitchen the following was noted:

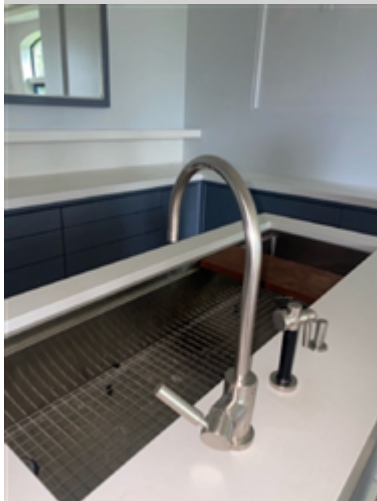
(H2 - 1.2) Kitchen

See item #2 in the comment above - sink

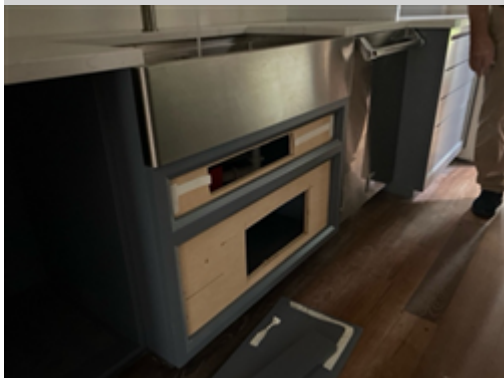
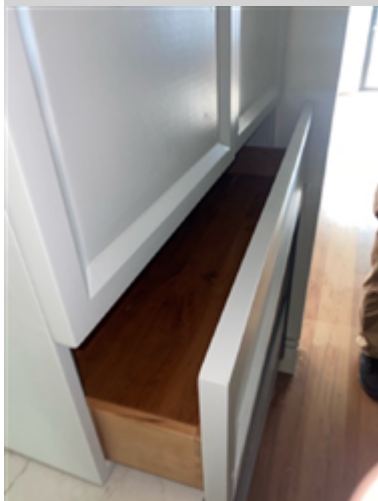
(H2 - 2.1) Butlers Pantry

At the butlers pantry the following was noted:
1 - The cabinet doors and drawers need to be adjusted.
2 - Drawer fronts missing.
3 - Pocket door hardware missing.
A general contractor should be contacted to complete the installation.

See item #1 in the comment above

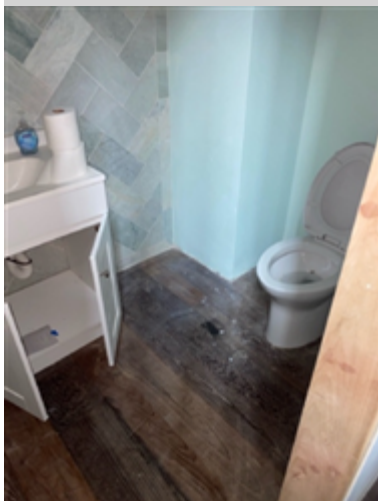
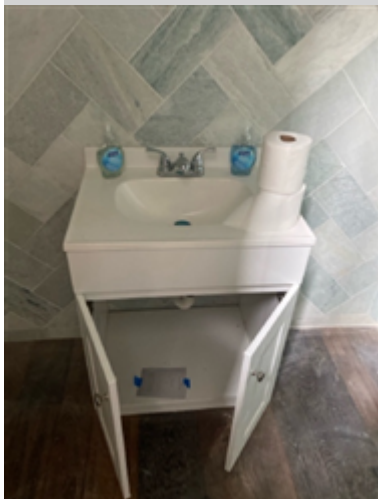
(H3 - 2.1) Bathroom: Half 1st Level

At the half bathroom:
1 - The vanity top is loose
2 - The sink drain stop does not hold water.
A general contractor should be contacted to complete as needed.

See comments above

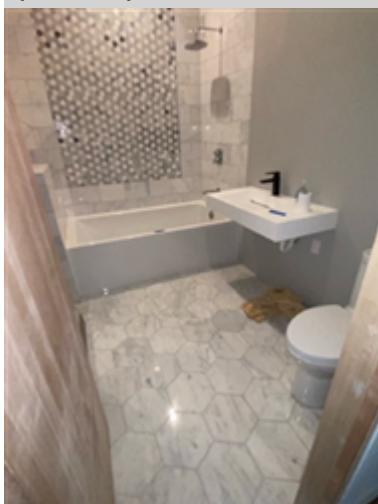
(H3 - 3.1) Bathroom: Hall 2nd Level - Left

At the hall bathroom on the 2nd level the following was noted:
1 - There is an active leak under the sink.
2 - The sink finish is damaged.
3 - Evidence suggest that the tub was installed without using a mortar base.
A licensed general contractor should be contacted to repair and complete as needed.

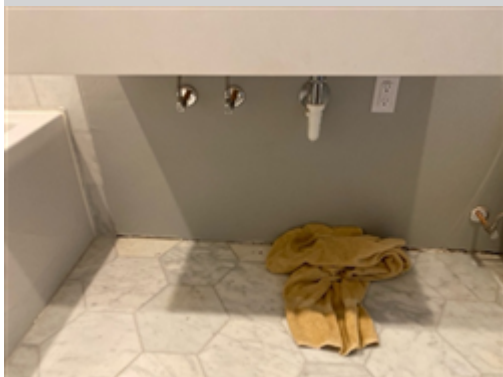
(H3 - 3.2) Bathroom: Hall 2nd Level - Left

See item #1 in the comment above - under sink

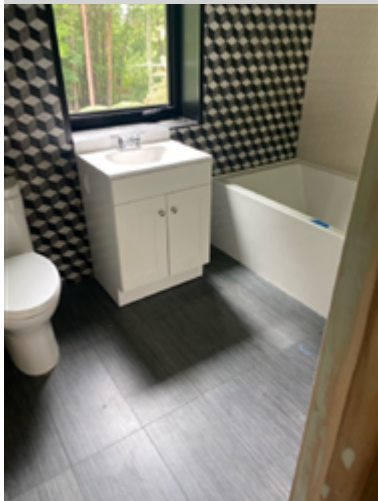
(H3 - 4.1) Bathroom: Private 2nd Left Front

At the private bathroom on the 2nd level (left front) the following was noted:
1 - Evidence suggest that the tub was installed without using a mortar base.
2 - There is a chip in the tub surface.
A licensed general contractor should be contacted to repair and complete as needed.

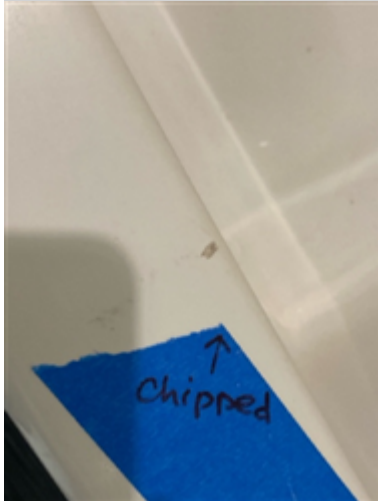
(H3 - 4.2) Bathroom: Private 2nd Left Front

See item #2 in the comment above - Tub

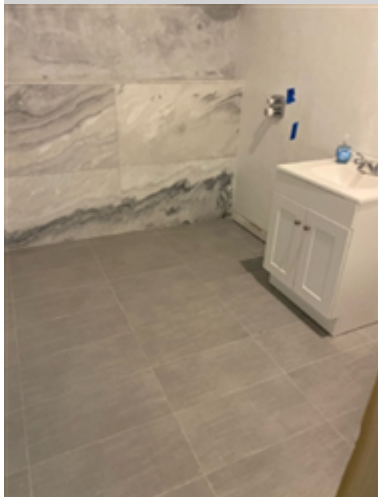
(H3 - 5.1) Bathroom: Private 2nd Right Front

At the private bathroom on the 2nd level (left front) the following was noted:

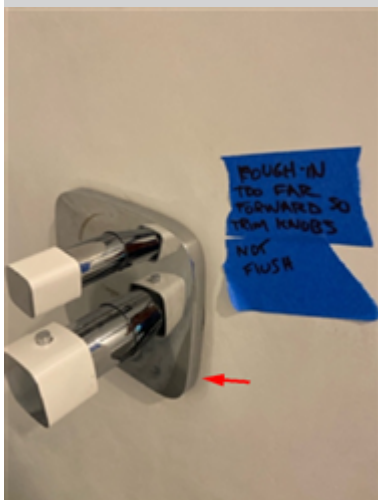
(H3 - 5.2) Bathroom: Private 2nd Right Front

See item #1 in the comment above

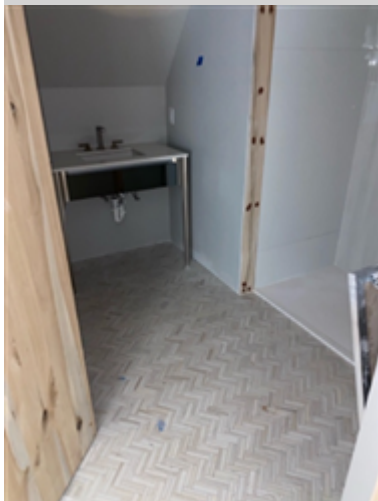
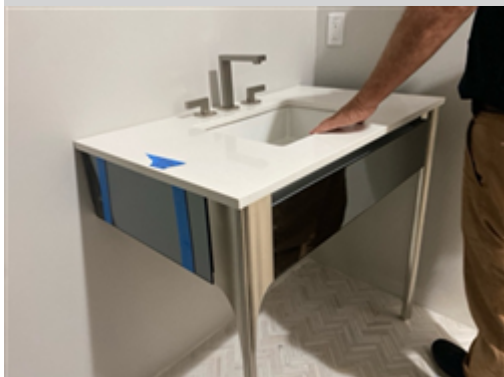
(H3 - 6.1) Bathroom: 3rd Level

At the 3rd level bathroom:
1 - The left side of the vanity is damaged.
2 - The right side tilt drawer hits the wall when opened.
3 - The sink drain installation is incomplete.
A general contractor should be contacted to repair.

See item #1 in the comment above - Vanity

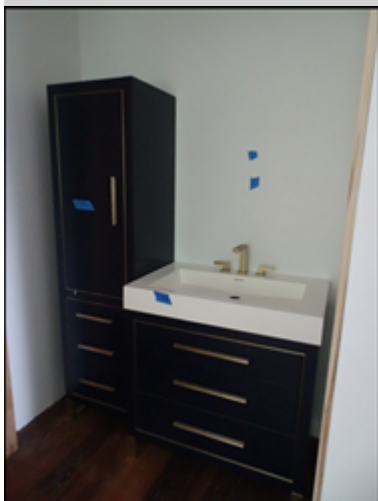
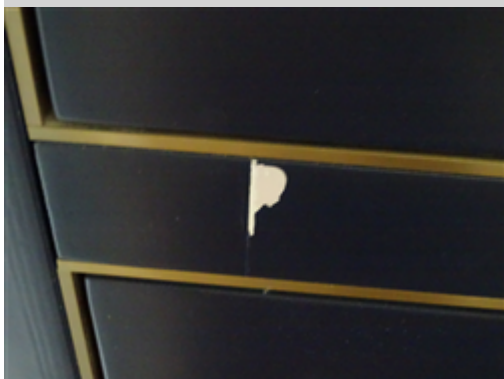
(H3 - 7.1) Hall Sink: 2nd Level

The vanity cabinet in the 2nd level right end hall:
1 - Cabinet is damaged.
2 - The sink surface is damaged.
3 - The drain stop is mismatched.
A general contractor should be contacted to repair.

See item #1 in the comment above

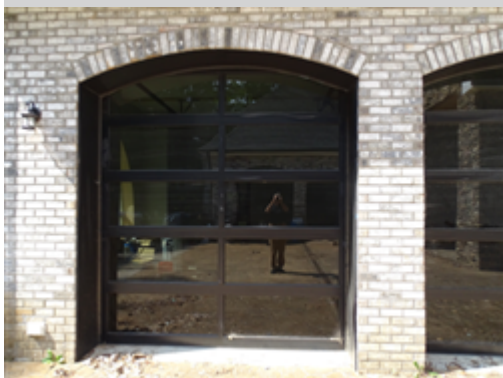
(H4 - 1.1) Garage #1

At the left side garage:
1 - The trim around both garage doors is defective.
2 - Bolts have been left protruding from the floor near utility room door - trip hazard and need to be removed.
A general contractor should be contacted to repair or replace.

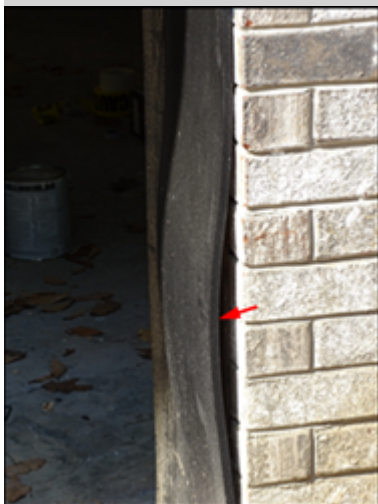
(H4 - 1.2) Garage #1

See item #1 in the comment above - left front door

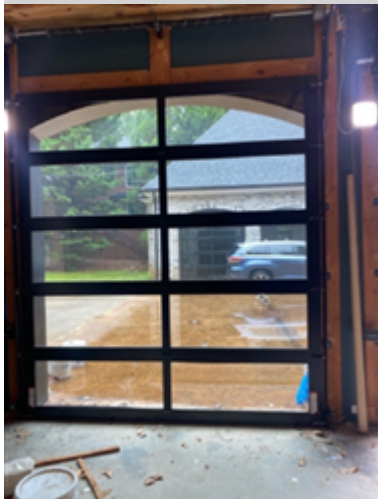
(H4 - 2.1) Garage #2 / Gym

At the garage/gym:
1 - The left side garage door did not respond to the operator to open the door. Repair is needed. A garage door installation company should be consulted for evaluation and repair to ensure that the door operates safely and properly.
2 - There are two (electrical) boxes in the floor of the gym that extend above the surface that are a trip hazard. A general contractor should be contacted to repair.

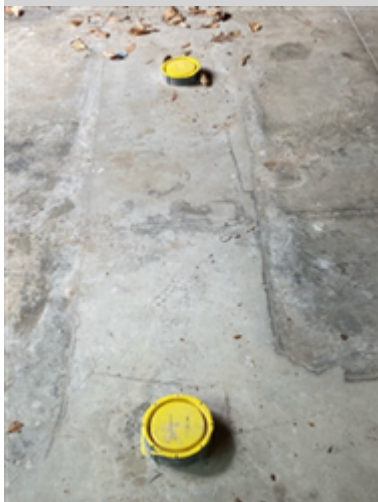
(H4 - 2.2) Garage #2 / Gym

See item #2 in the comment above

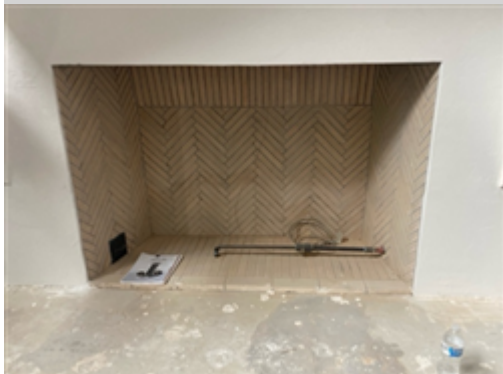
(H6 - 1.1) Fireplace: Masonry

The family room fireplace hearth installation is incomplete. A general contractor should be contacted.

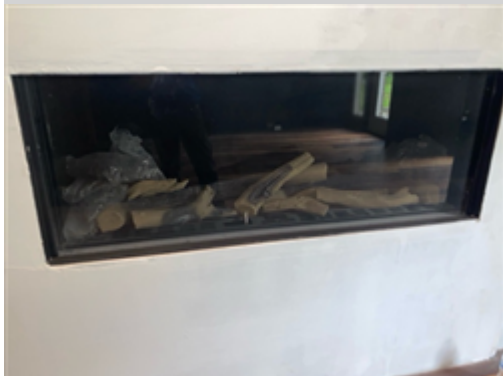
(H6 - 2.1) Fireplace: Pre-Manufactured: Metal

The master bedroom fireplace installation is incomplete and was not operated. The fireplace installation company should be contacted for further evaluation and completion.

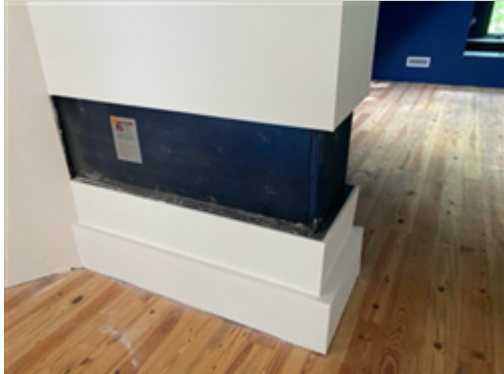
(H6 - 3.1) Fireplace: Pre-Manufactured: Metal

The 3rd floor fireplace installation is incomplete and was not operated. The fireplace installation company should be contacted for further evaluation and completion.
