Correction needed

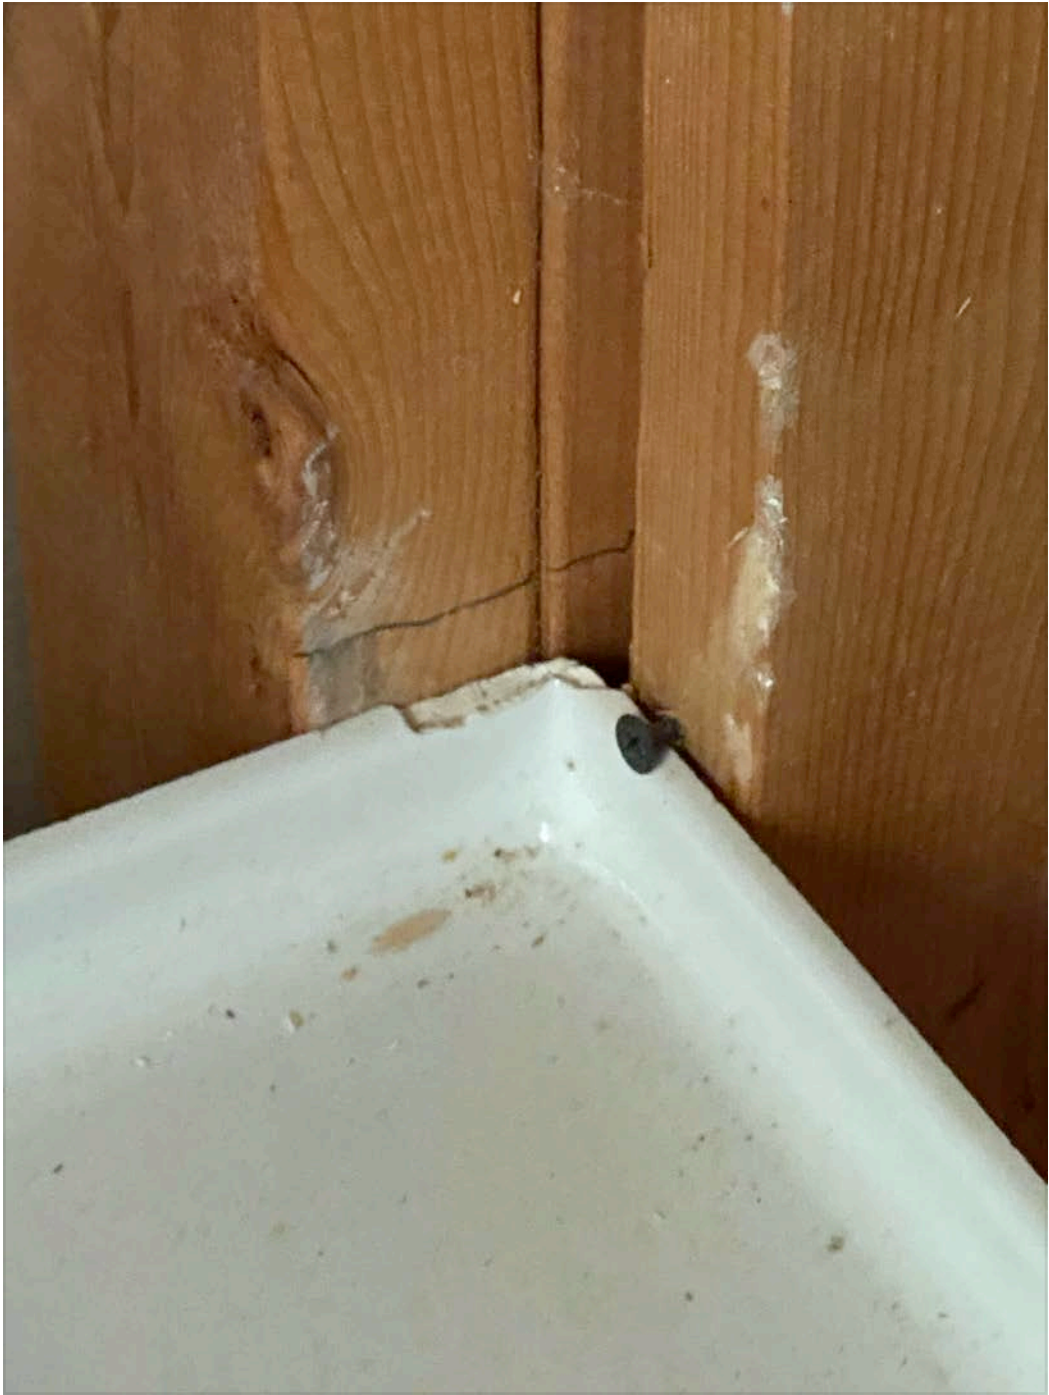
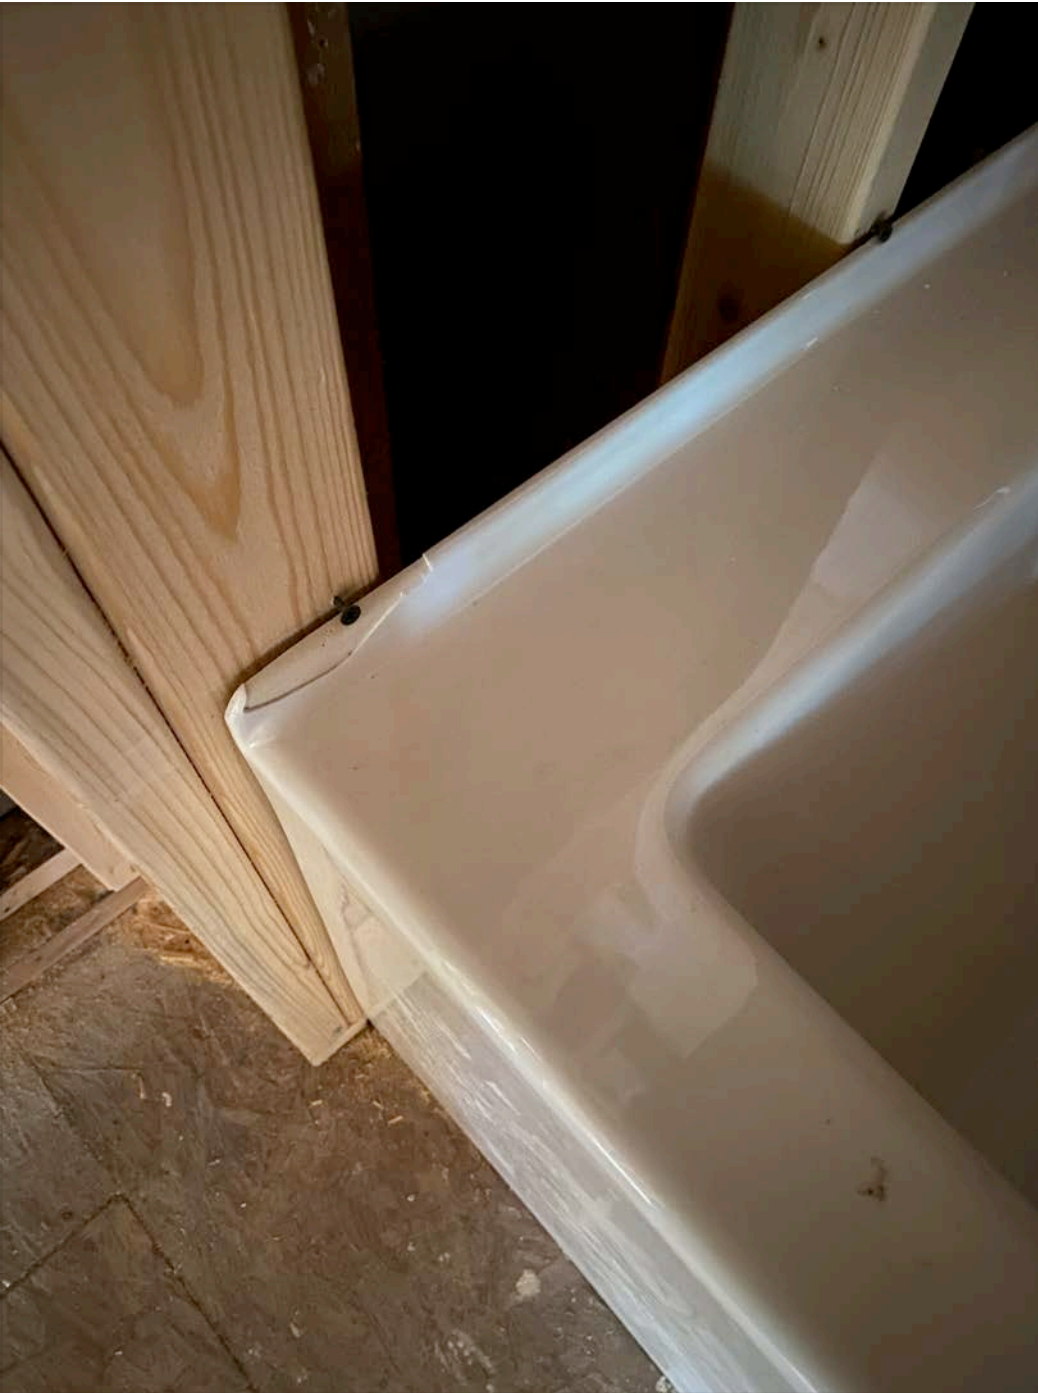
Two tub finishes broken when installed by WH, Andrew bath and Patrick bath

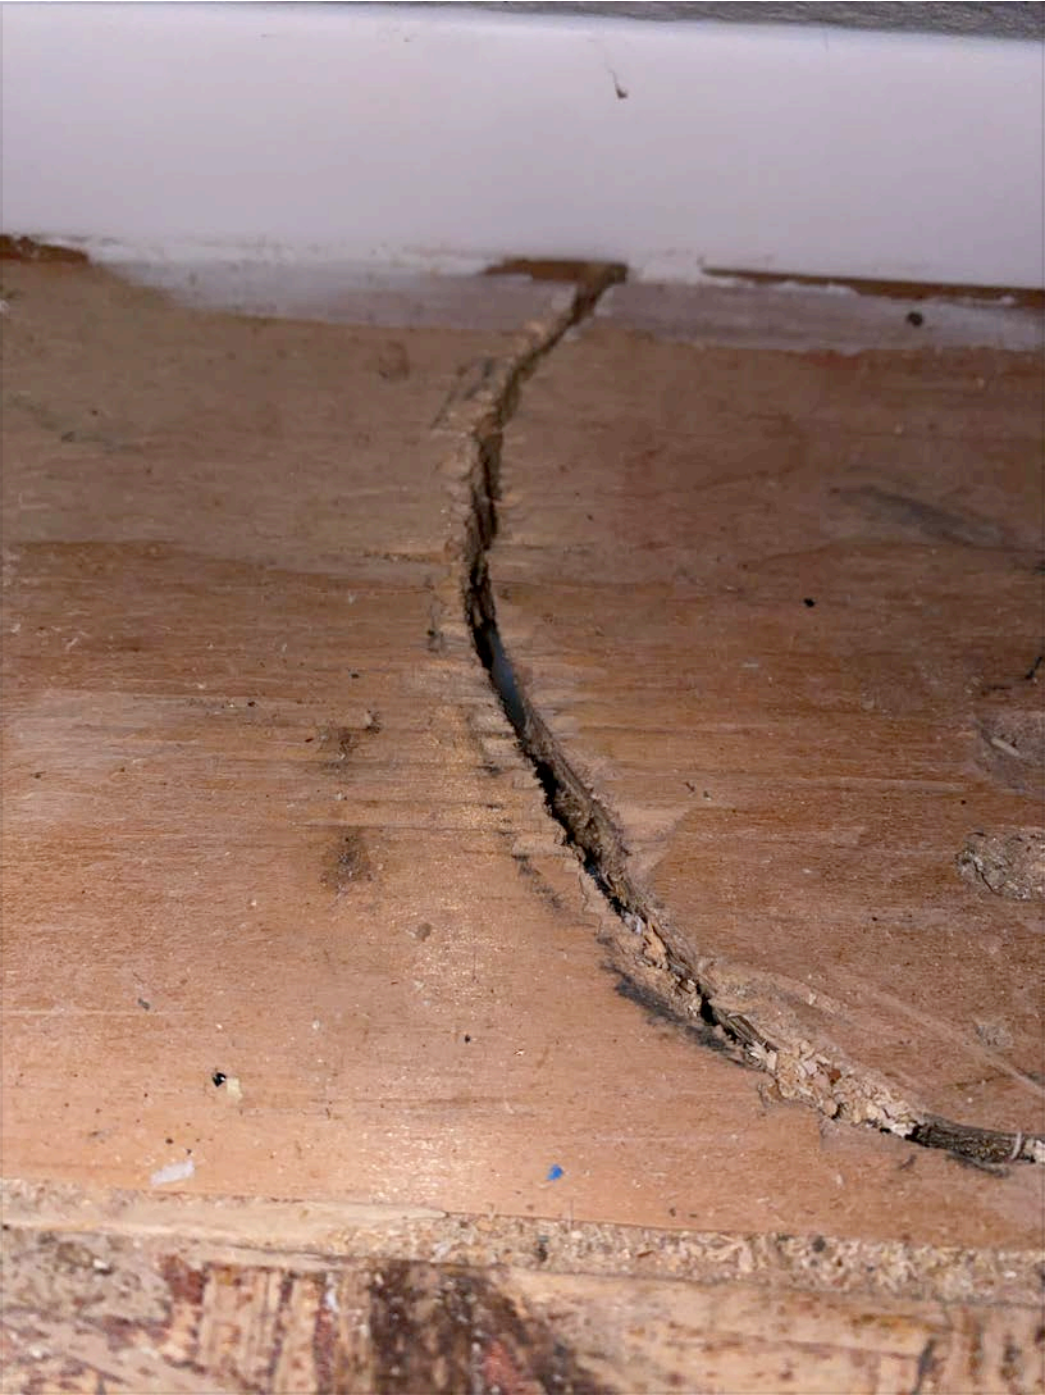
Third floor shower pan installed over circular cut portion of mismatched subfloor without consideration of adjacent marble flooring and what is necessary to exist underneath to support that:

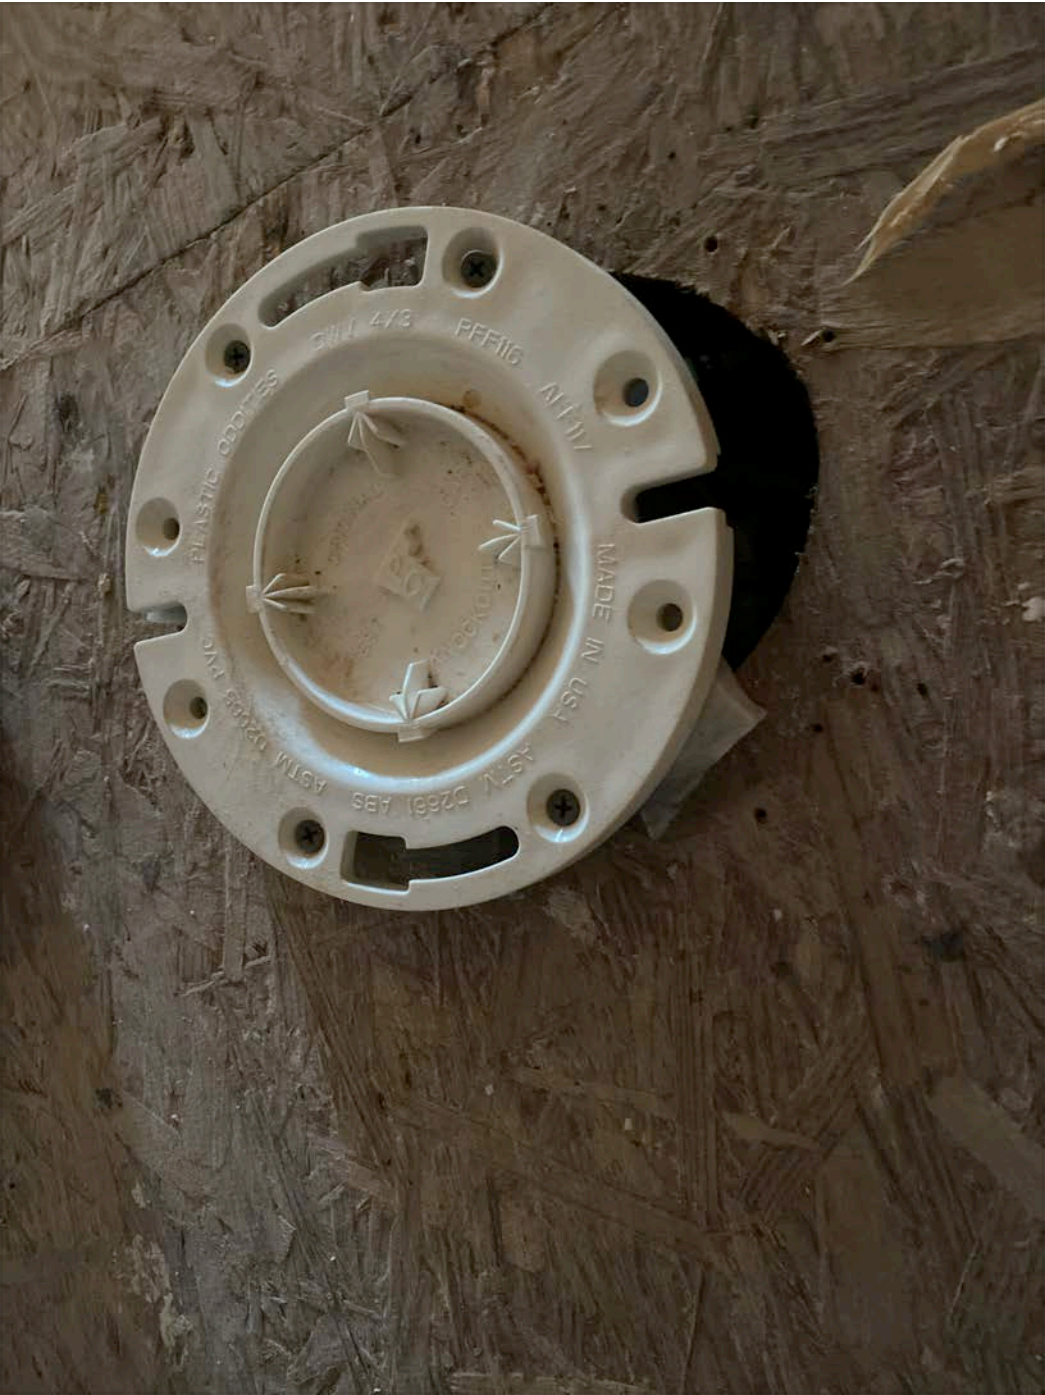
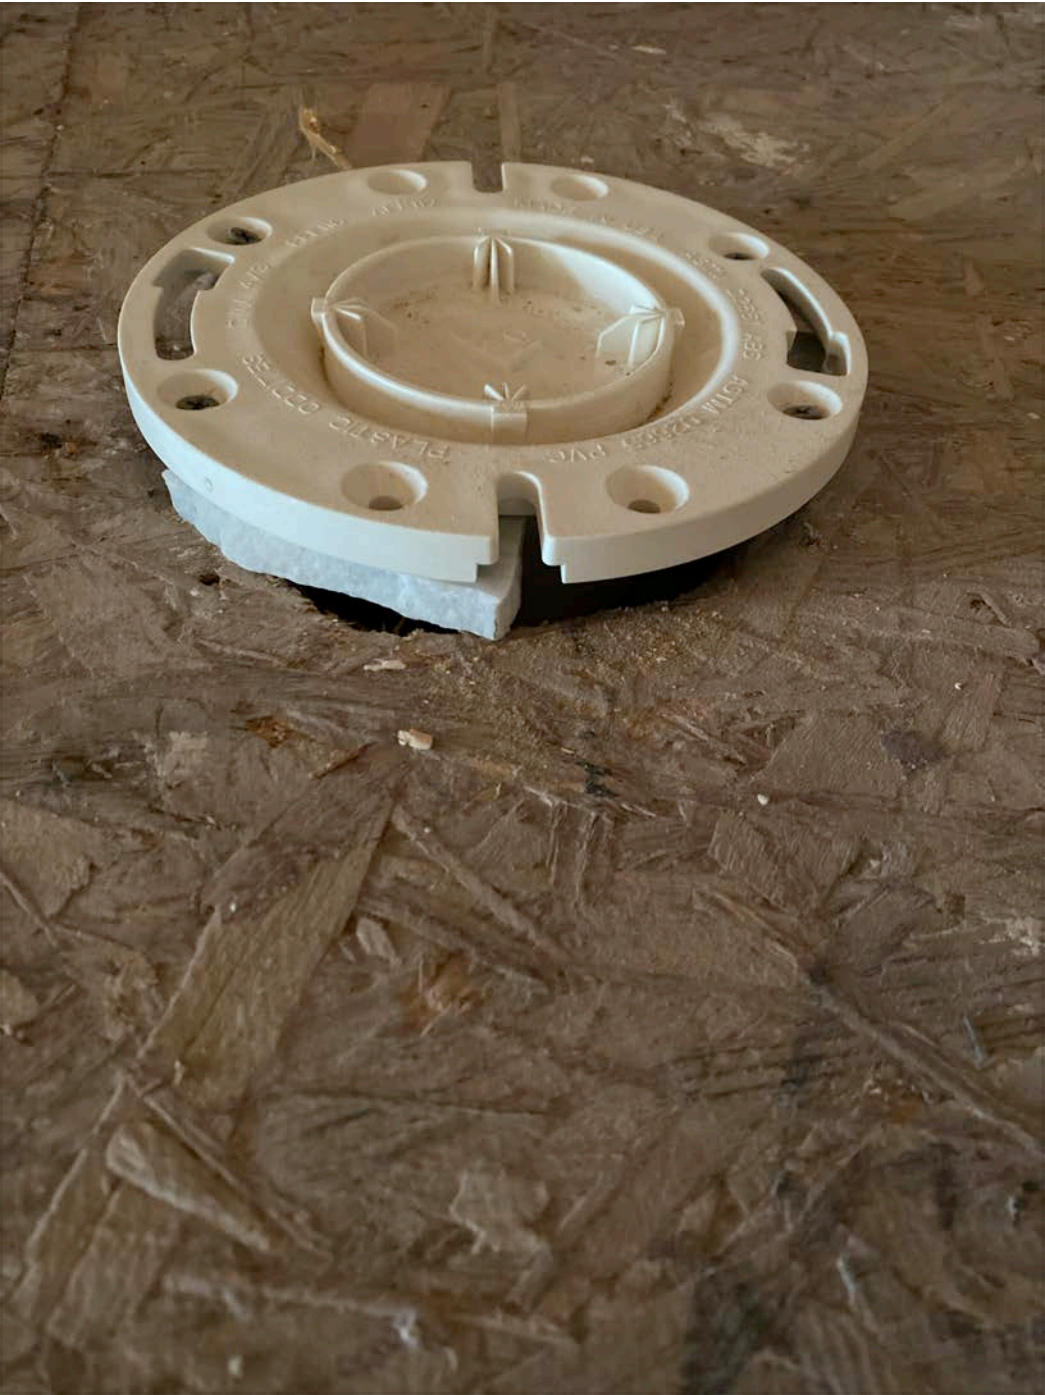
2nd floor bathroom toilet drain not secure

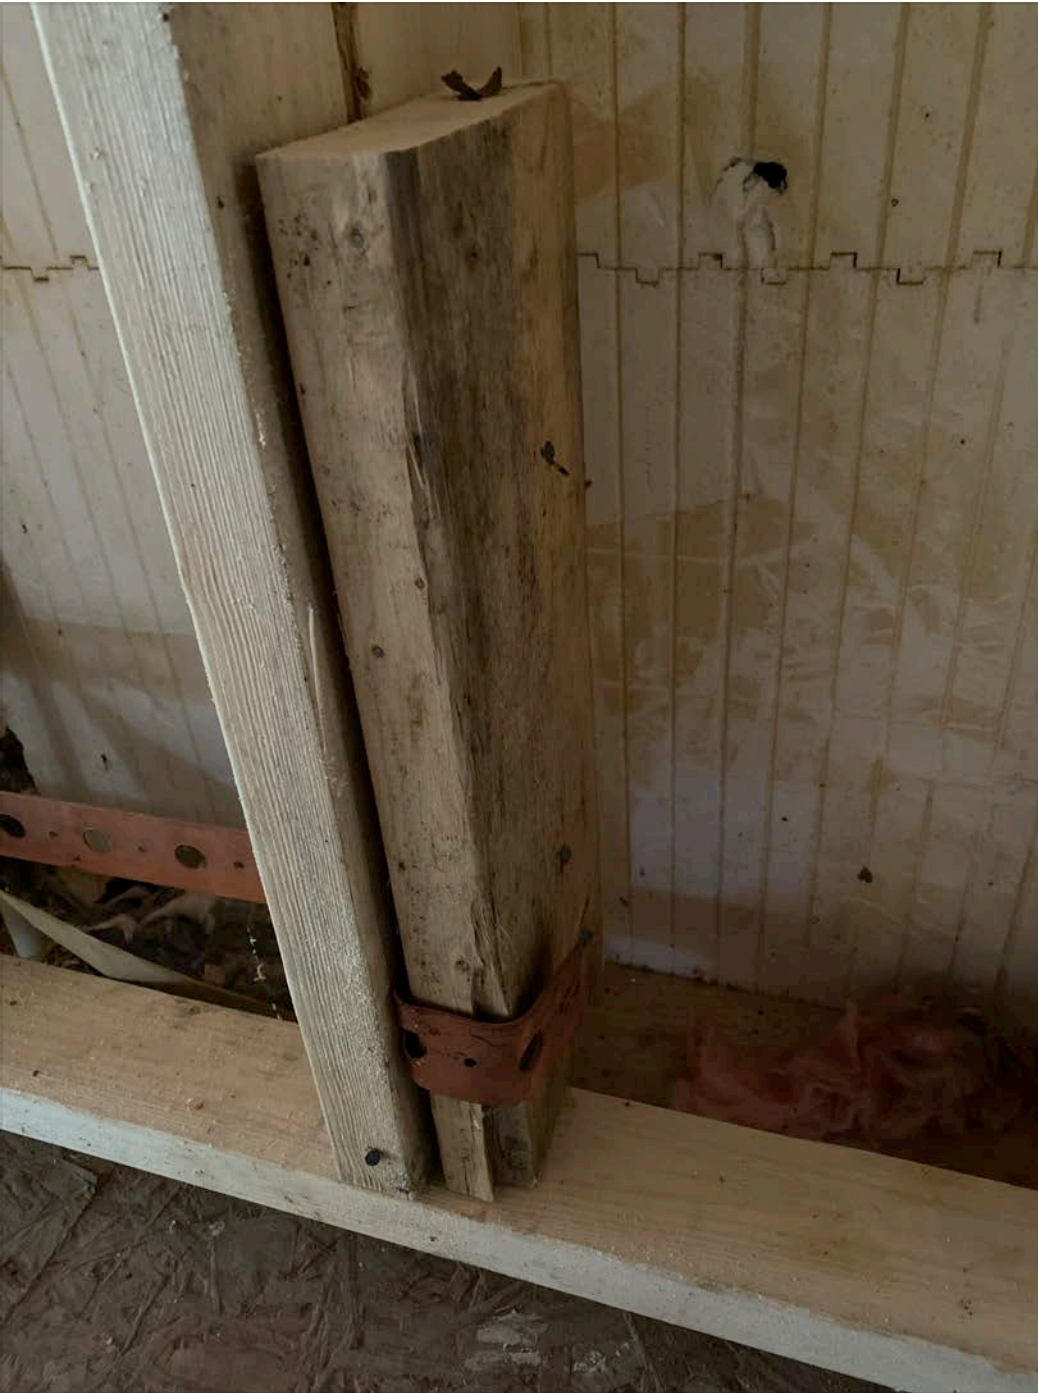
Framing incorporates salvage / molded / unsuitable materials, examples:

Moldy boards used in framing of guest bathroom

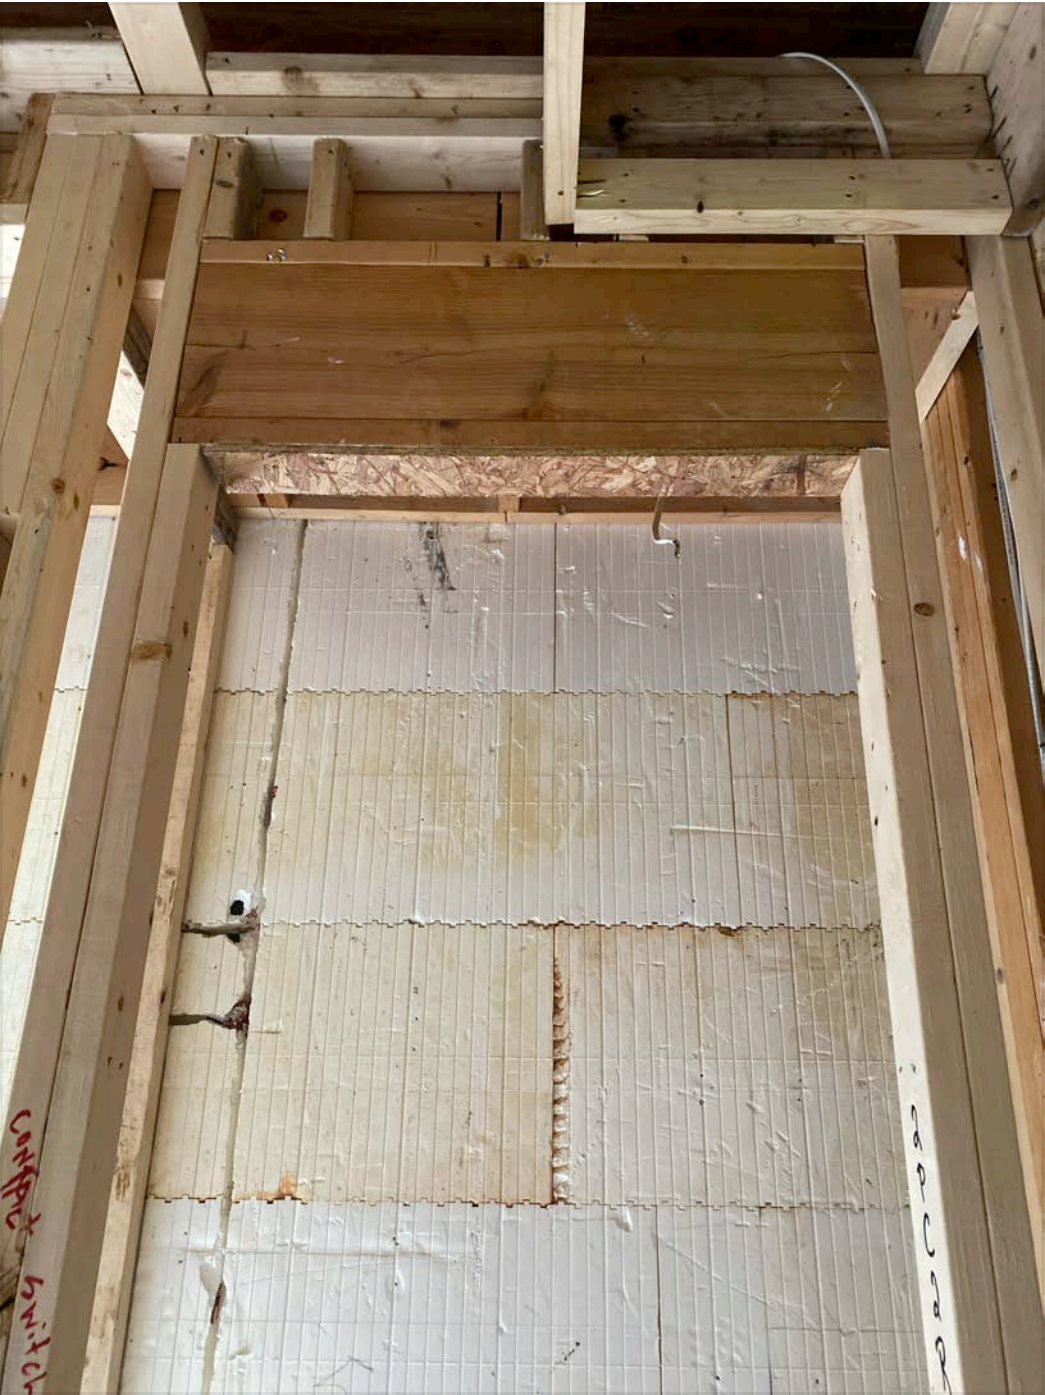
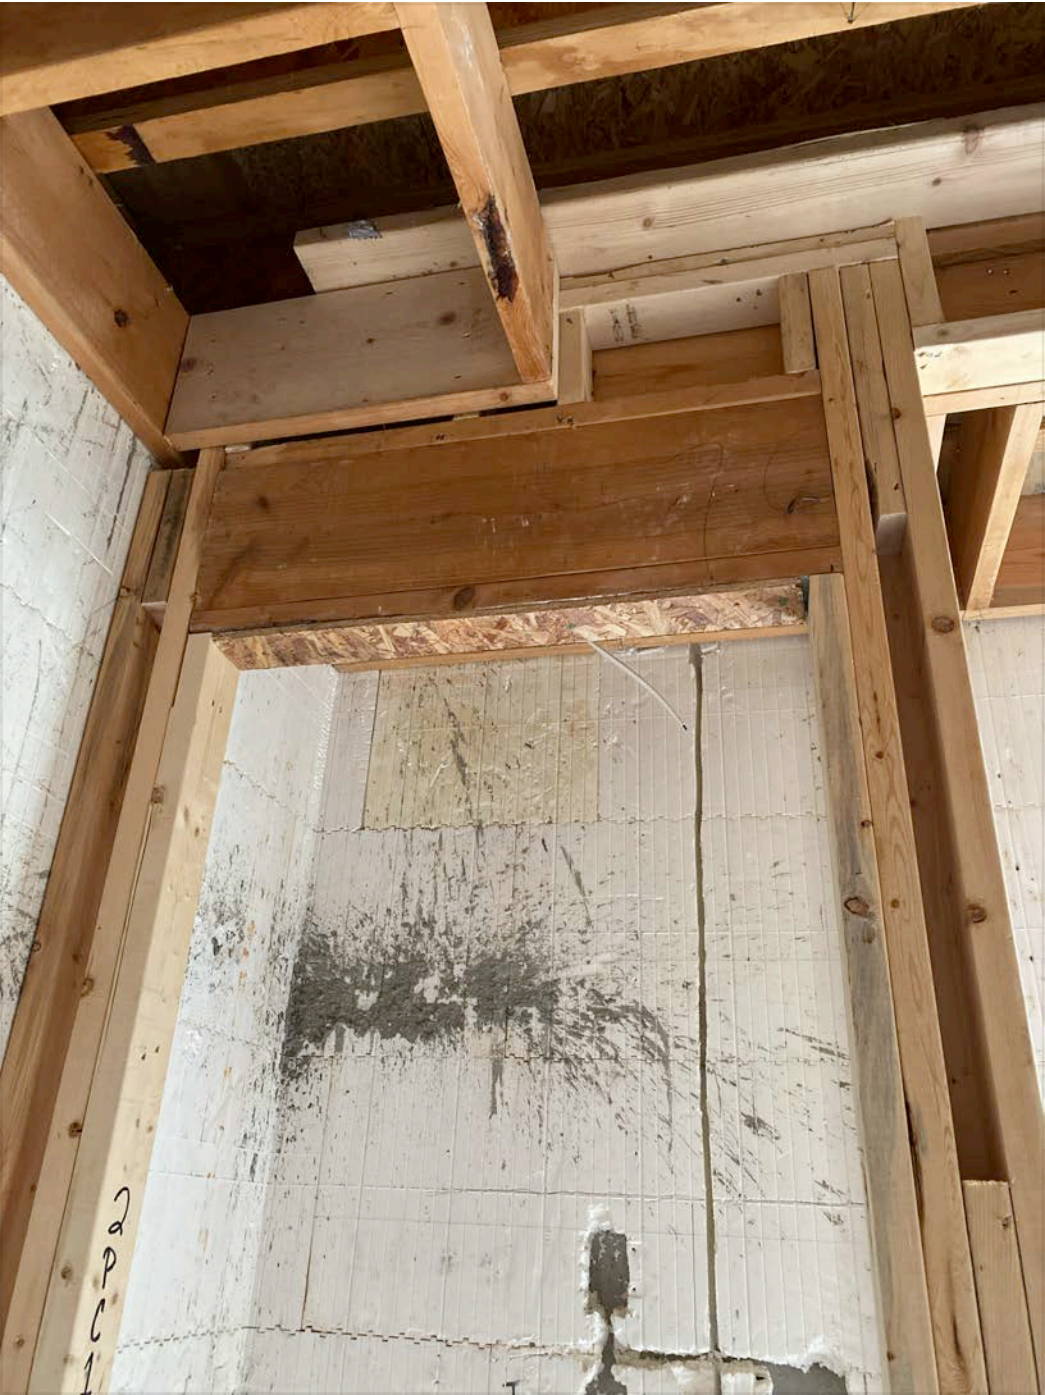
Old materials from original closet header cut in half and reused in both of Patrick's closet headers:

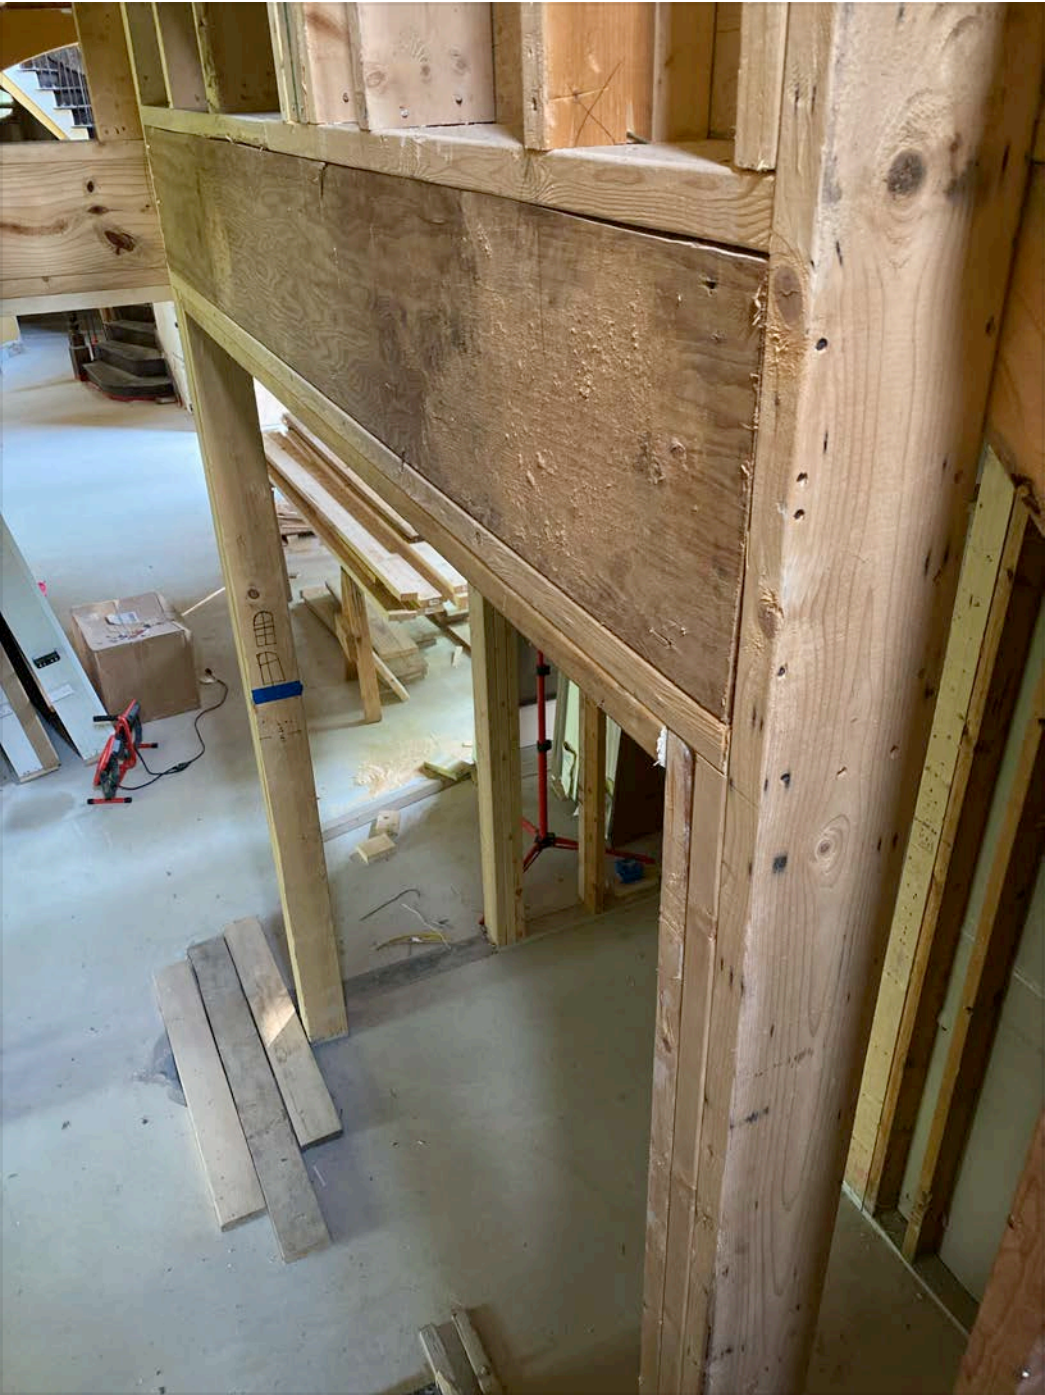
Muddy salvage header installed in mud room entry:

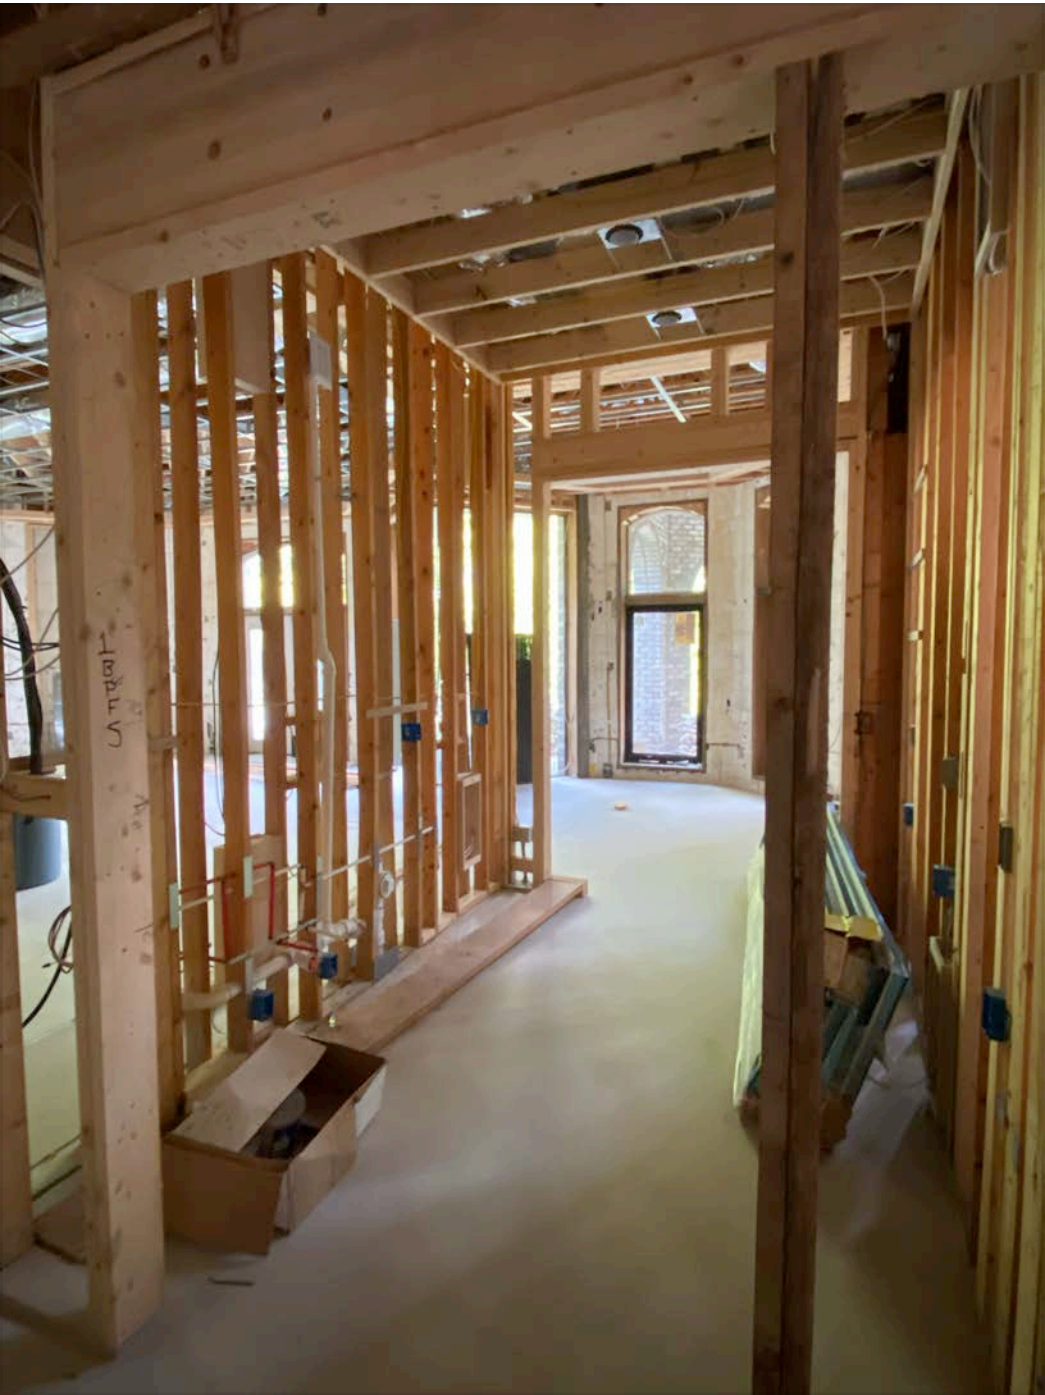
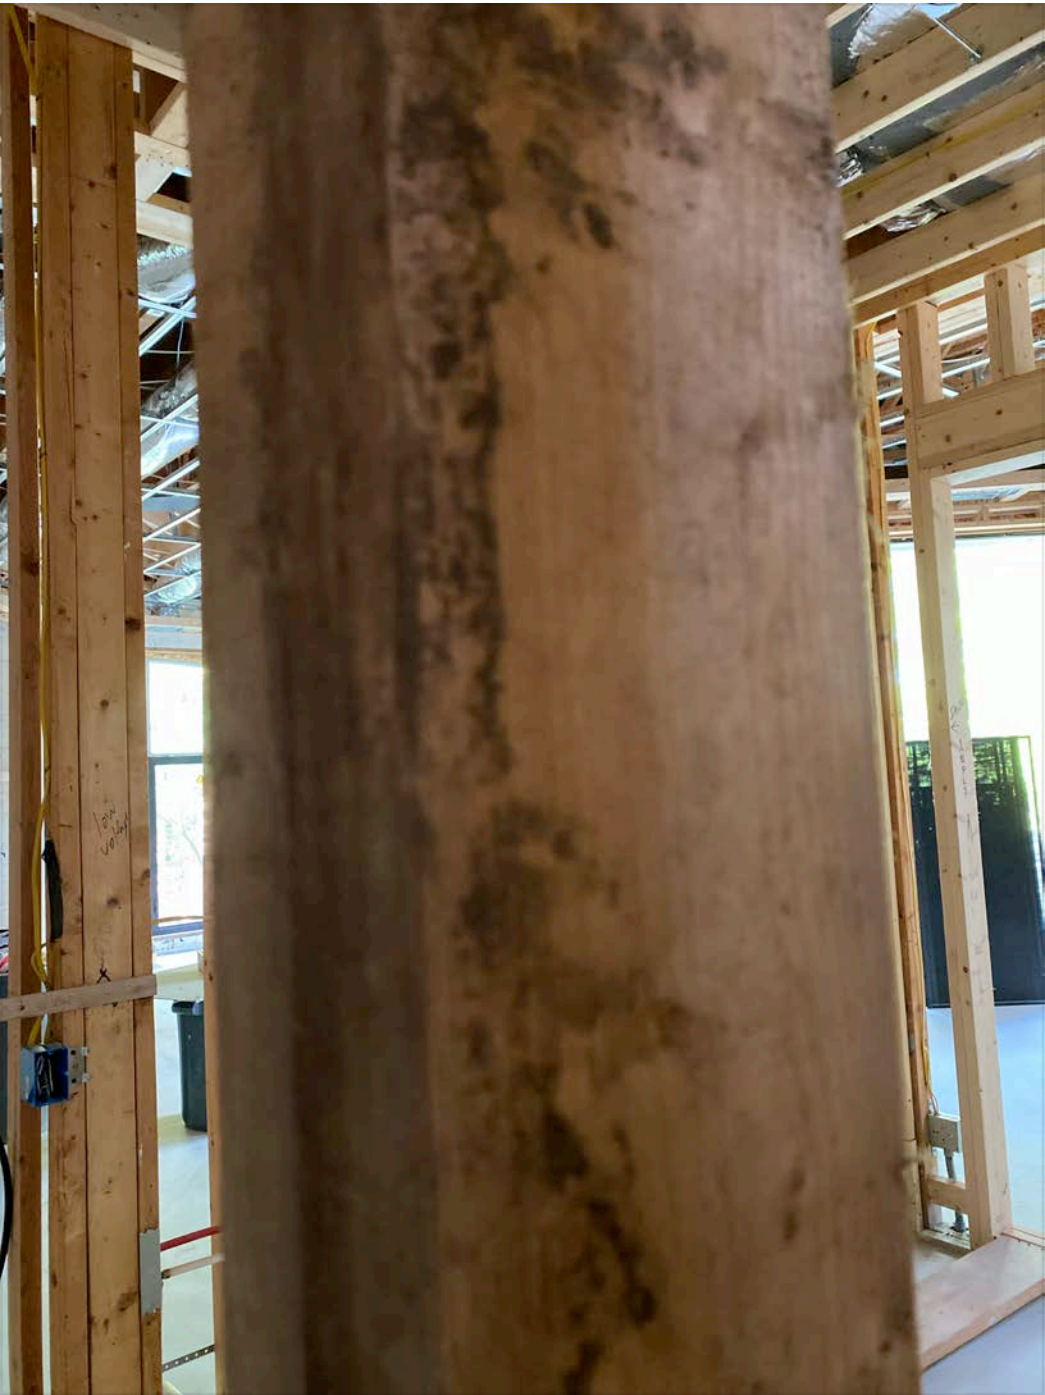
Moldy boards used in pantry entry framing

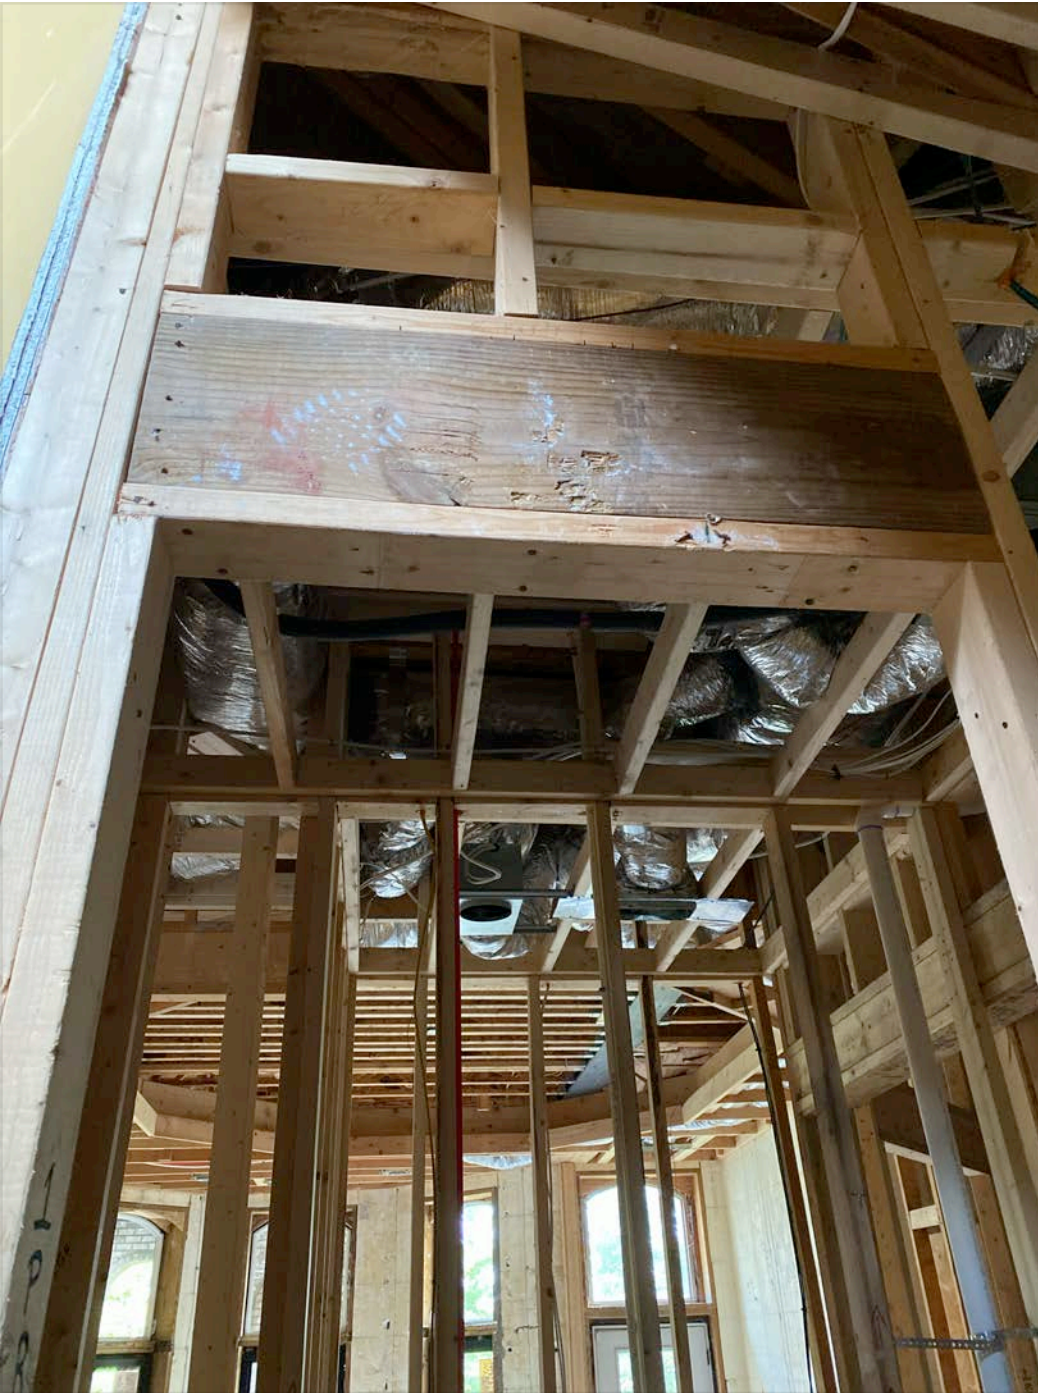
Salvage header used in entry to powder room

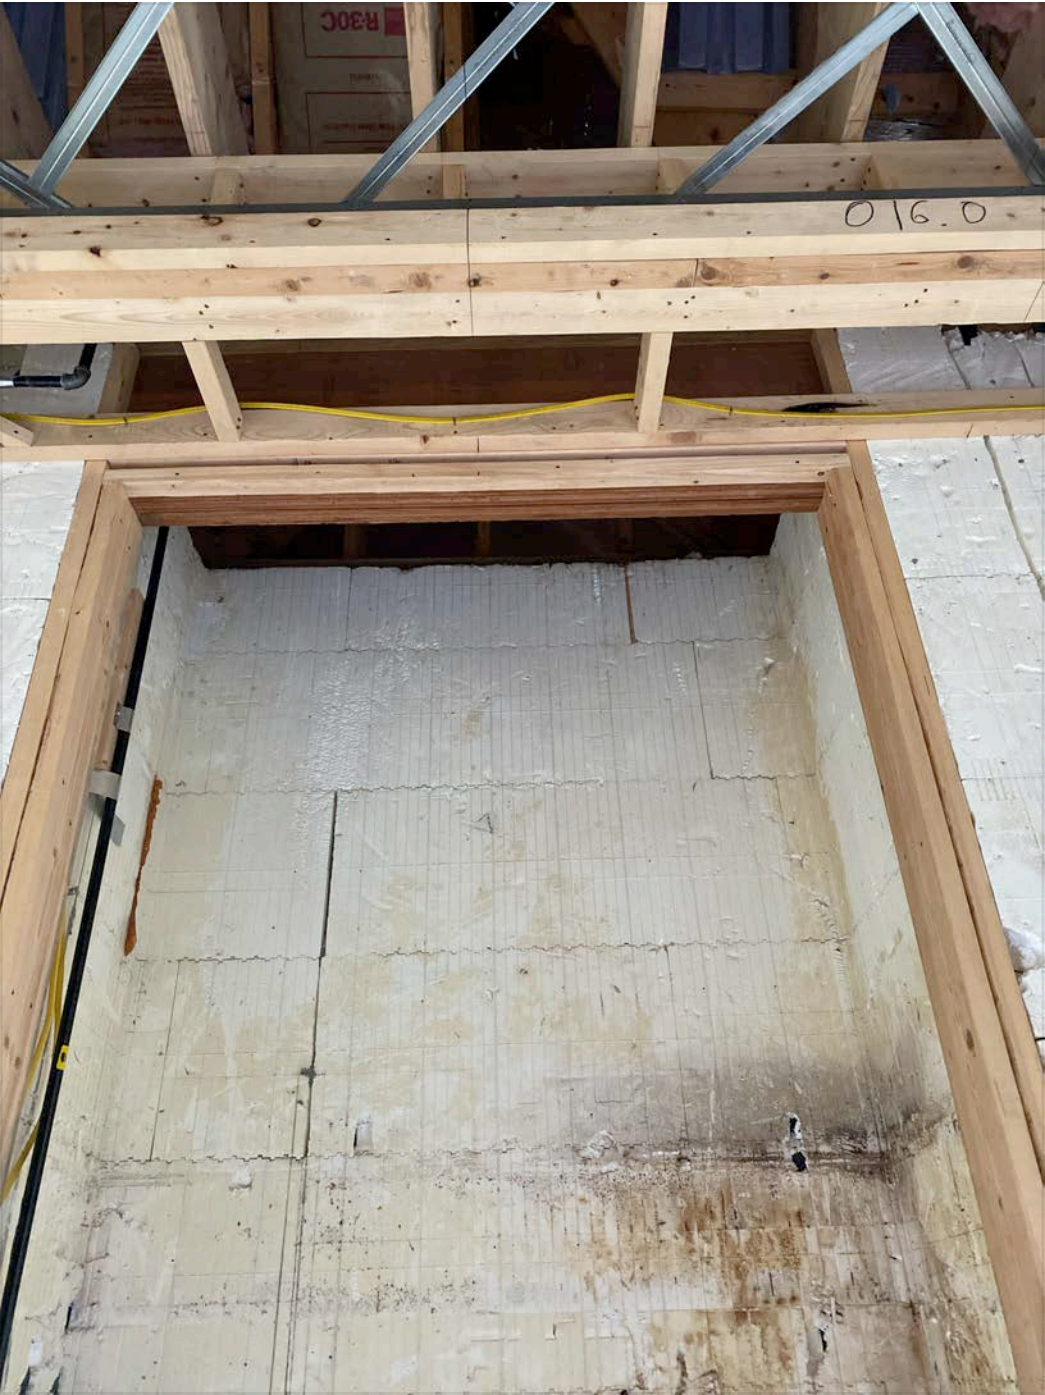
The engineered beam in the fireplace area is not sized appropriately to the space and the area is not framed in a way that sufficiently supports the load above (according to the neighborhood architect I brought in who looked at it):
