Correction needed

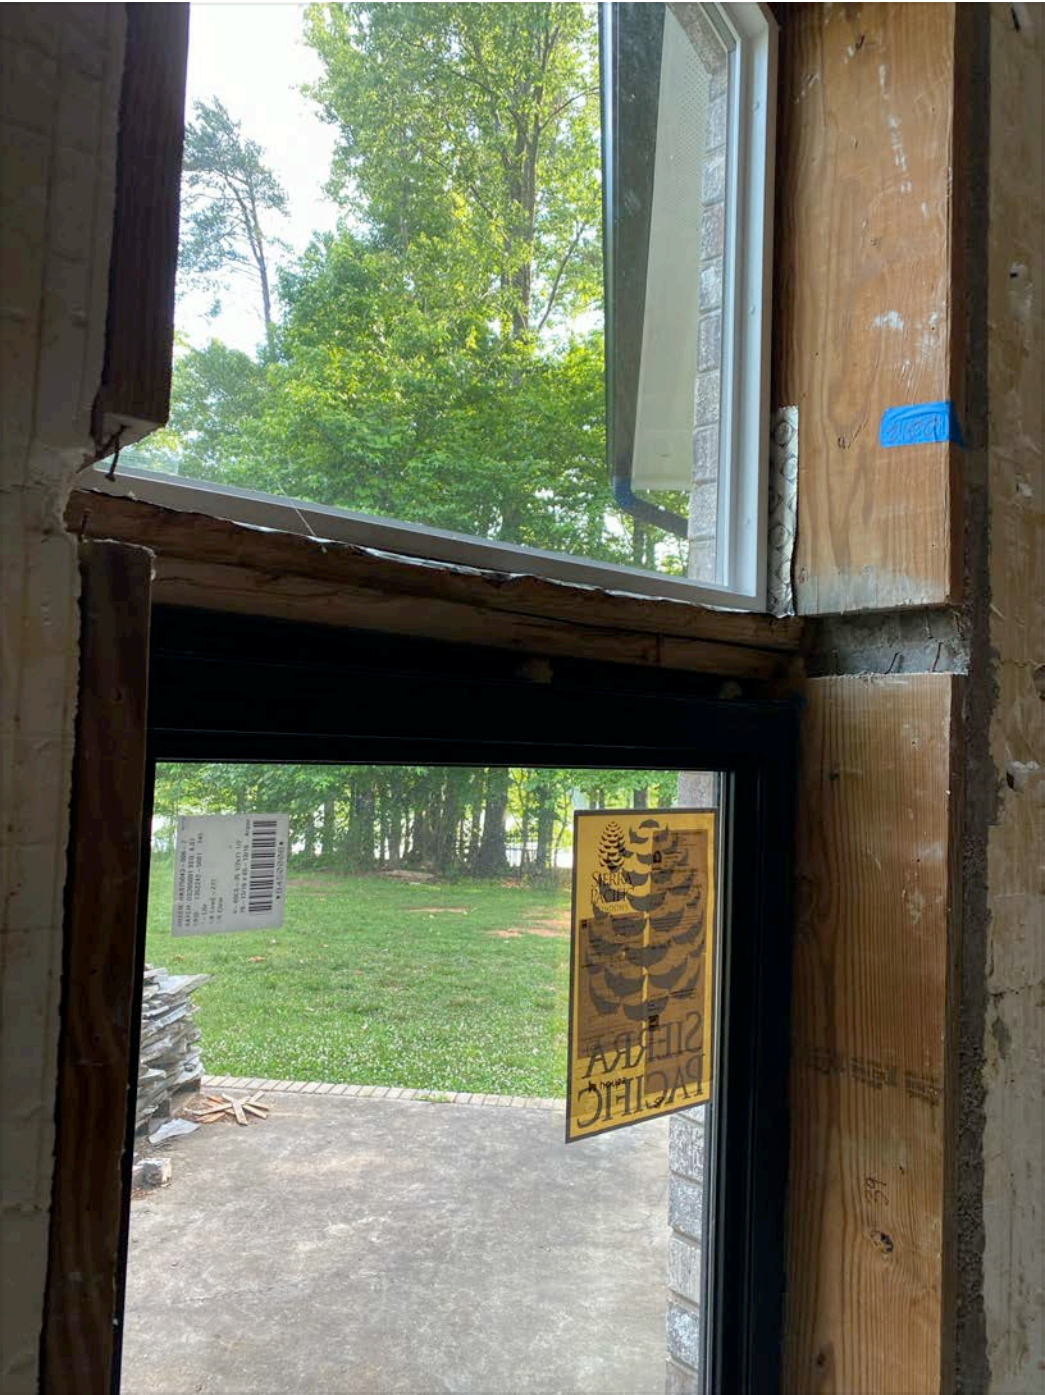
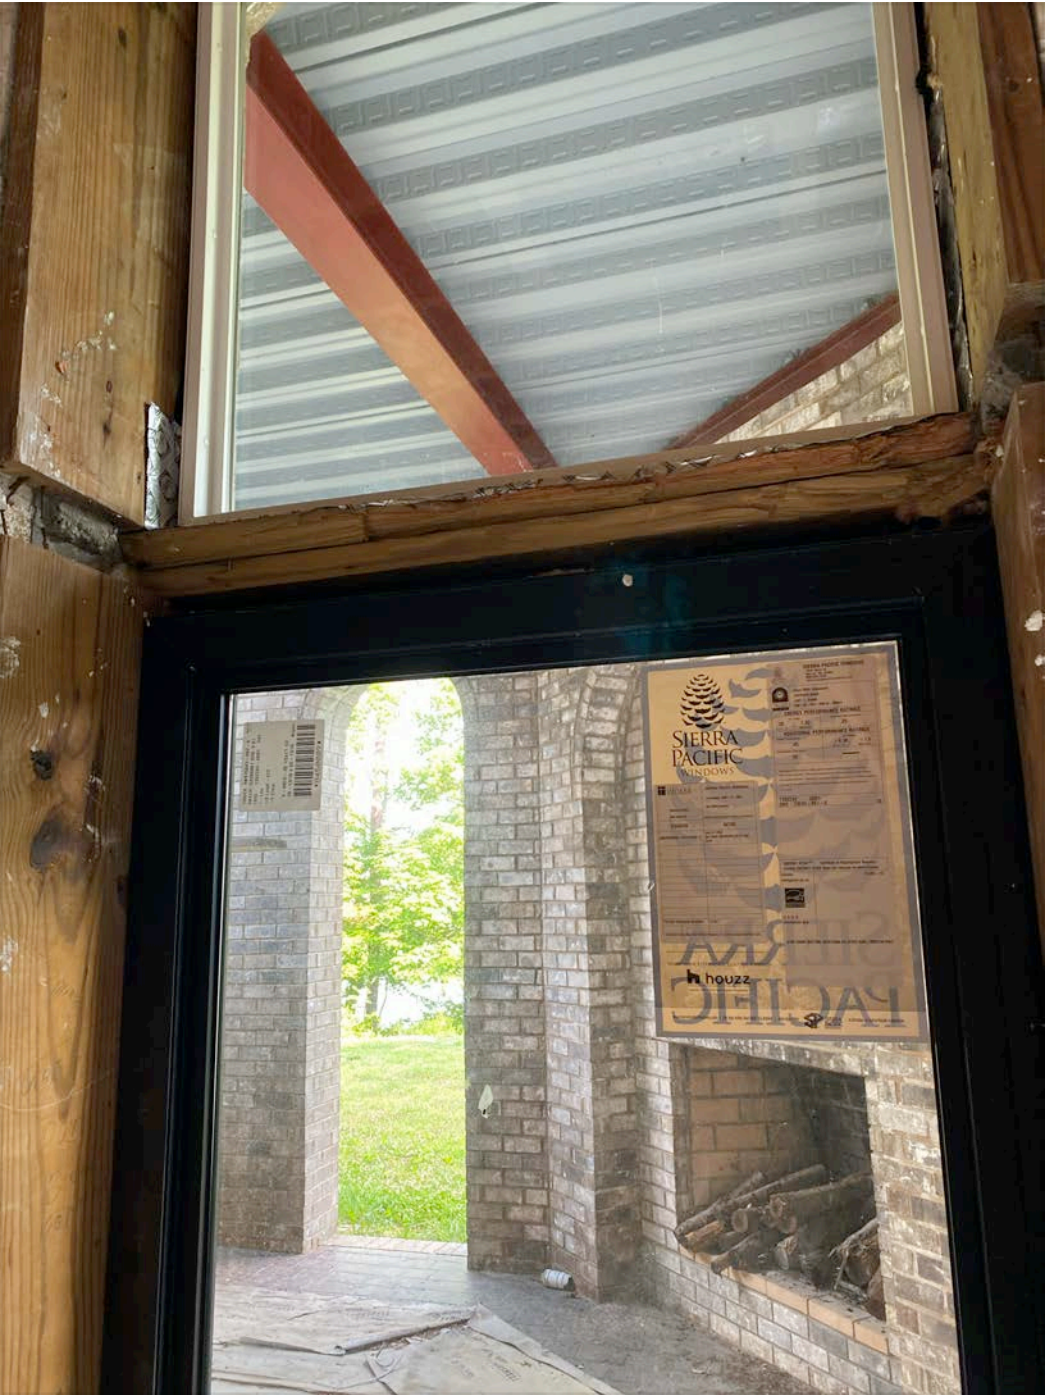
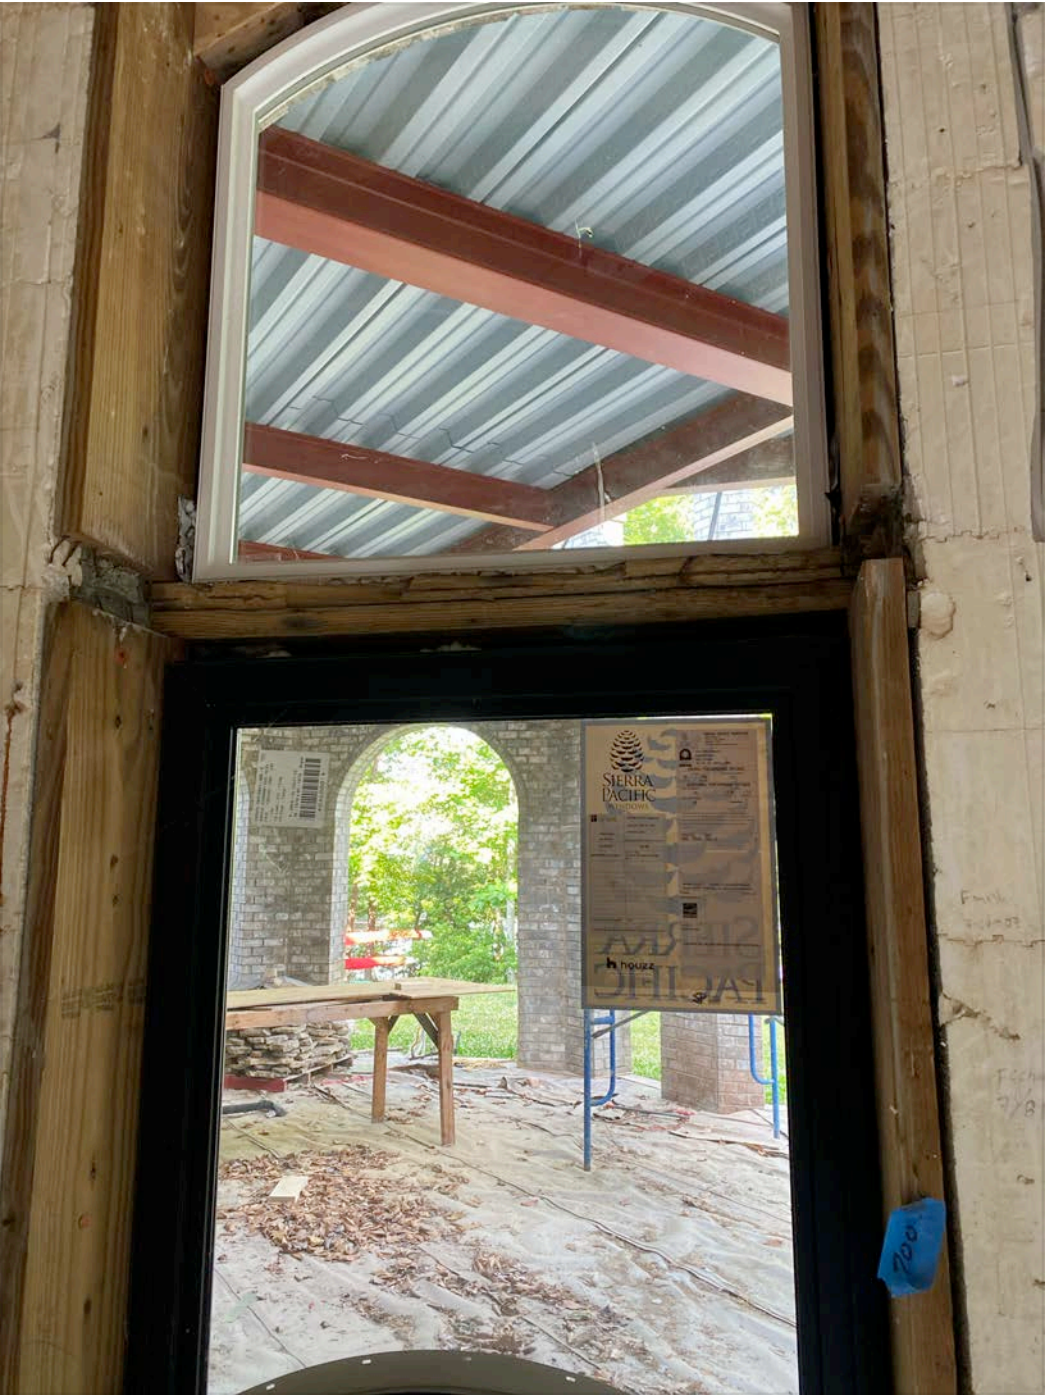
Preparations not made after demo to wooden areas between windows (which will require more time to trim out than it would have taken to remedy prior to window installs):
Master bedroom:

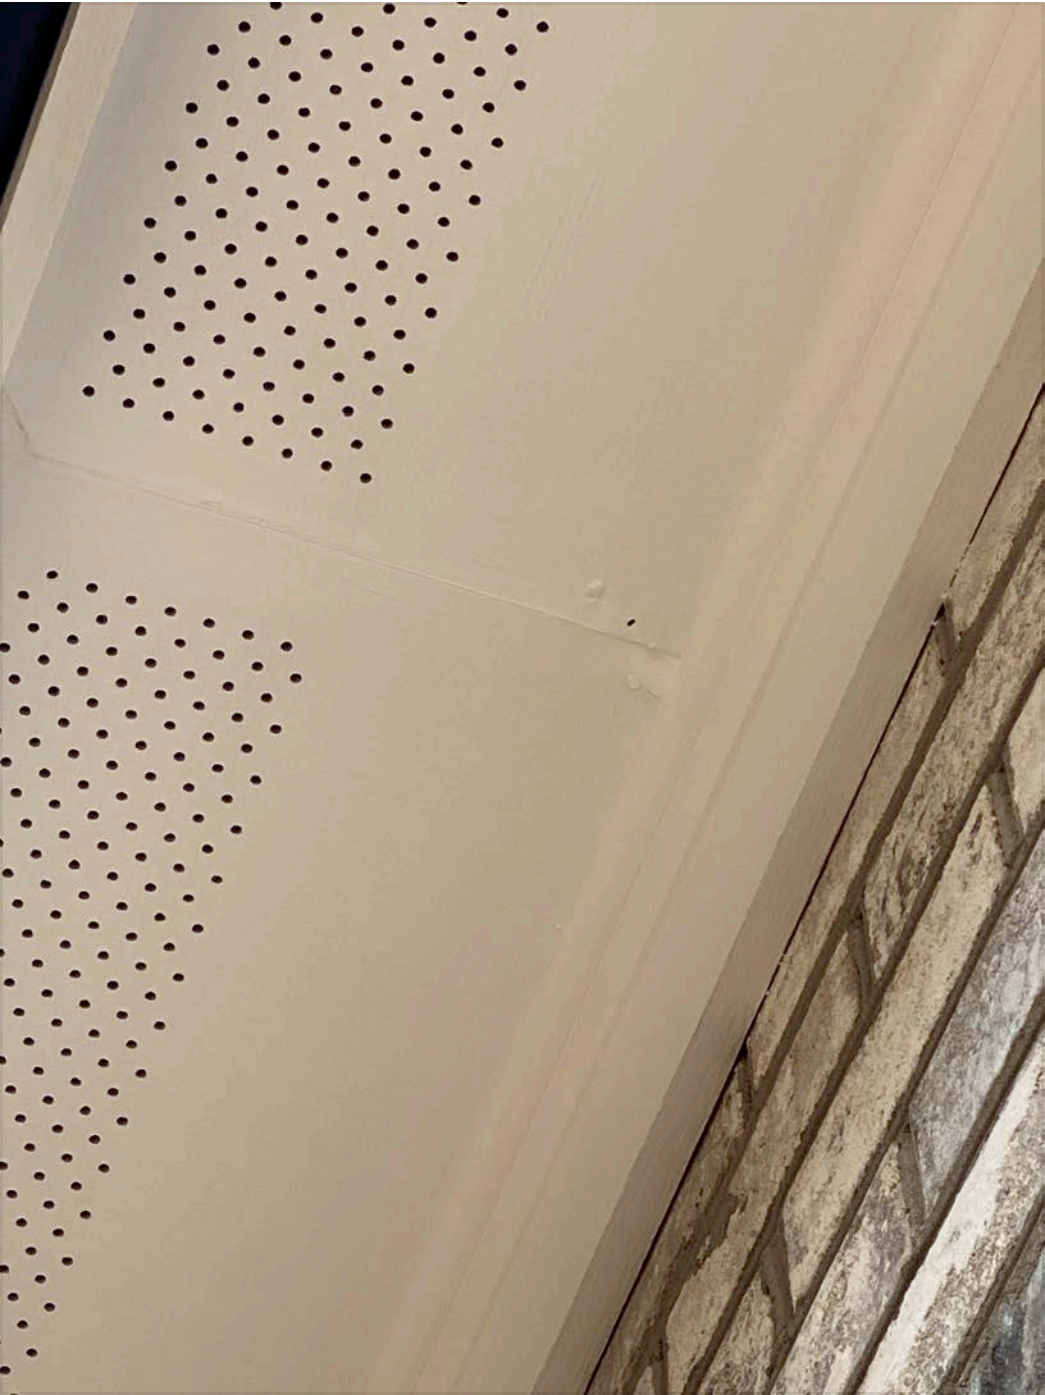
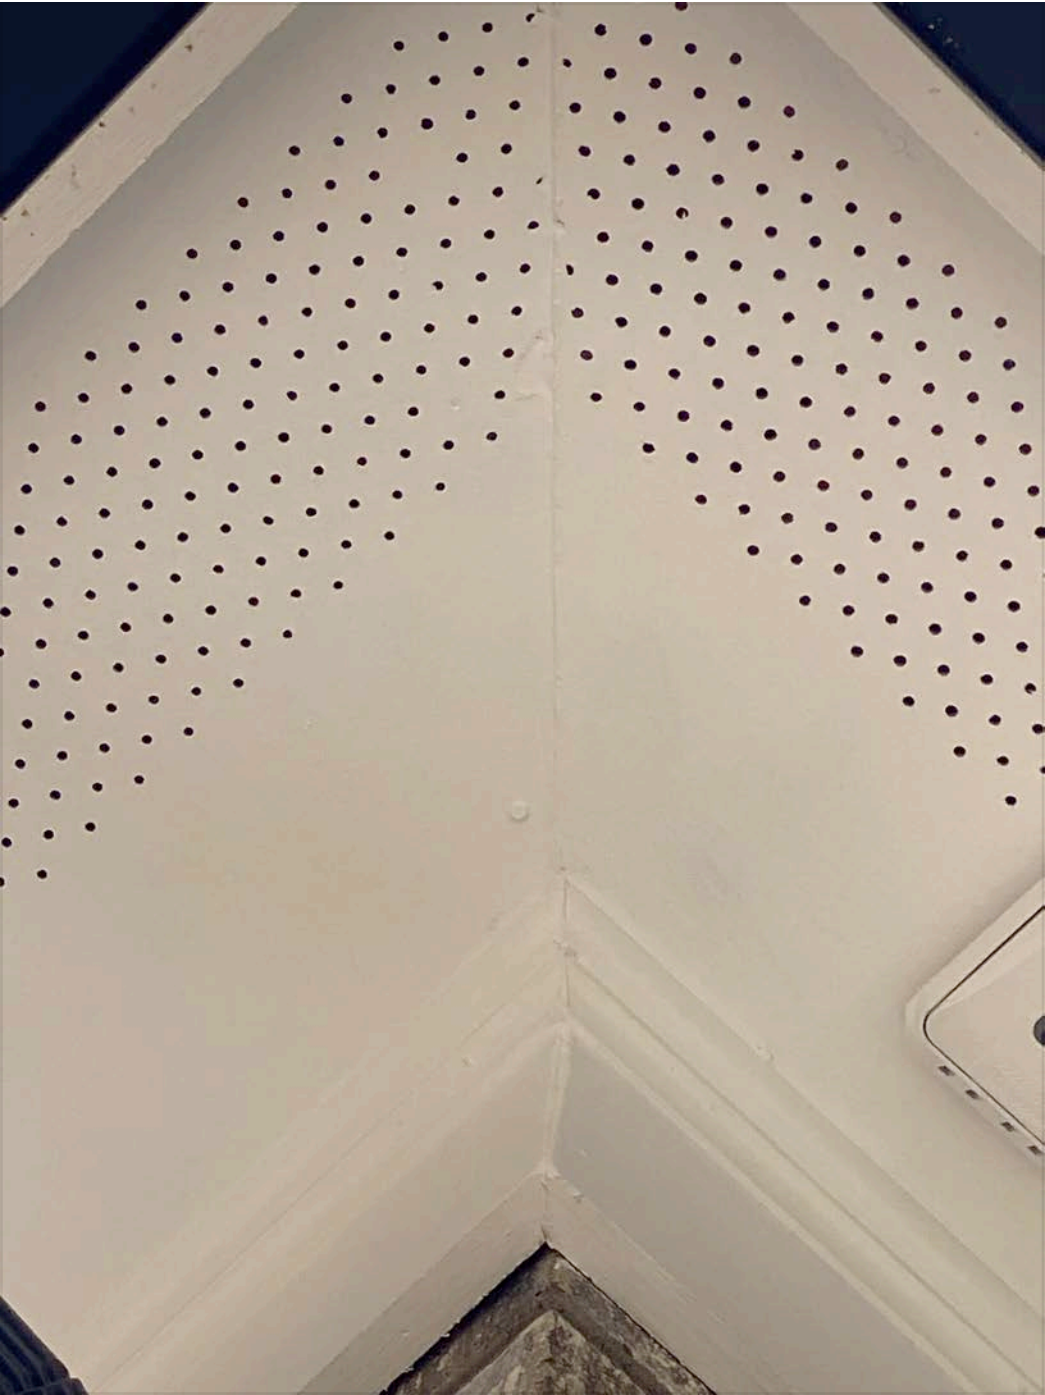
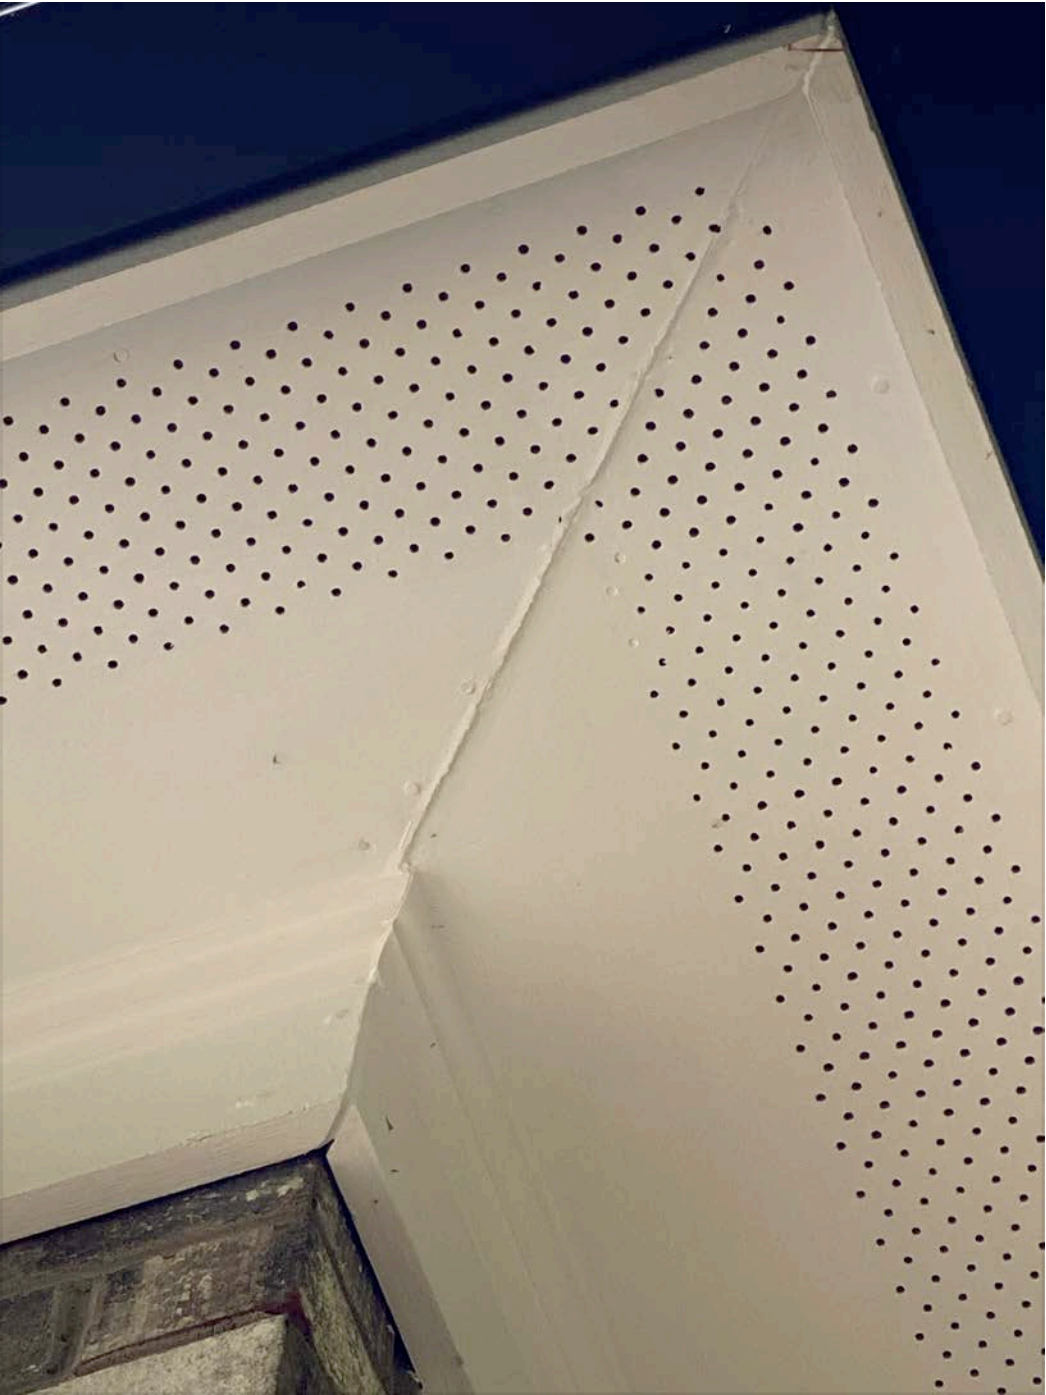
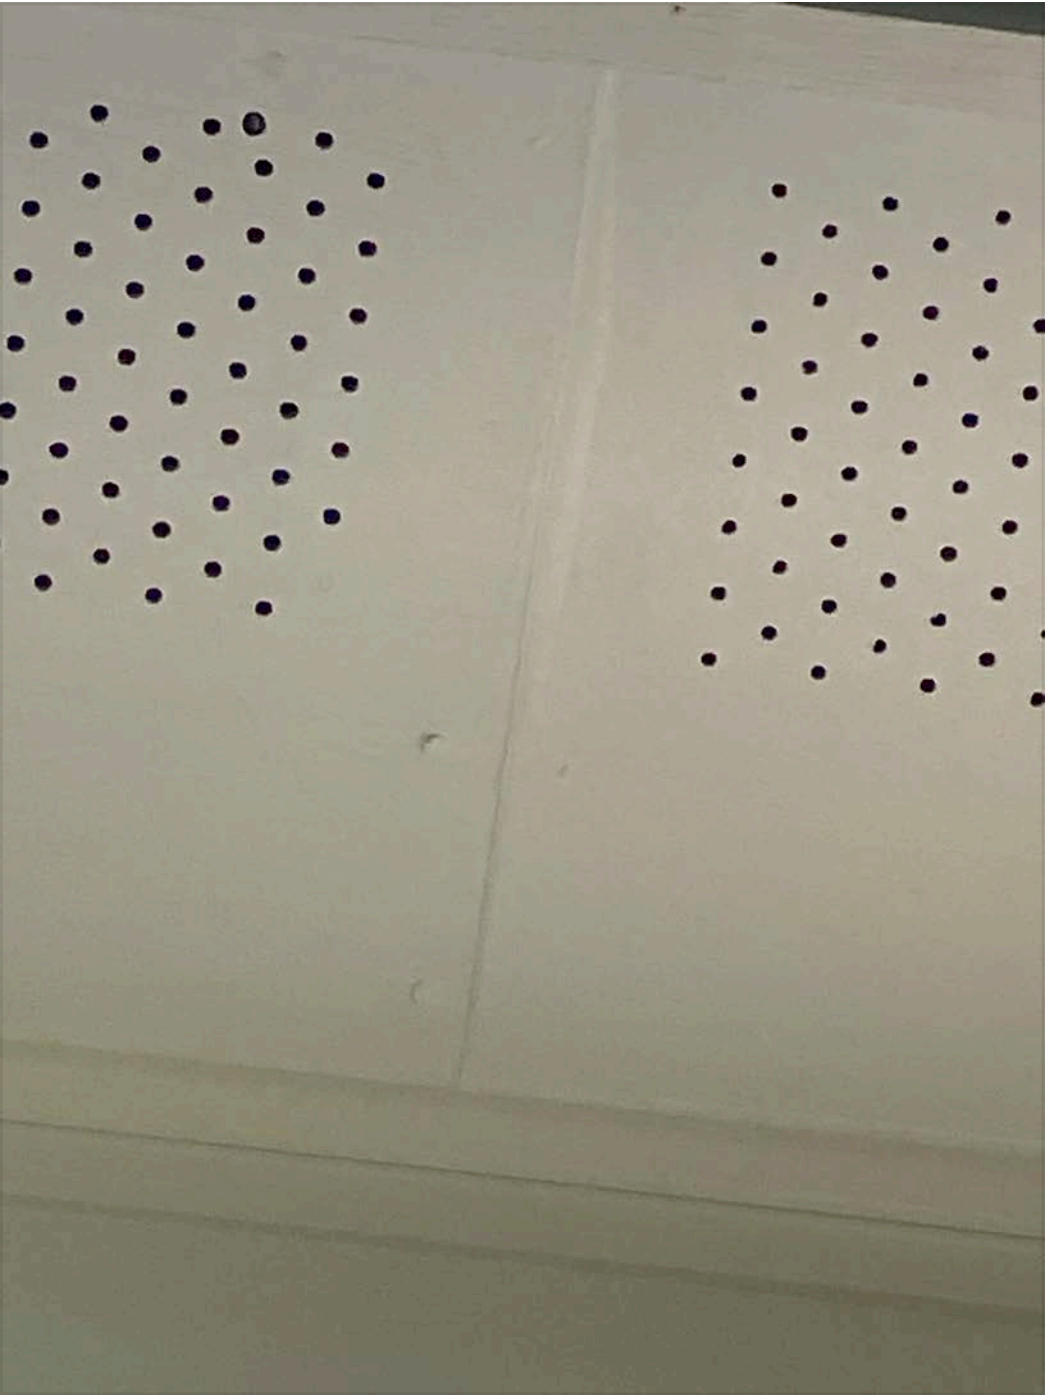
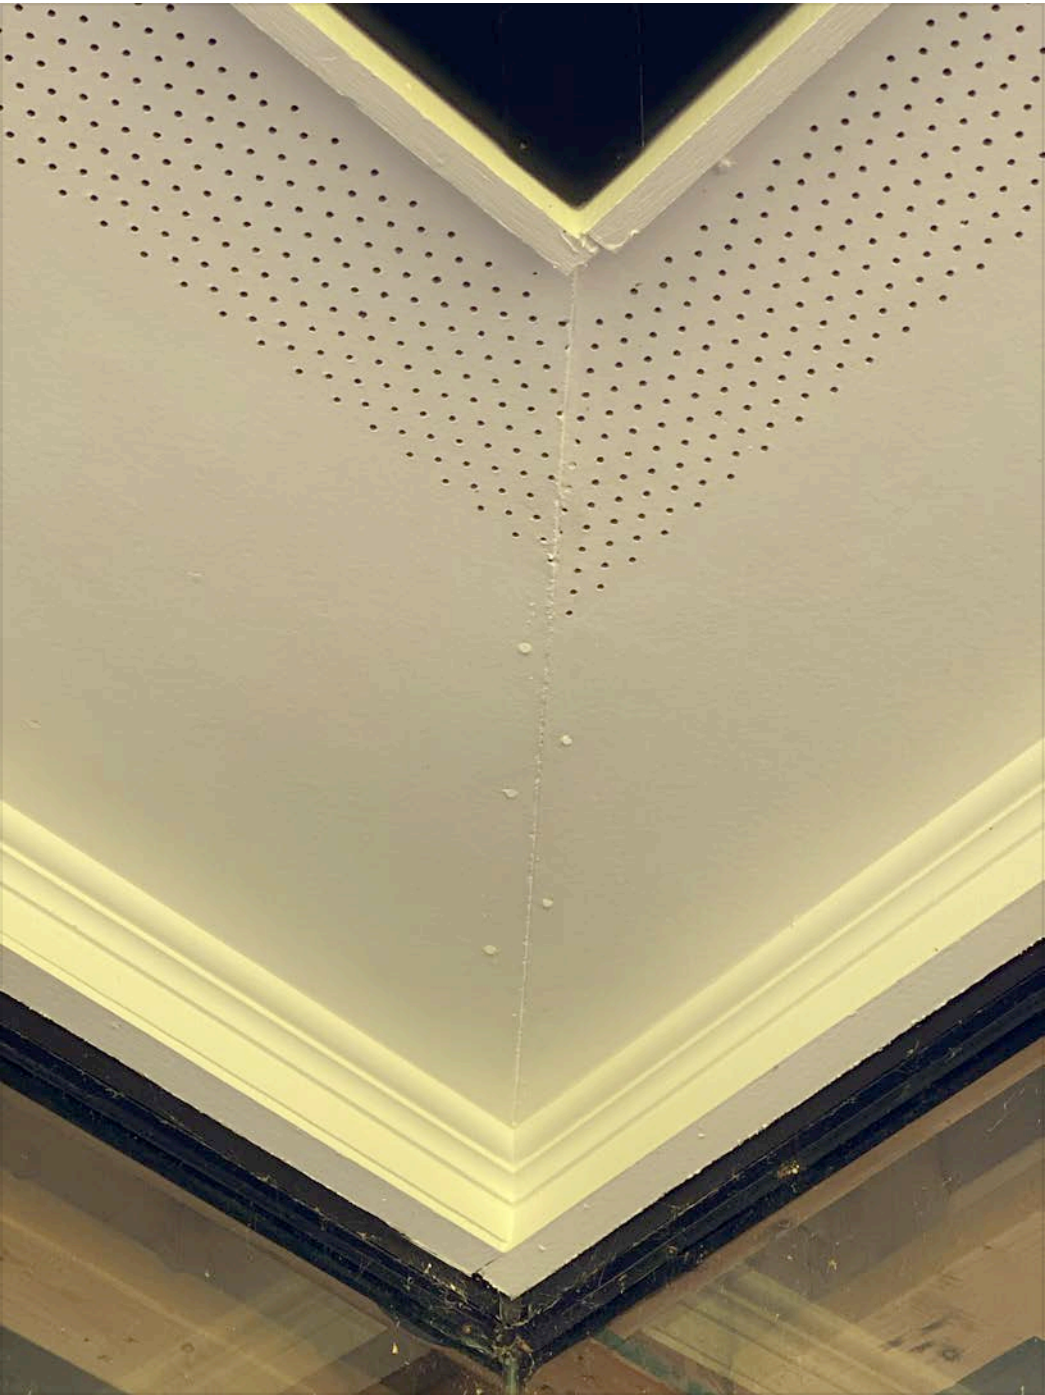
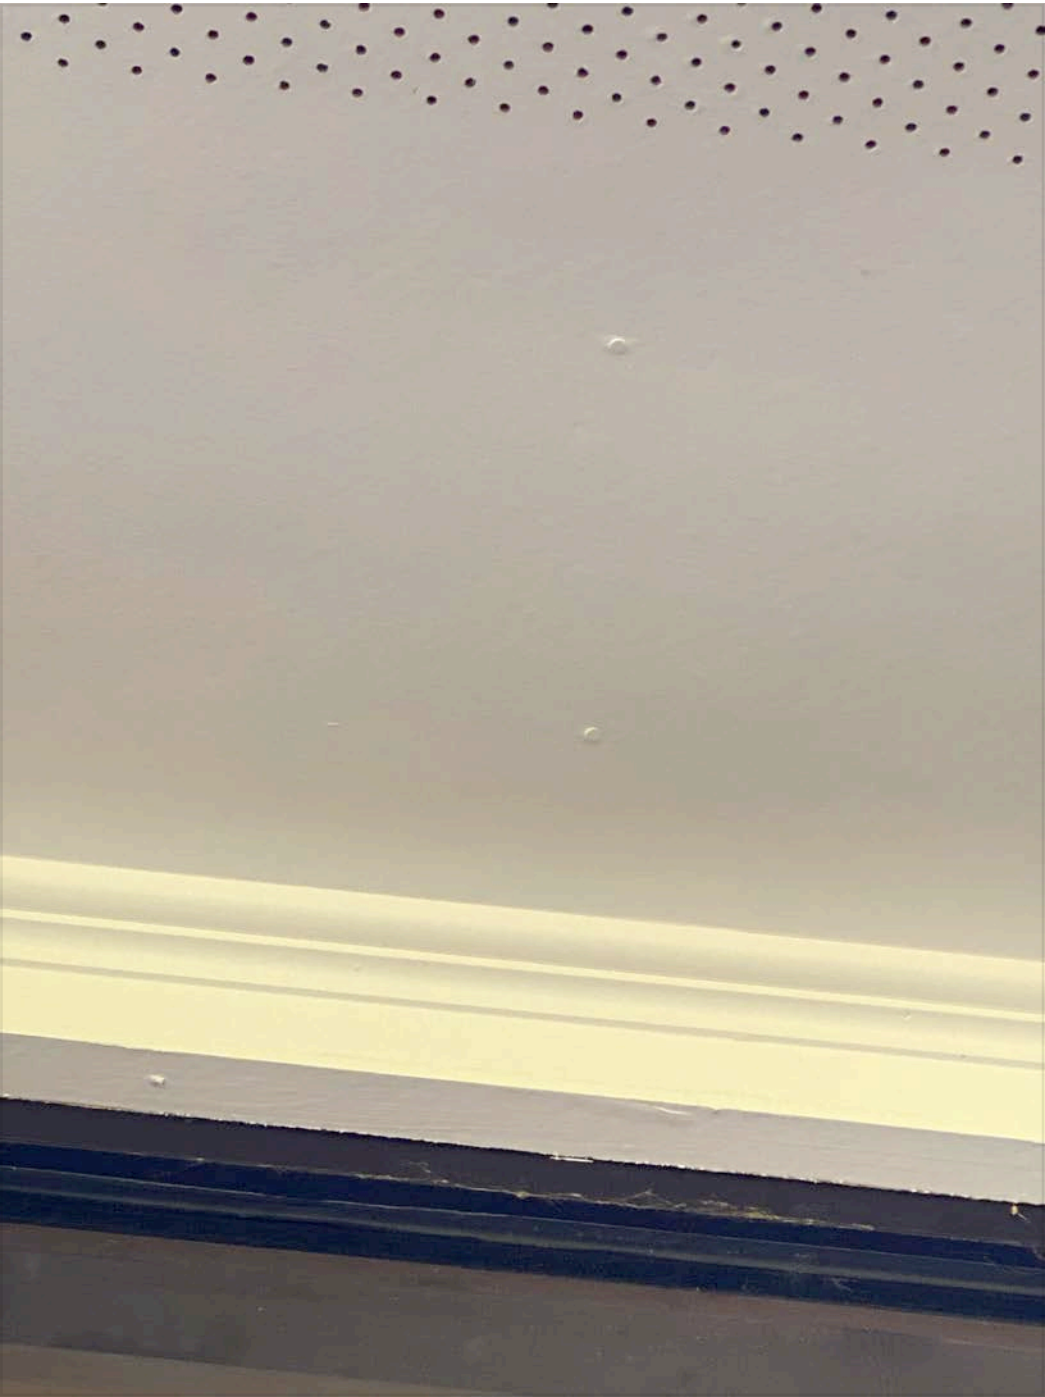
By garage door:

Outside soffit and fascia fasteners seem to be inconsistent type and some are already popping, plus there are multiple gouged areas filled with caulk:

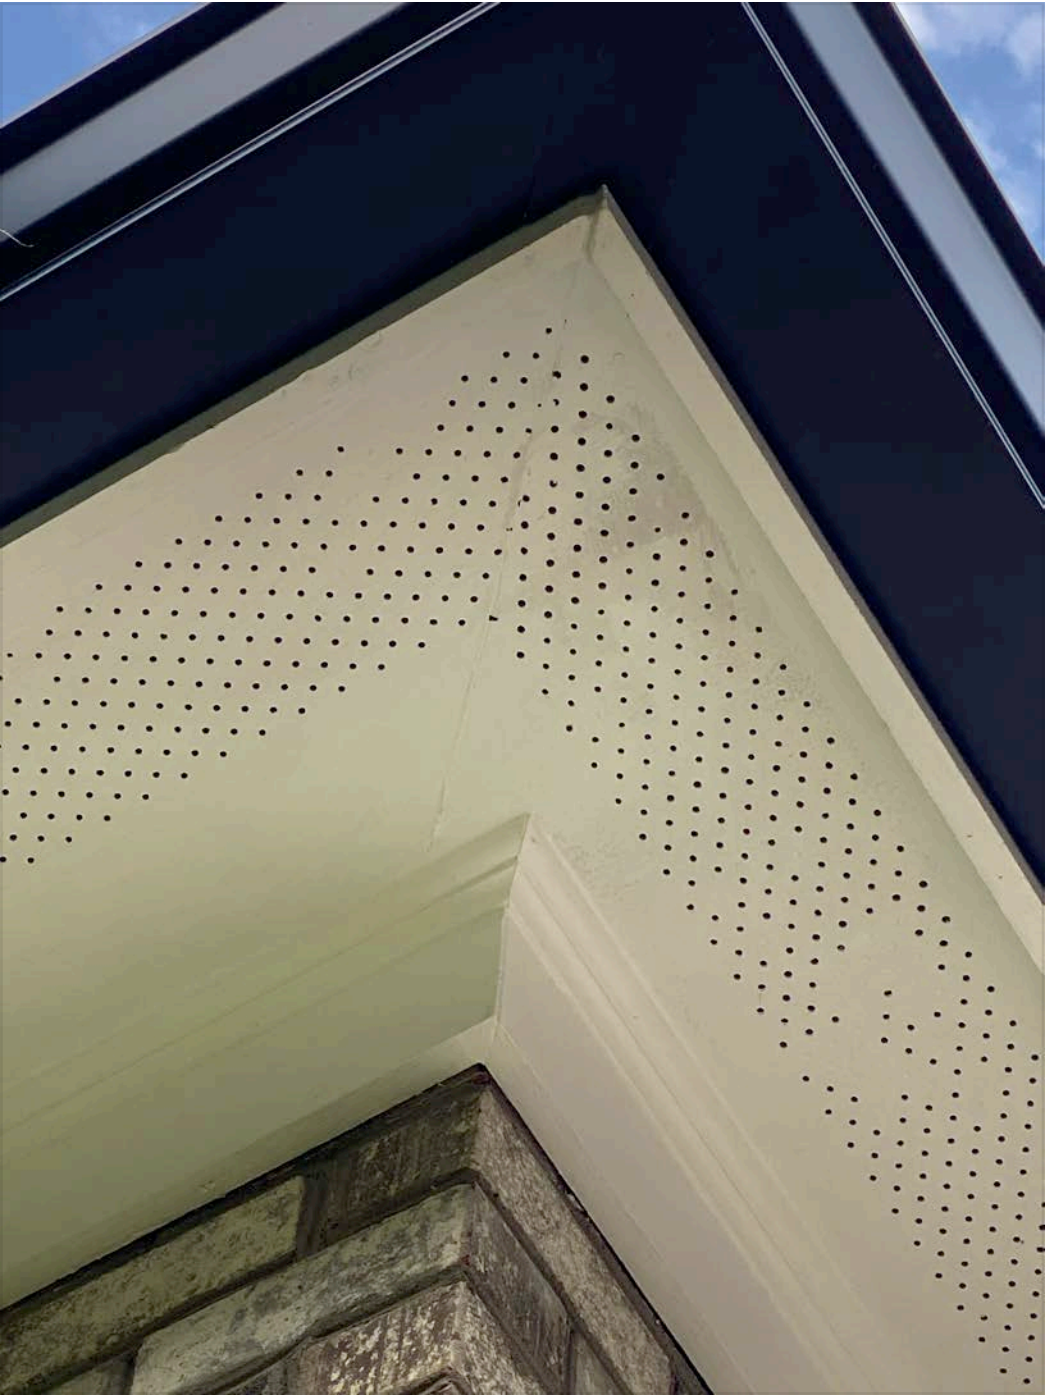
Samples of poor quality and/or inconsistent installation cuts:

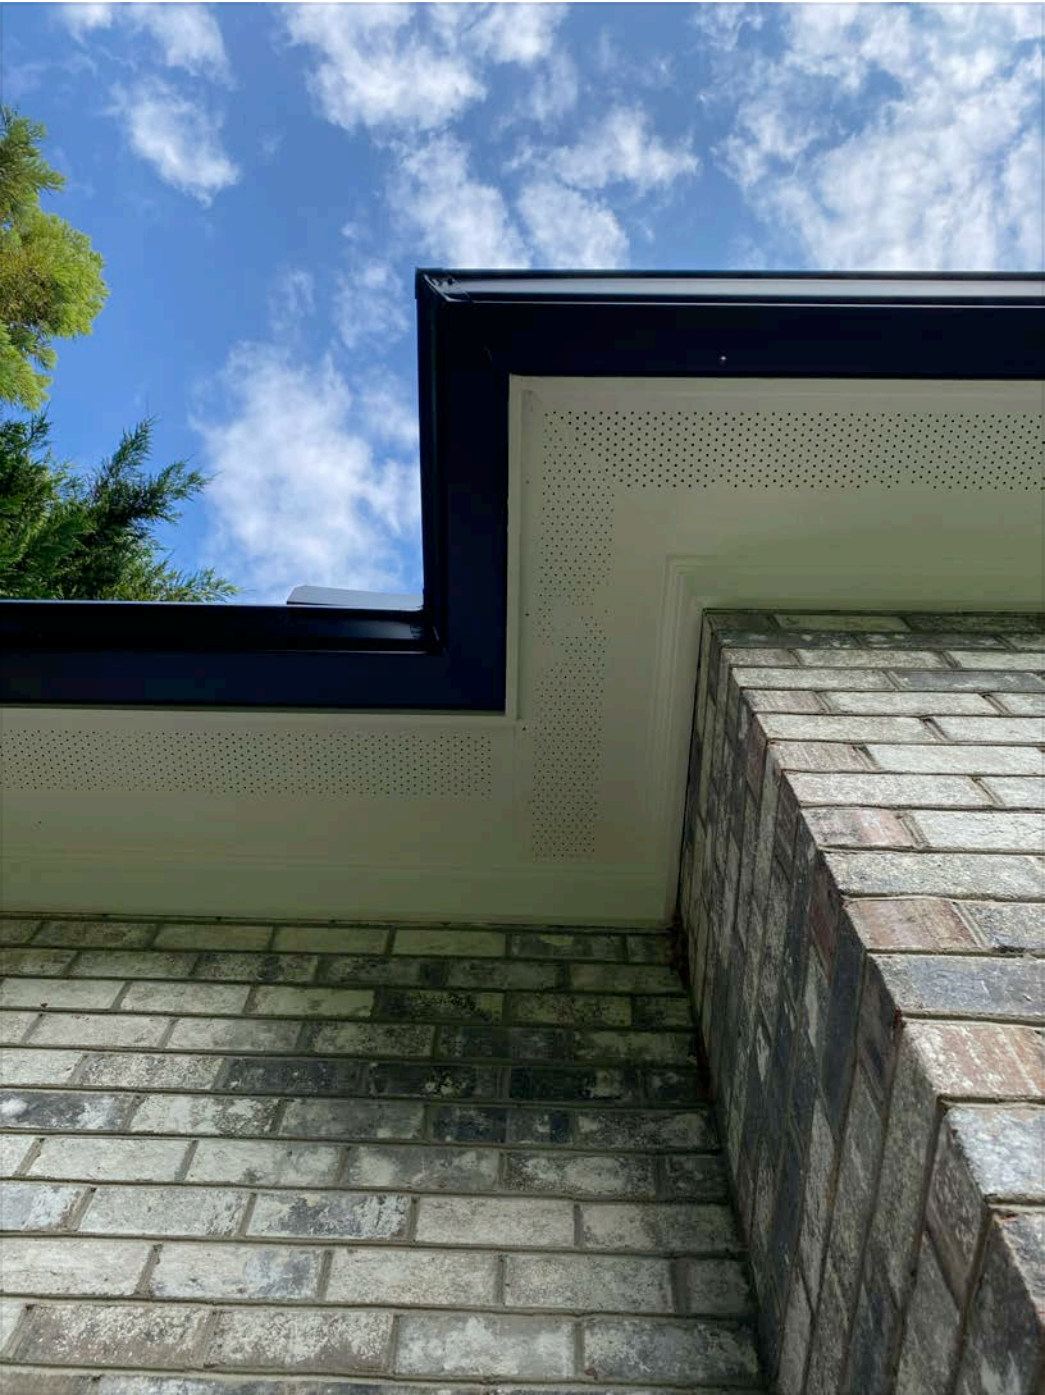
Near left gothic window (holes run straight back versus being angled to meet)

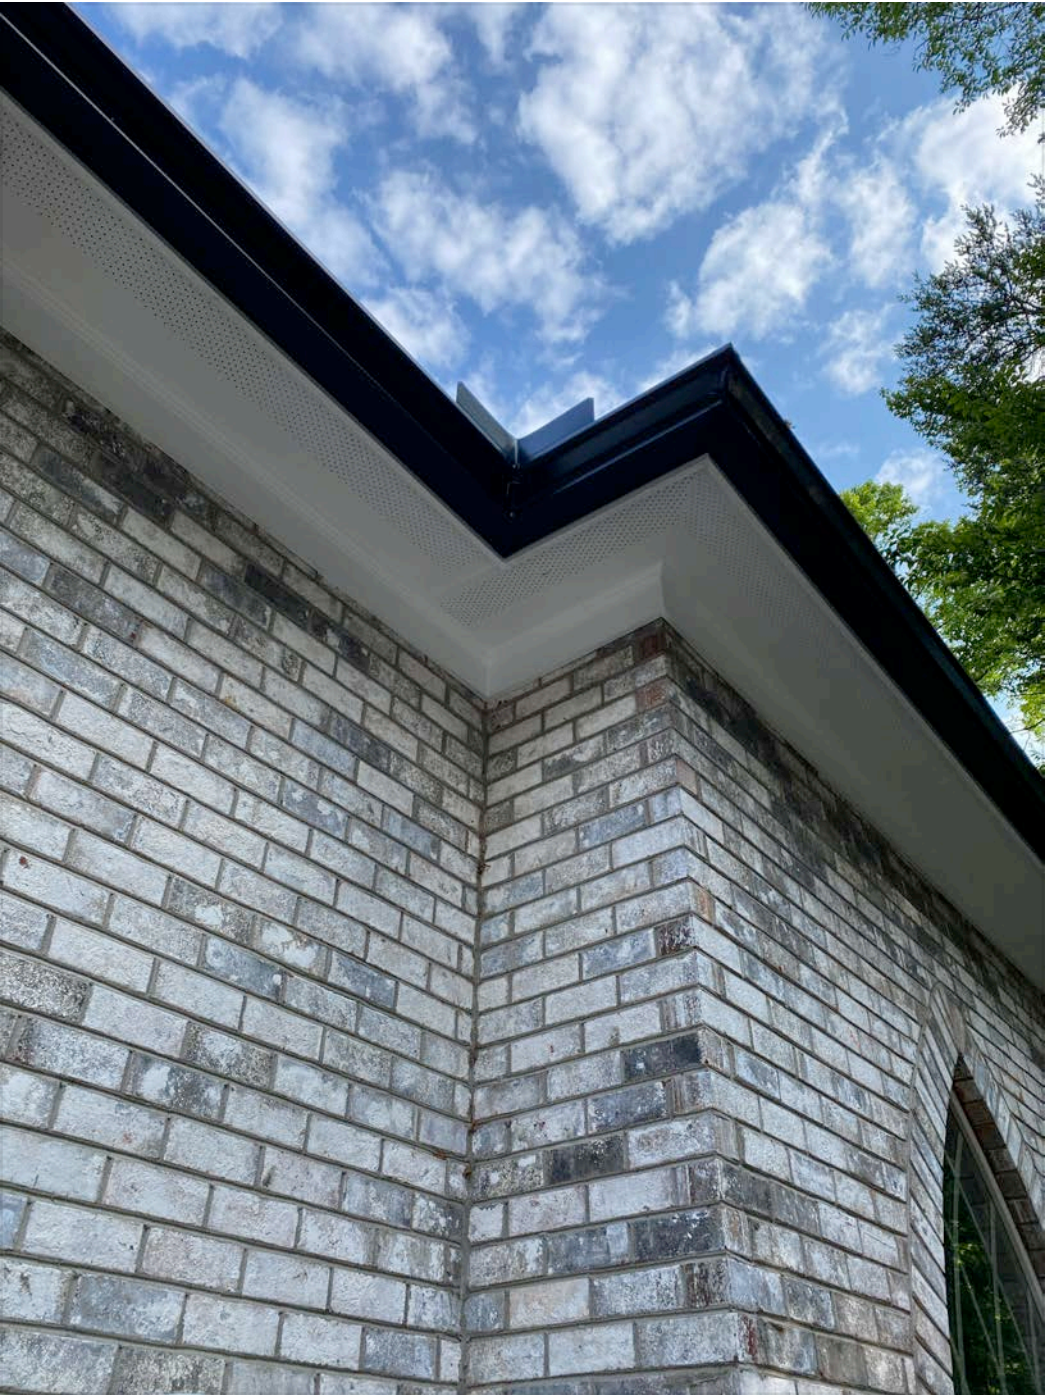
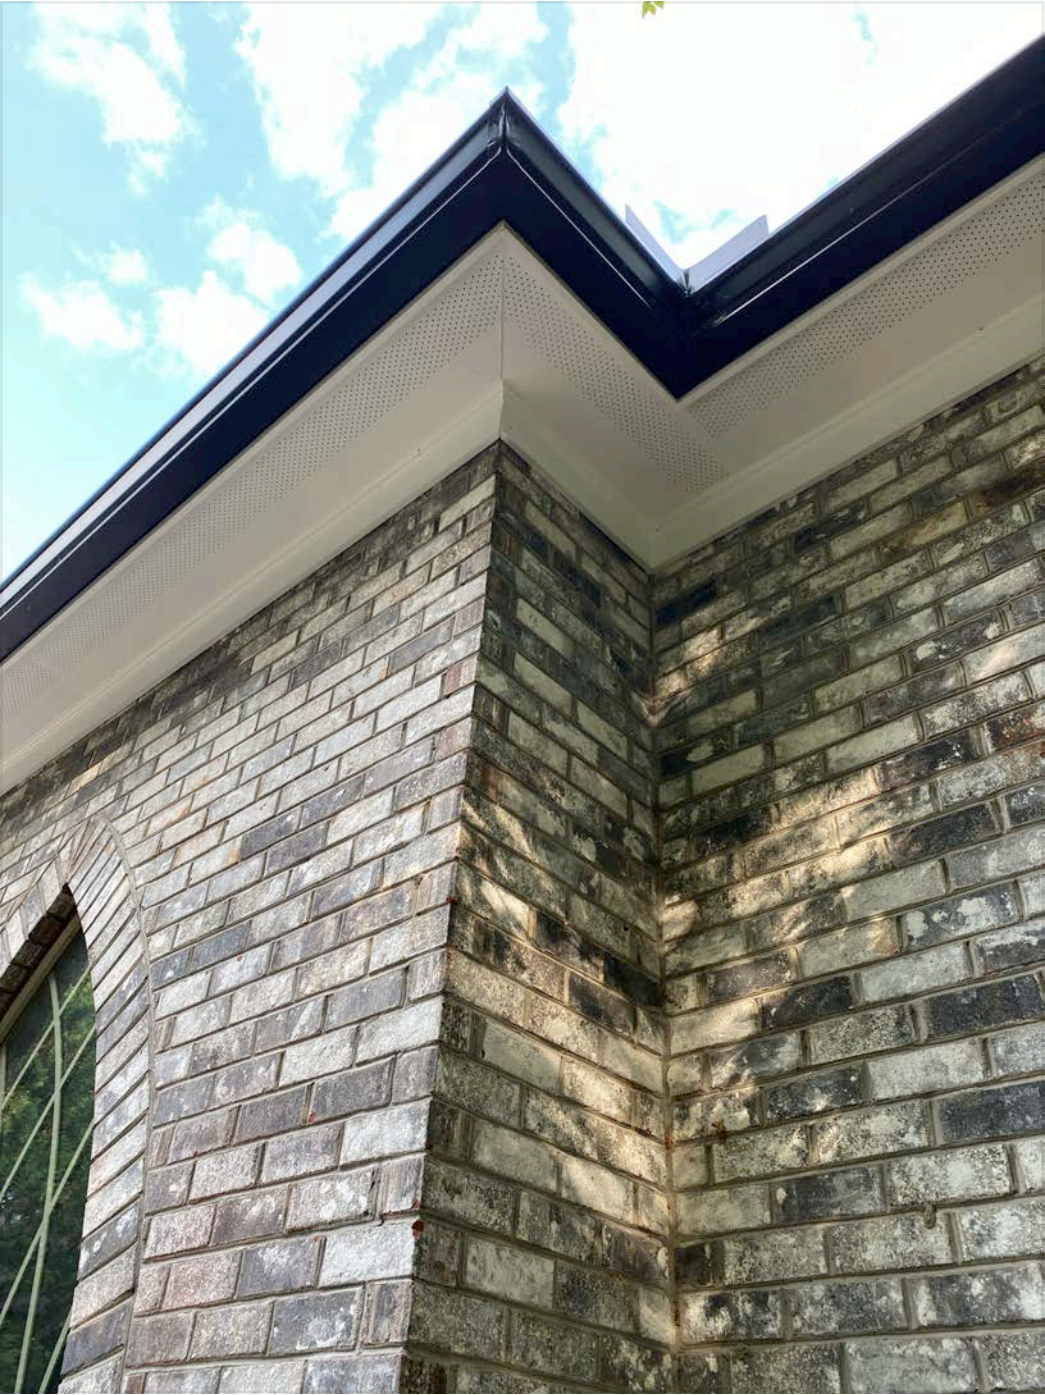
Near right gothic window (holes run straight back versus being angled to meet)
