Correction needed

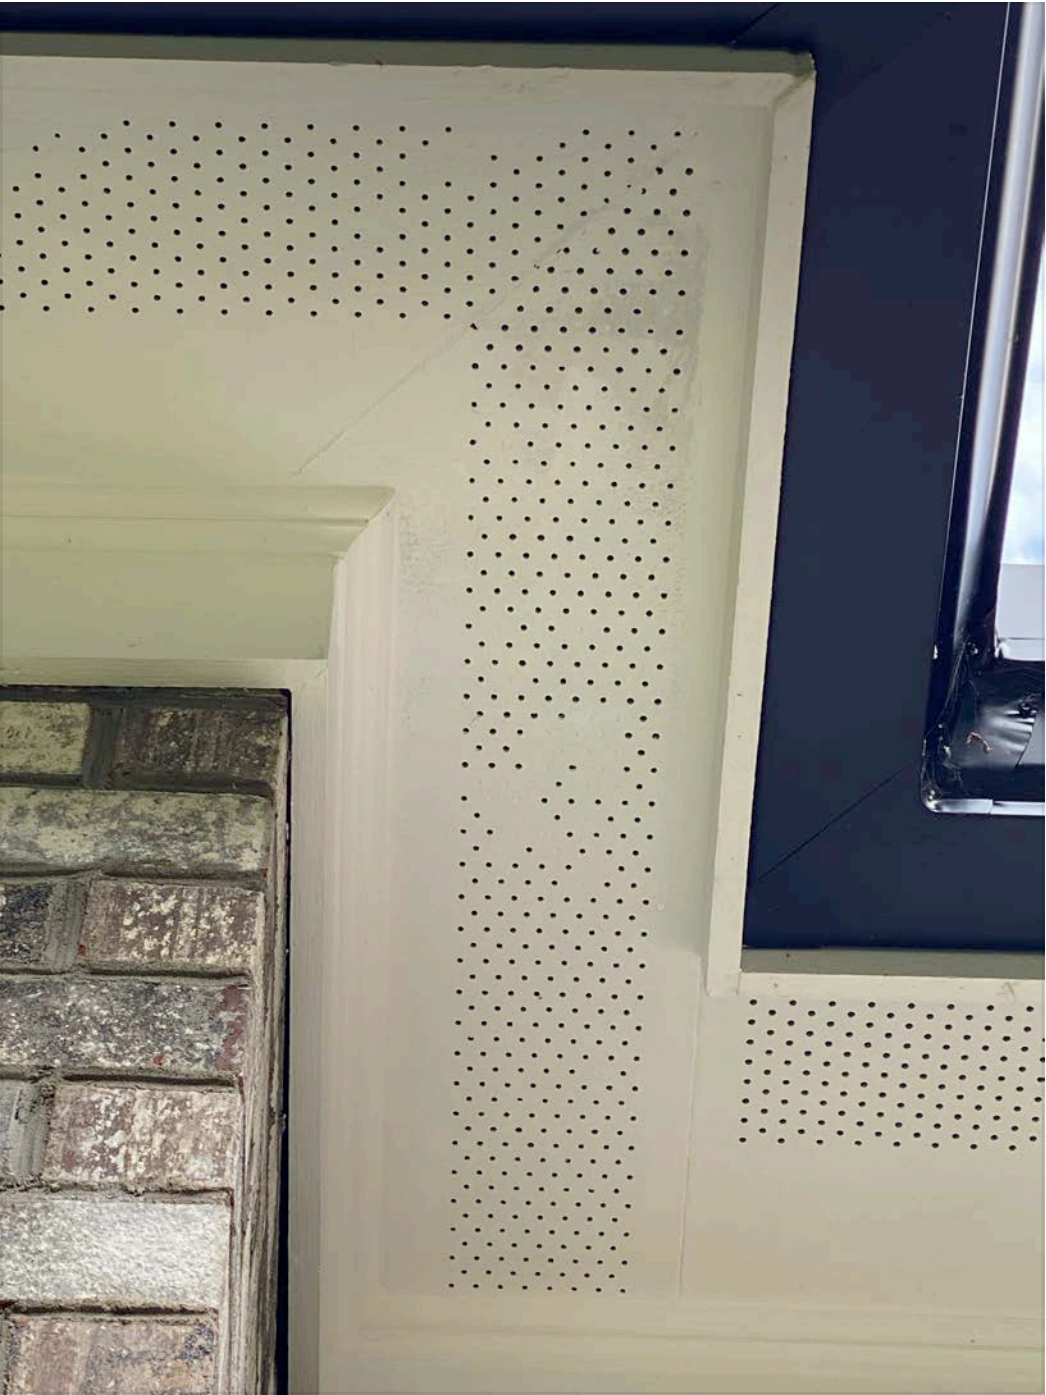
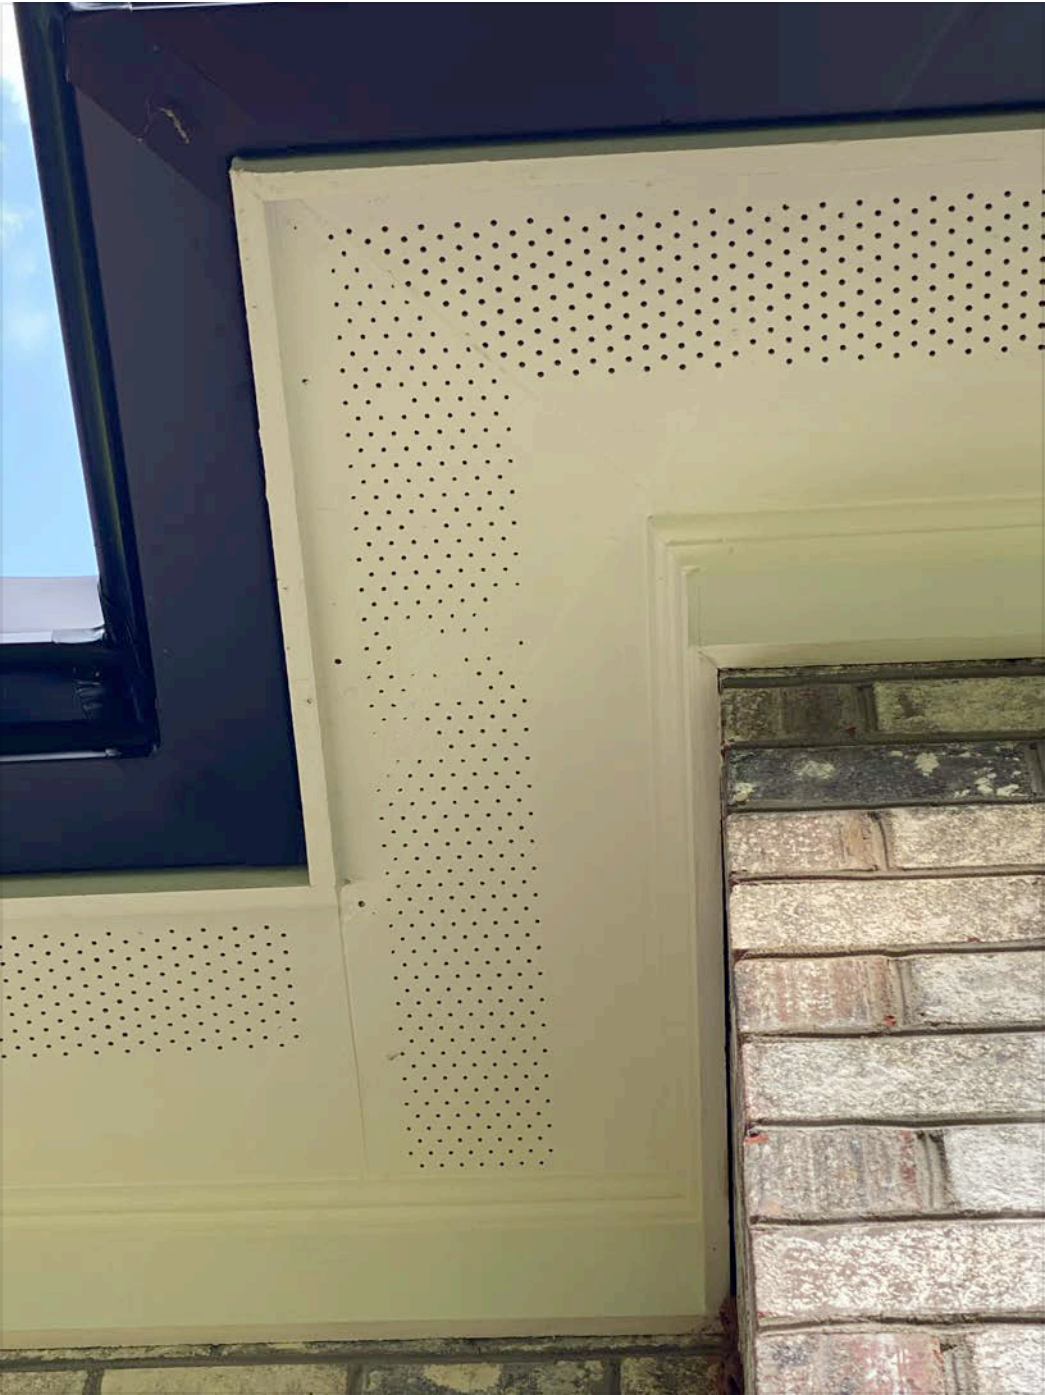
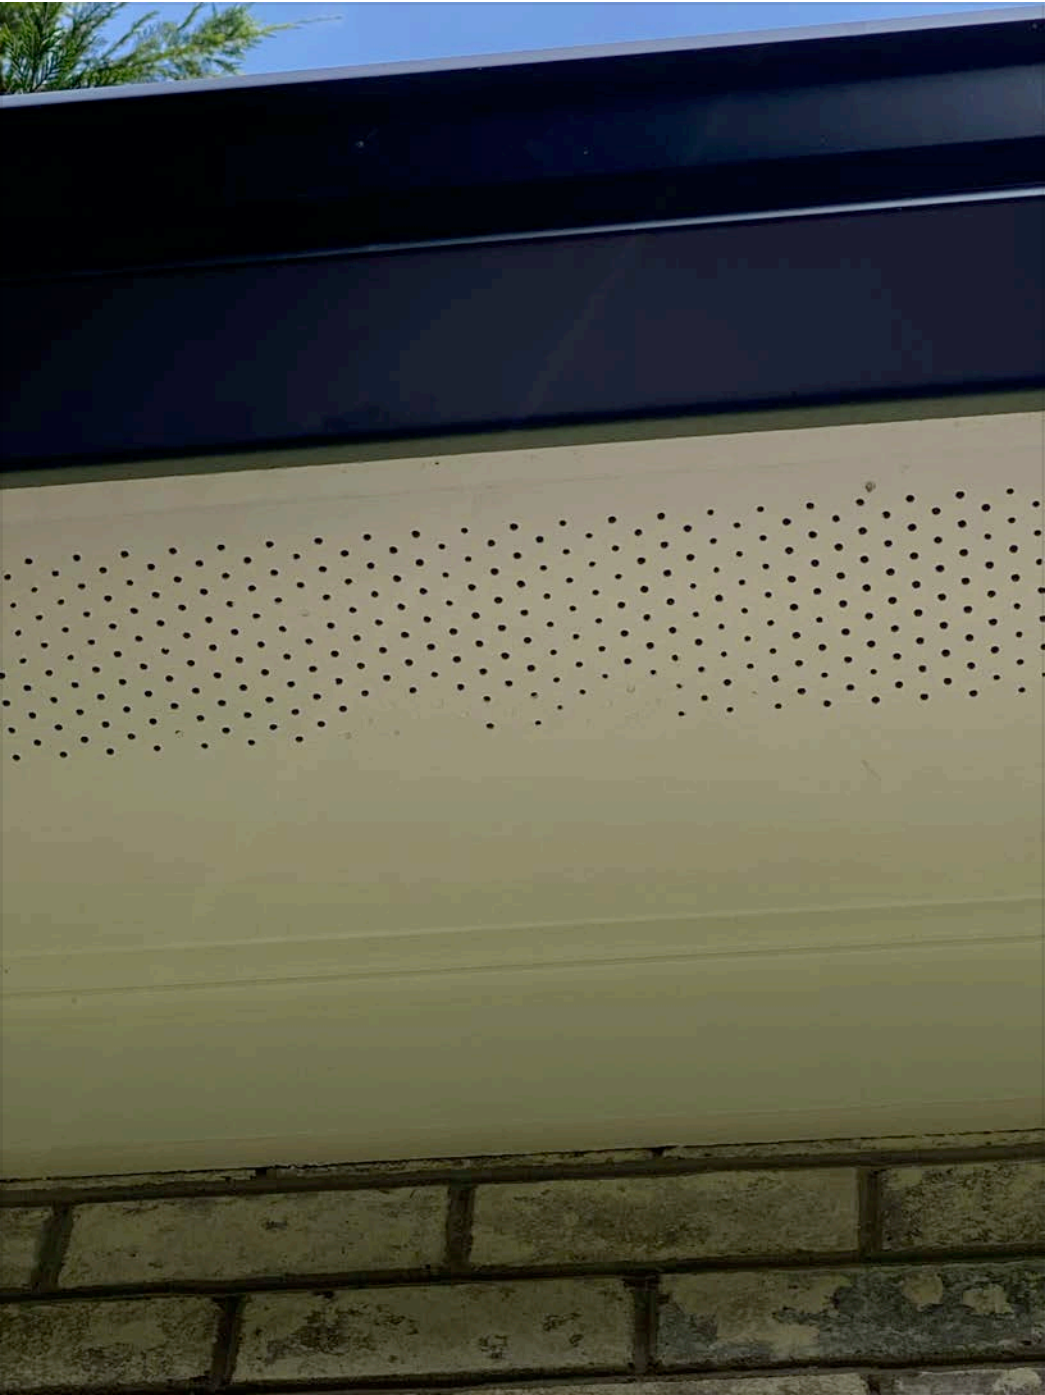
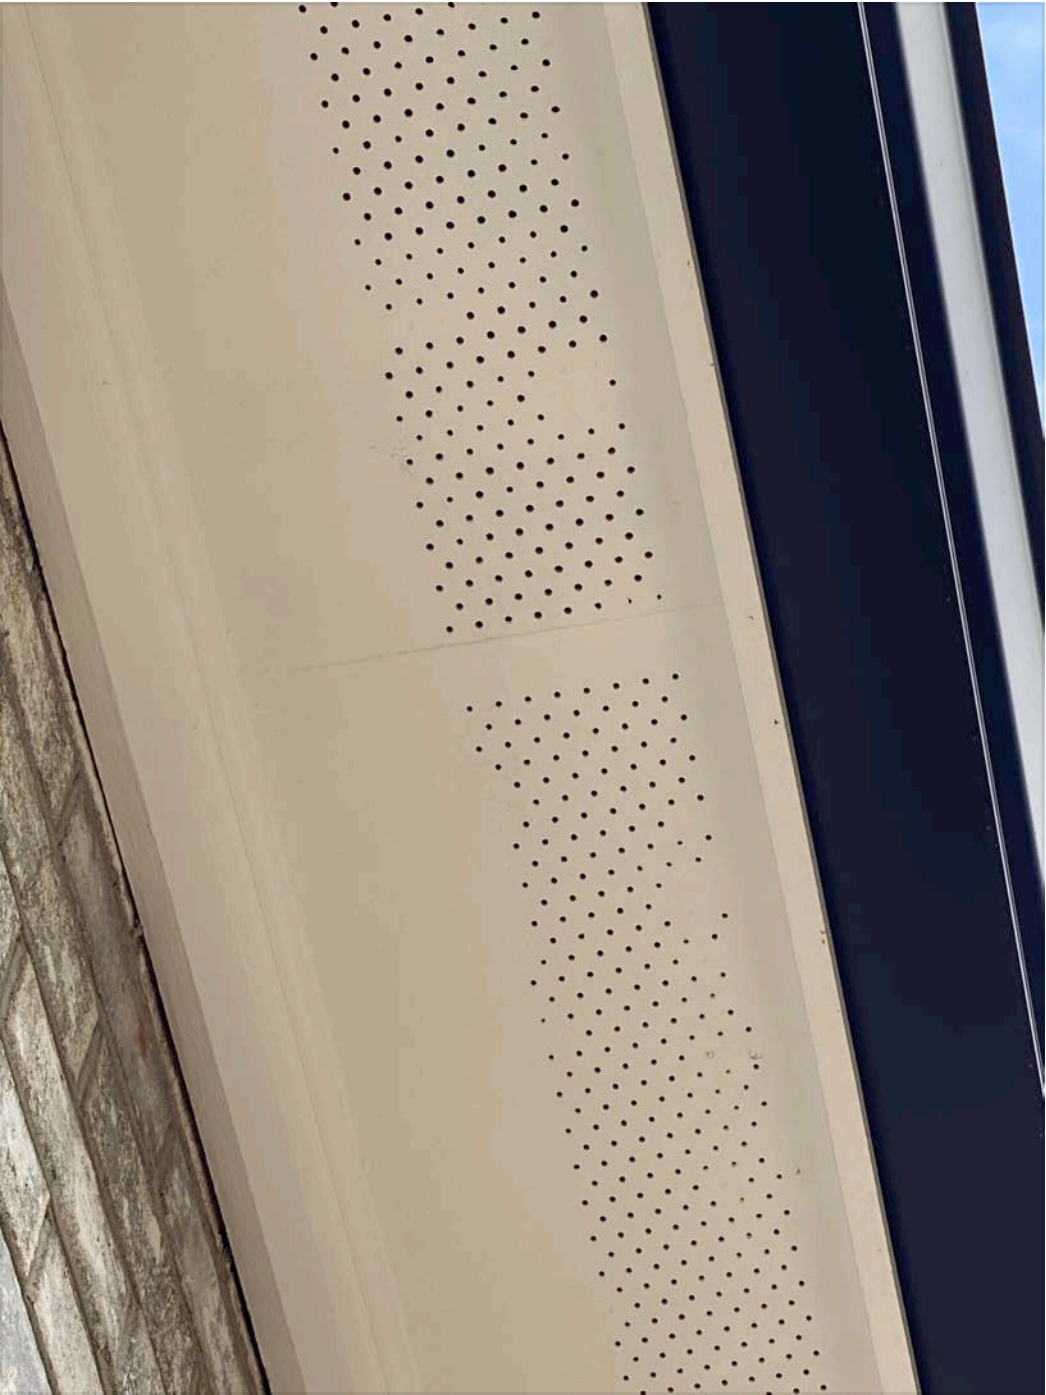
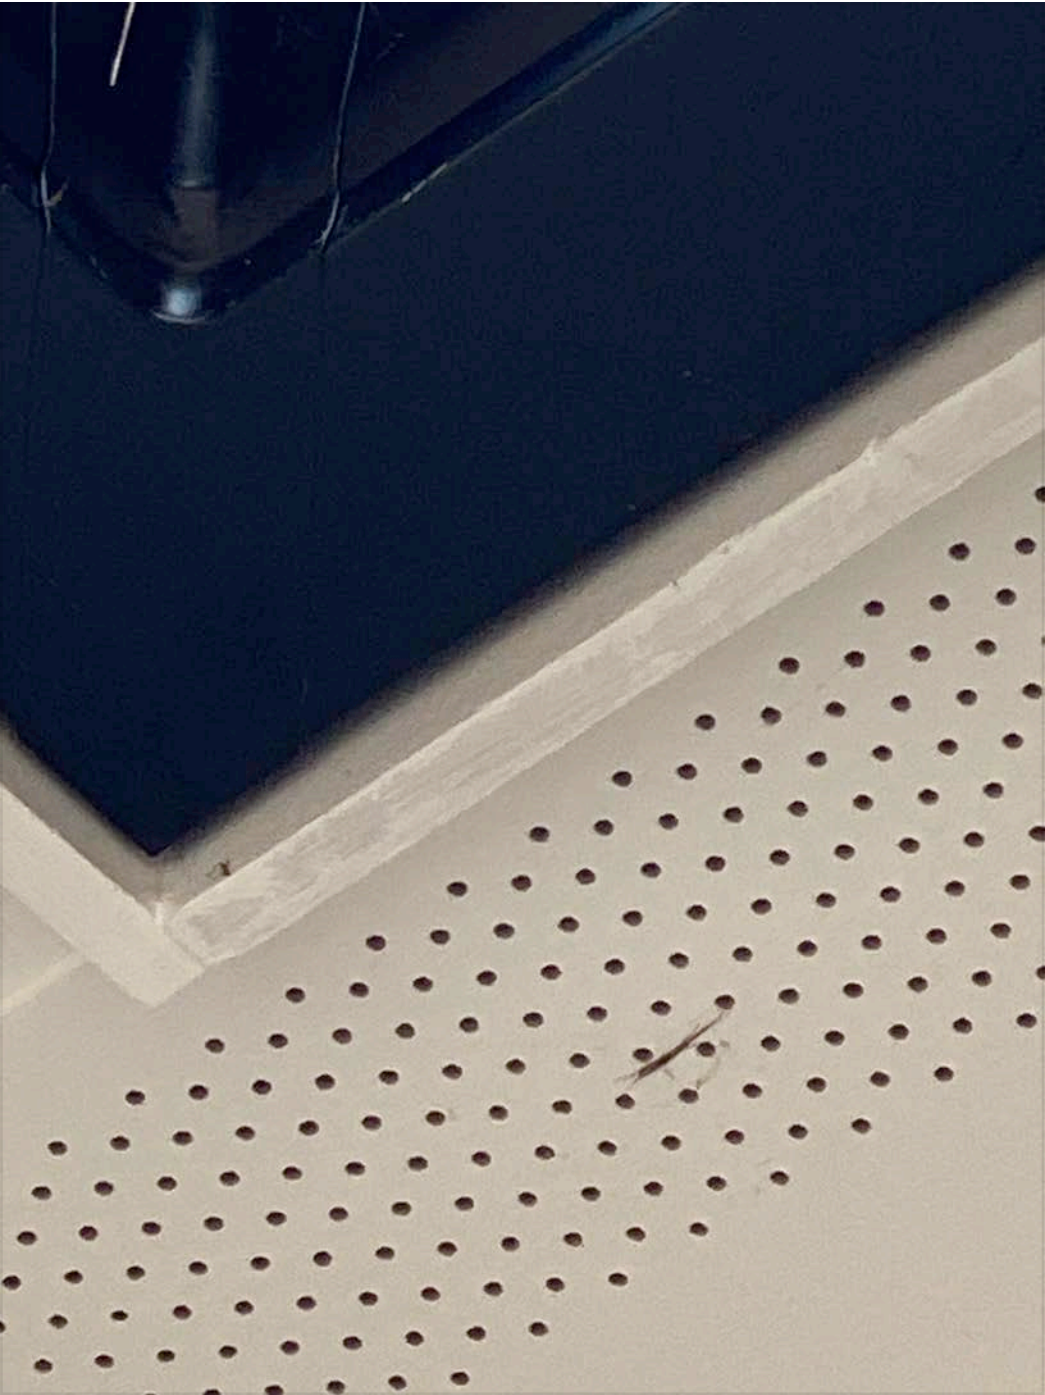
Examples of paint job poor quality for soffits and fascia:

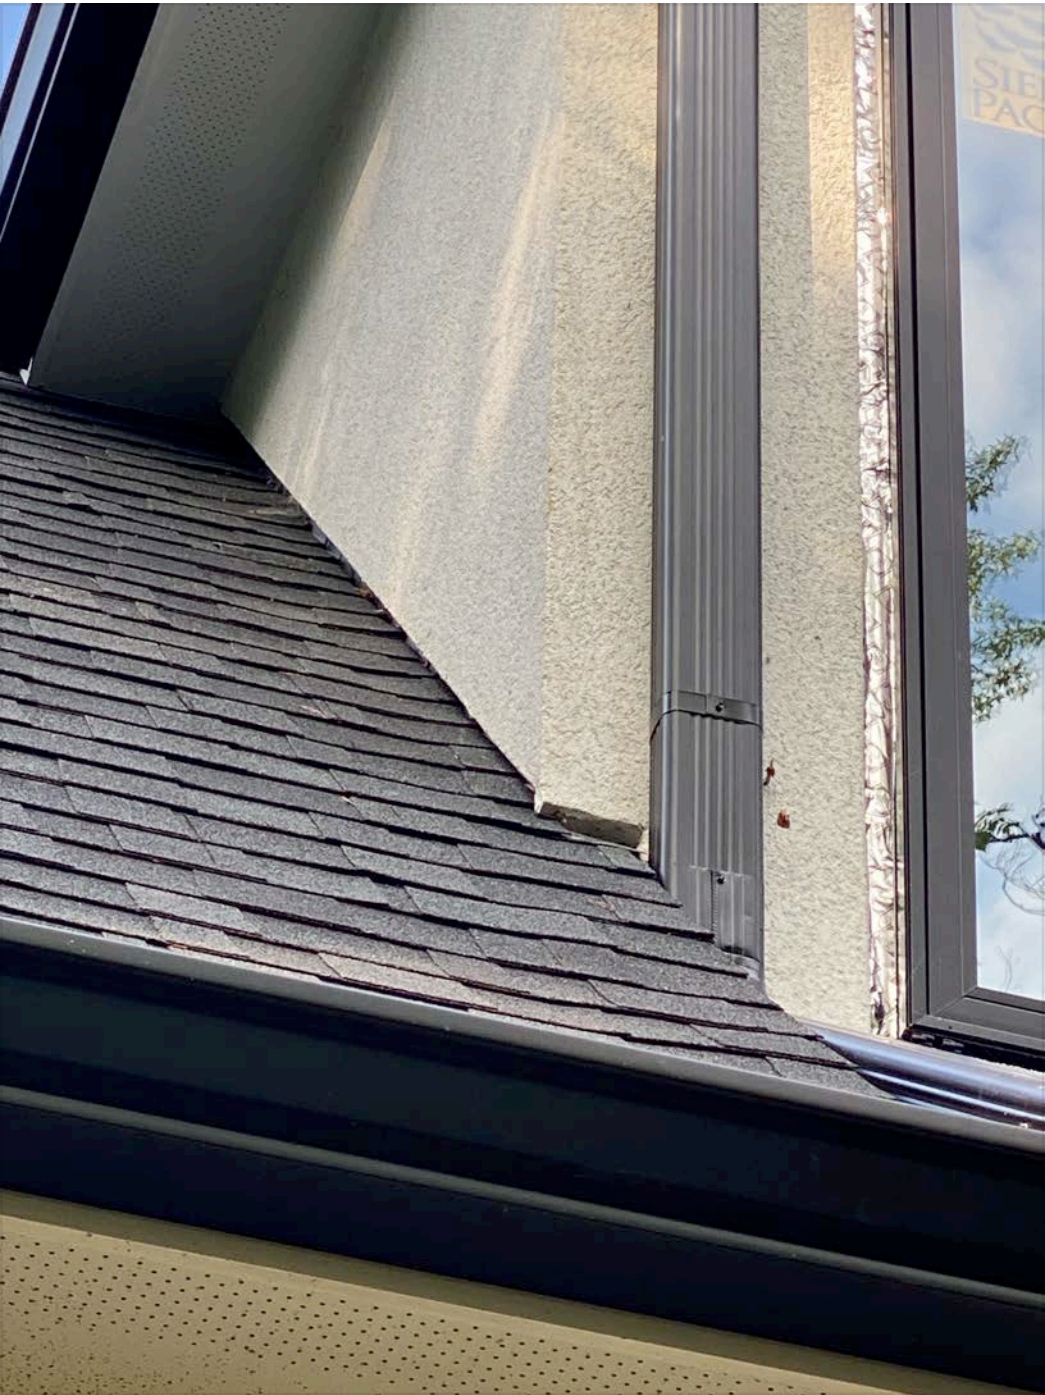
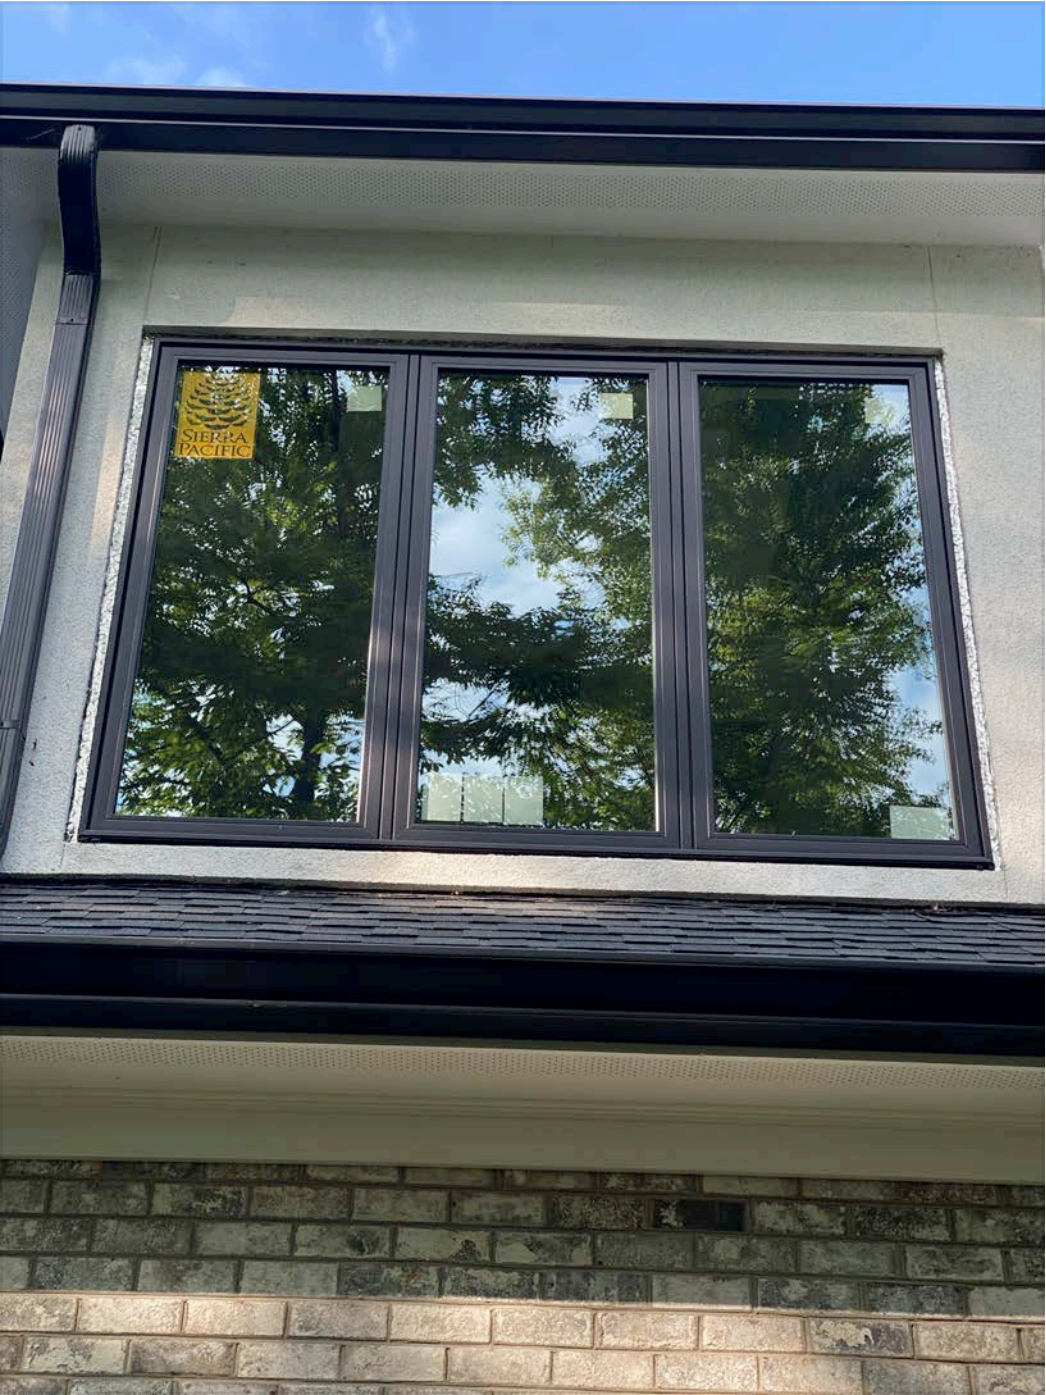
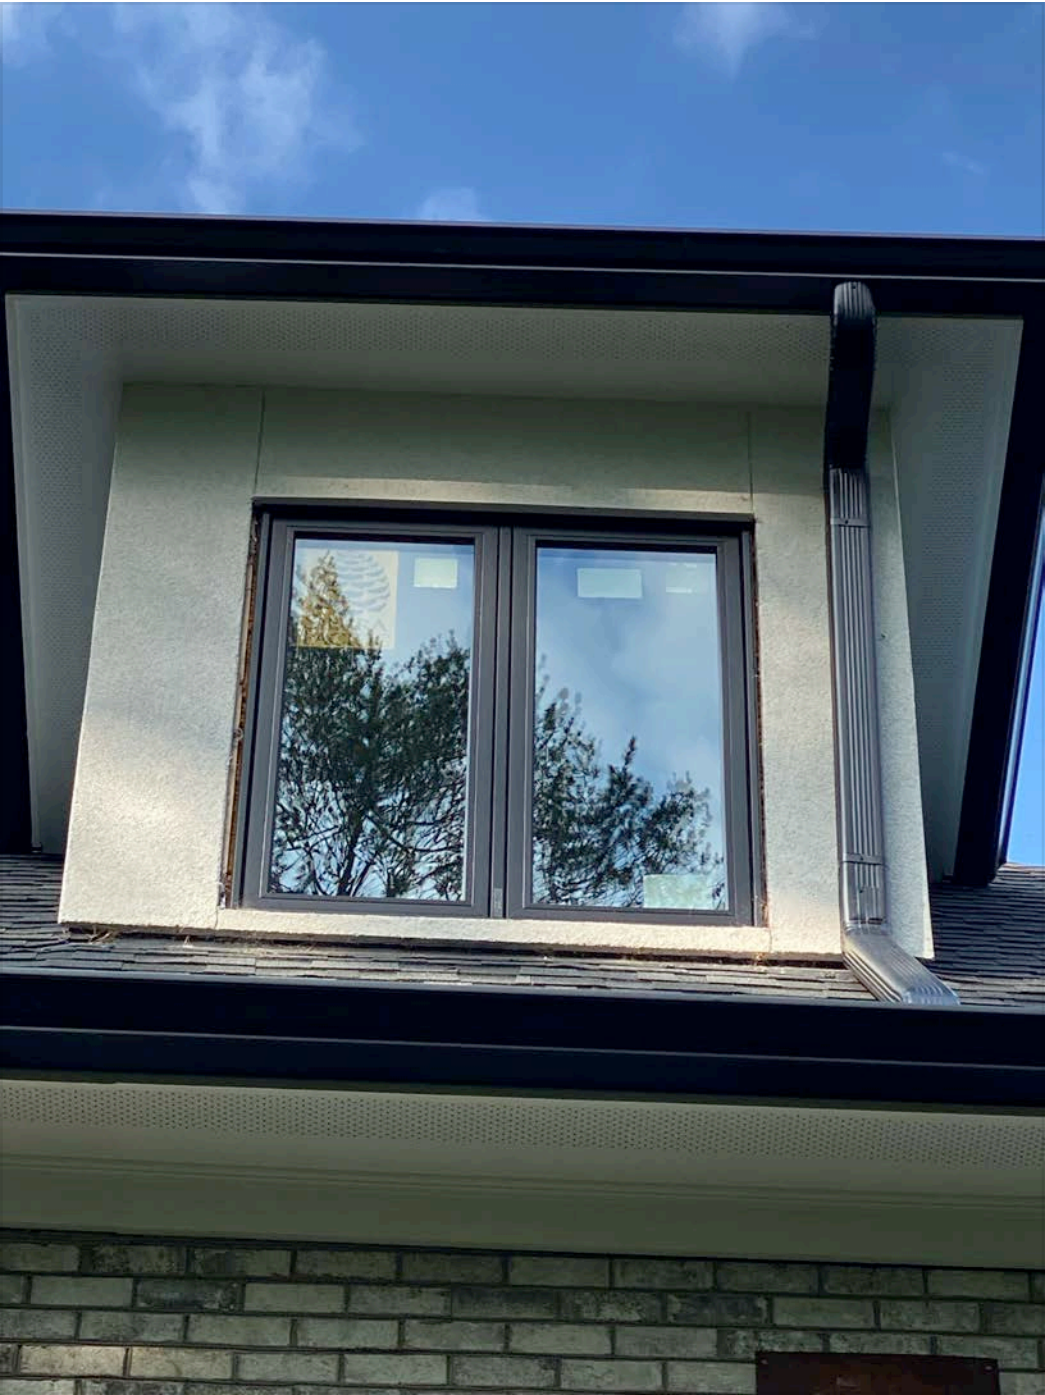
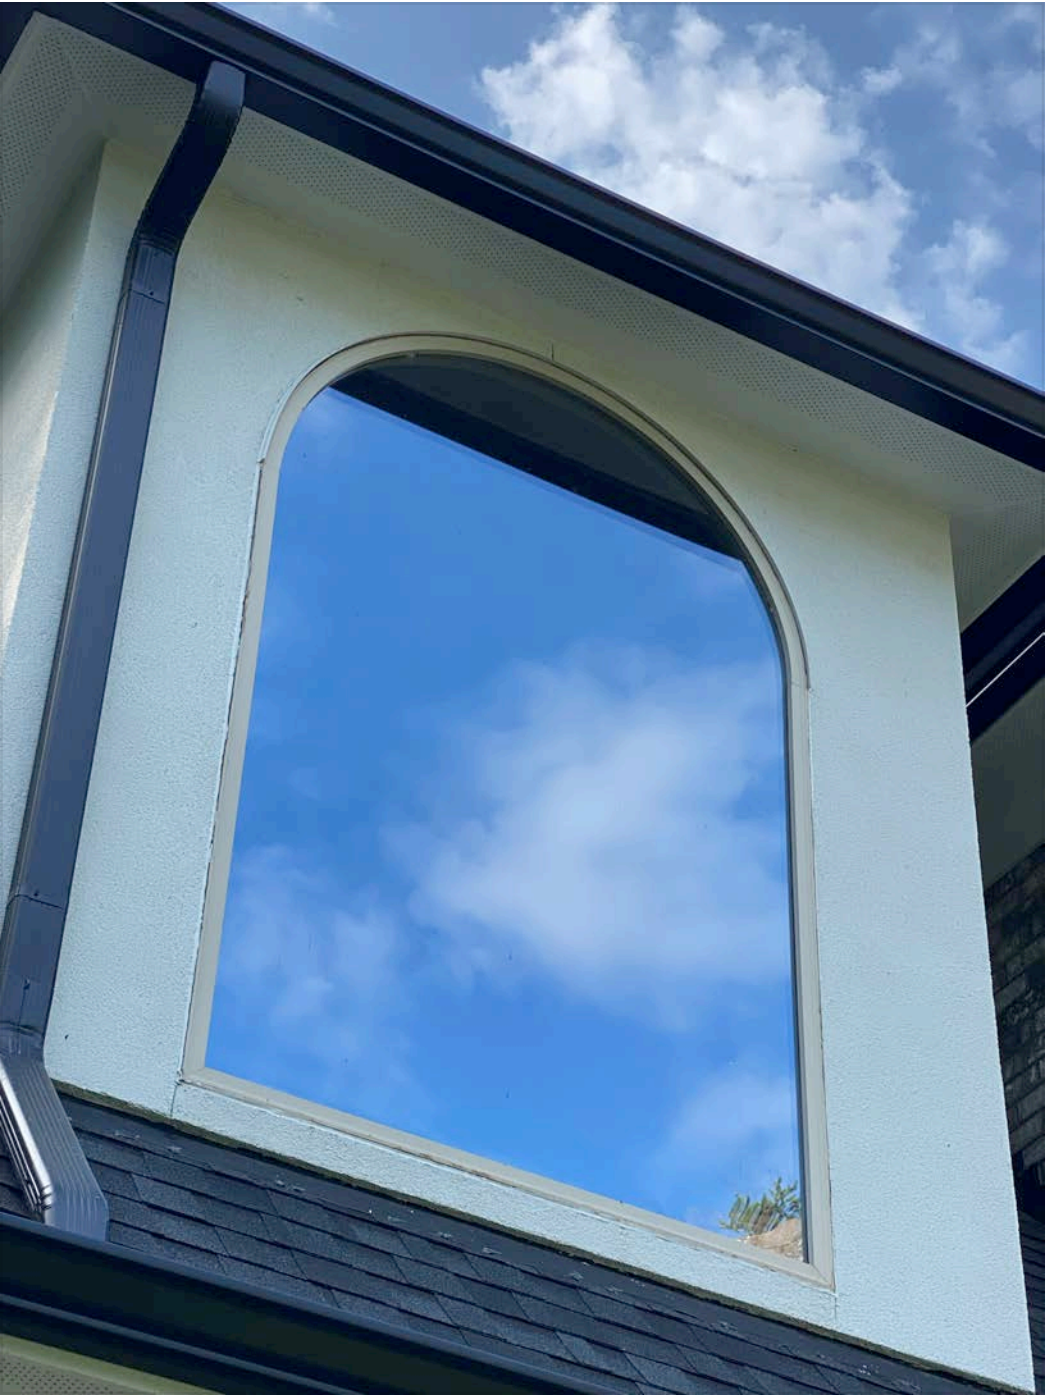
Stucco gaps, rough cuts, and mismatches to windows:

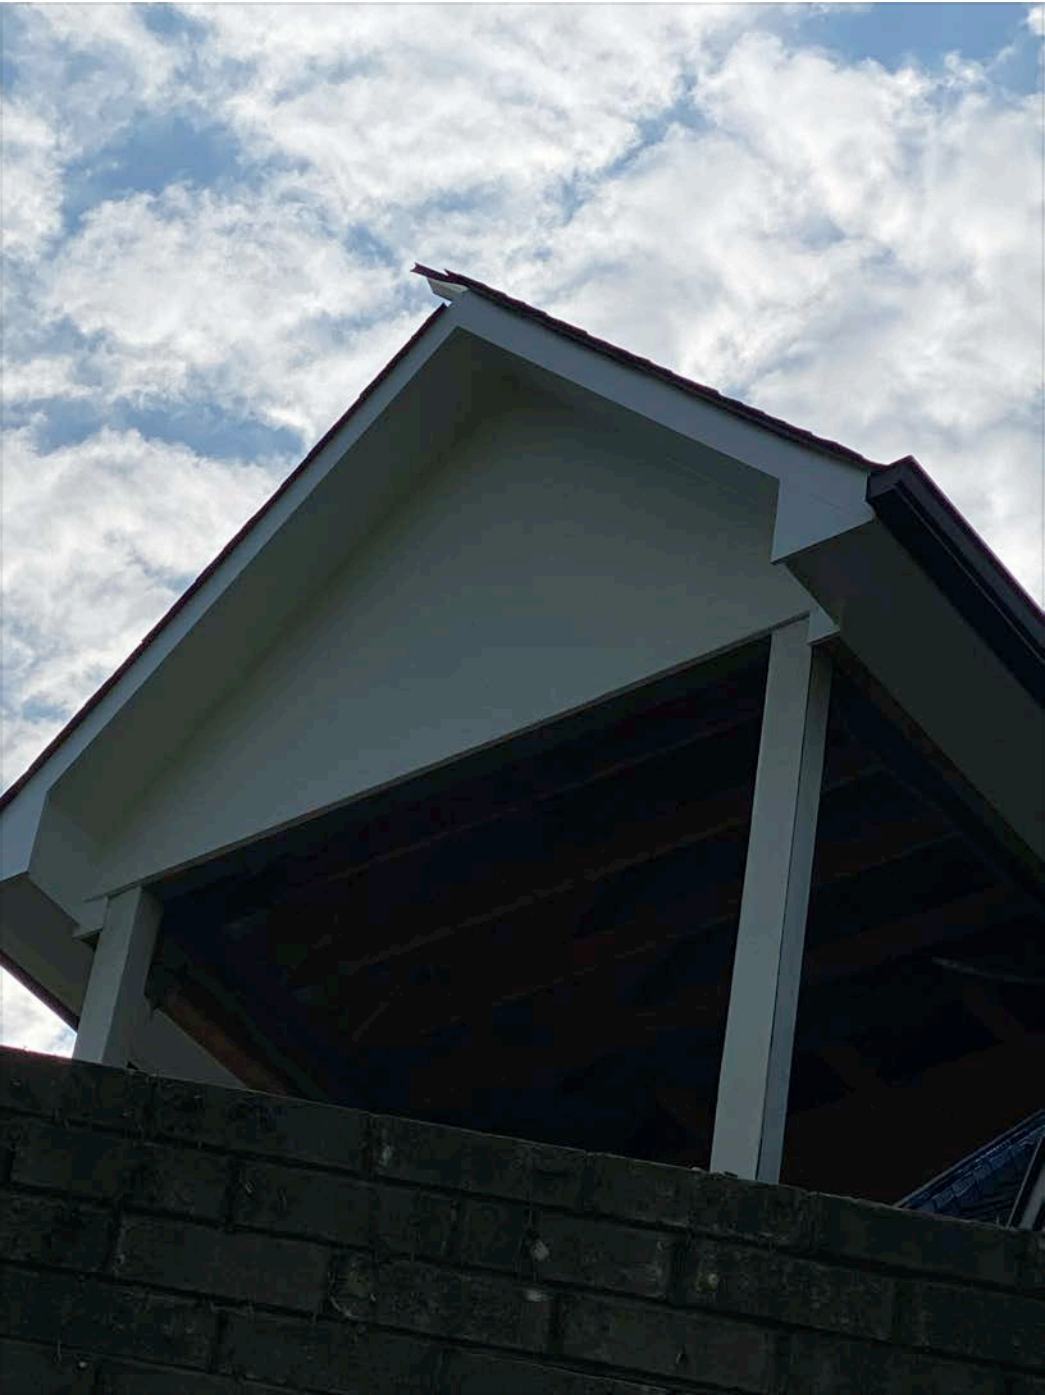
Difficult to see in this particular photo, however caulk separated

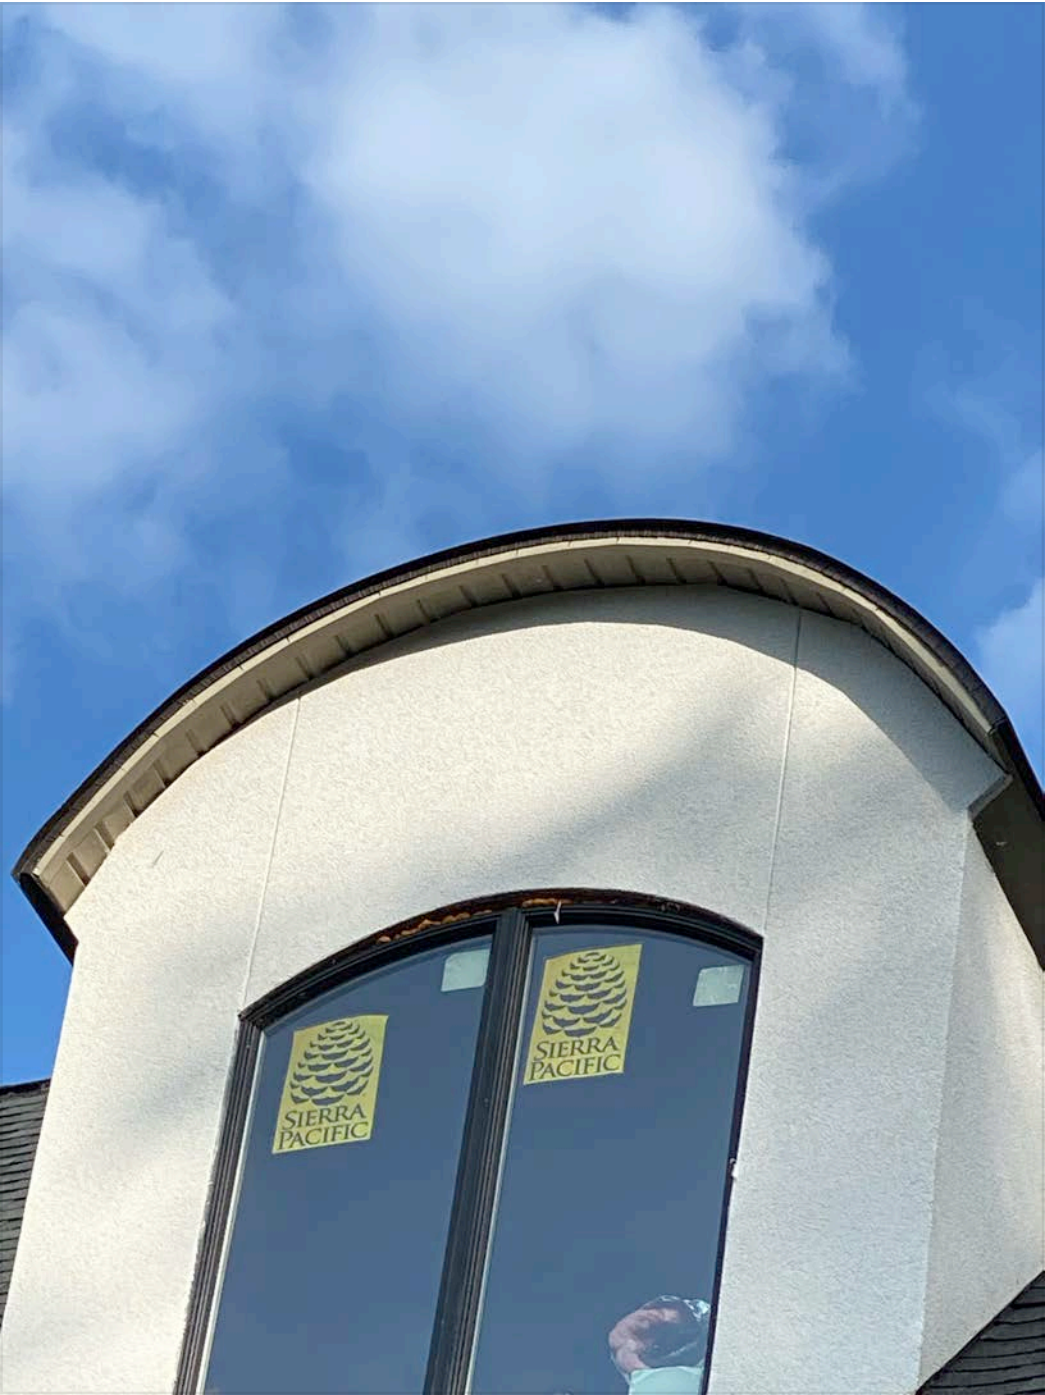
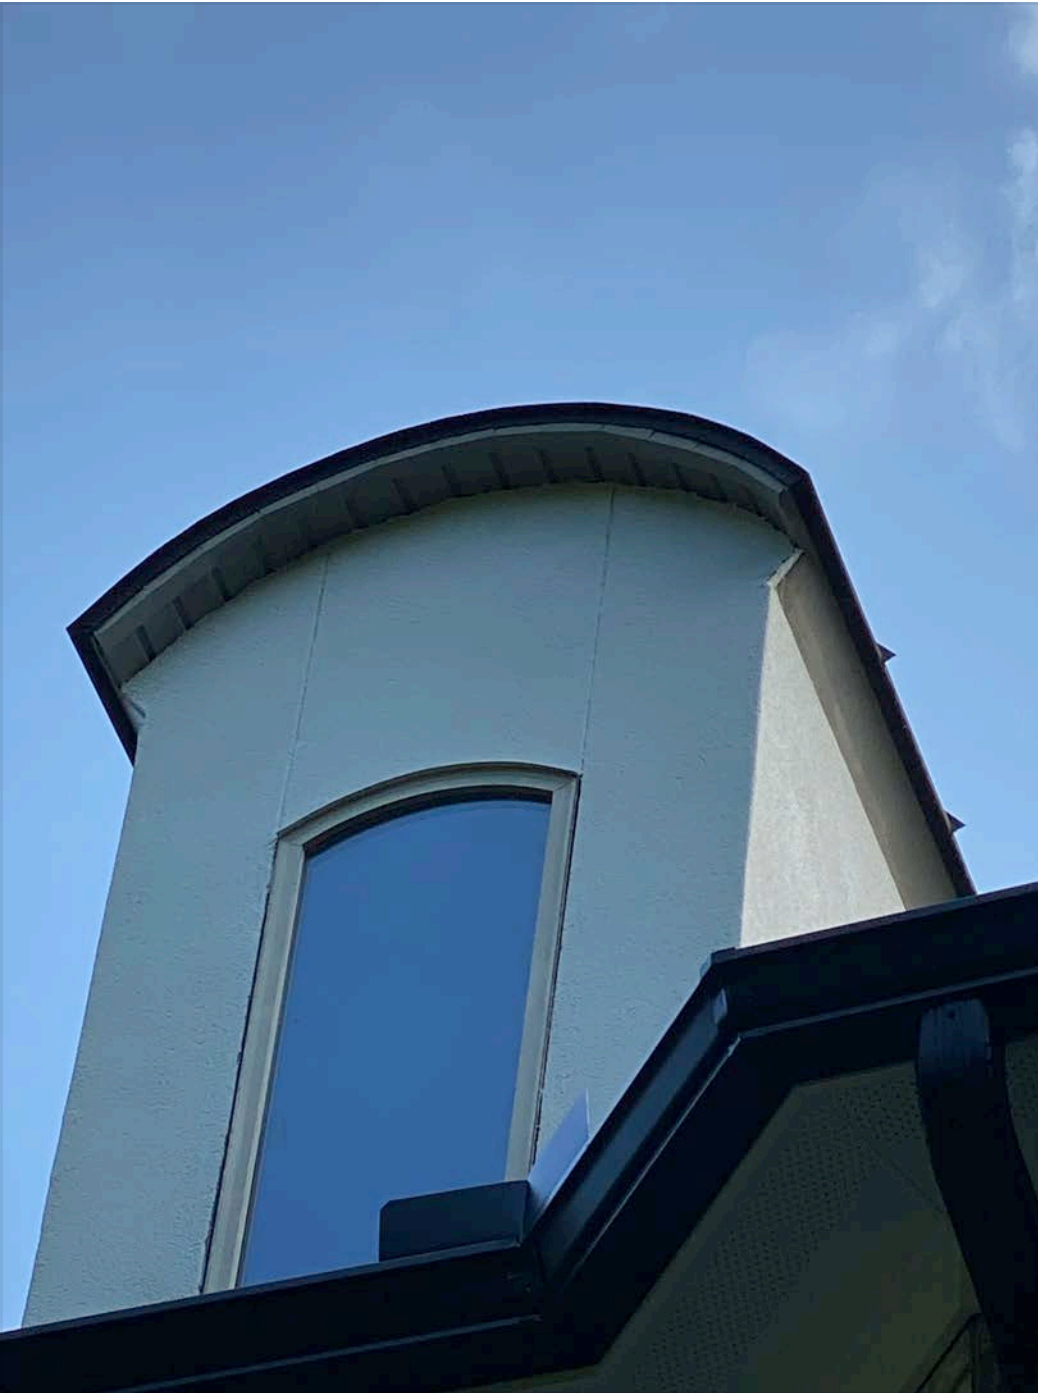
Old miscolored curved venting/soffit with gap underneath:
