Correction needed

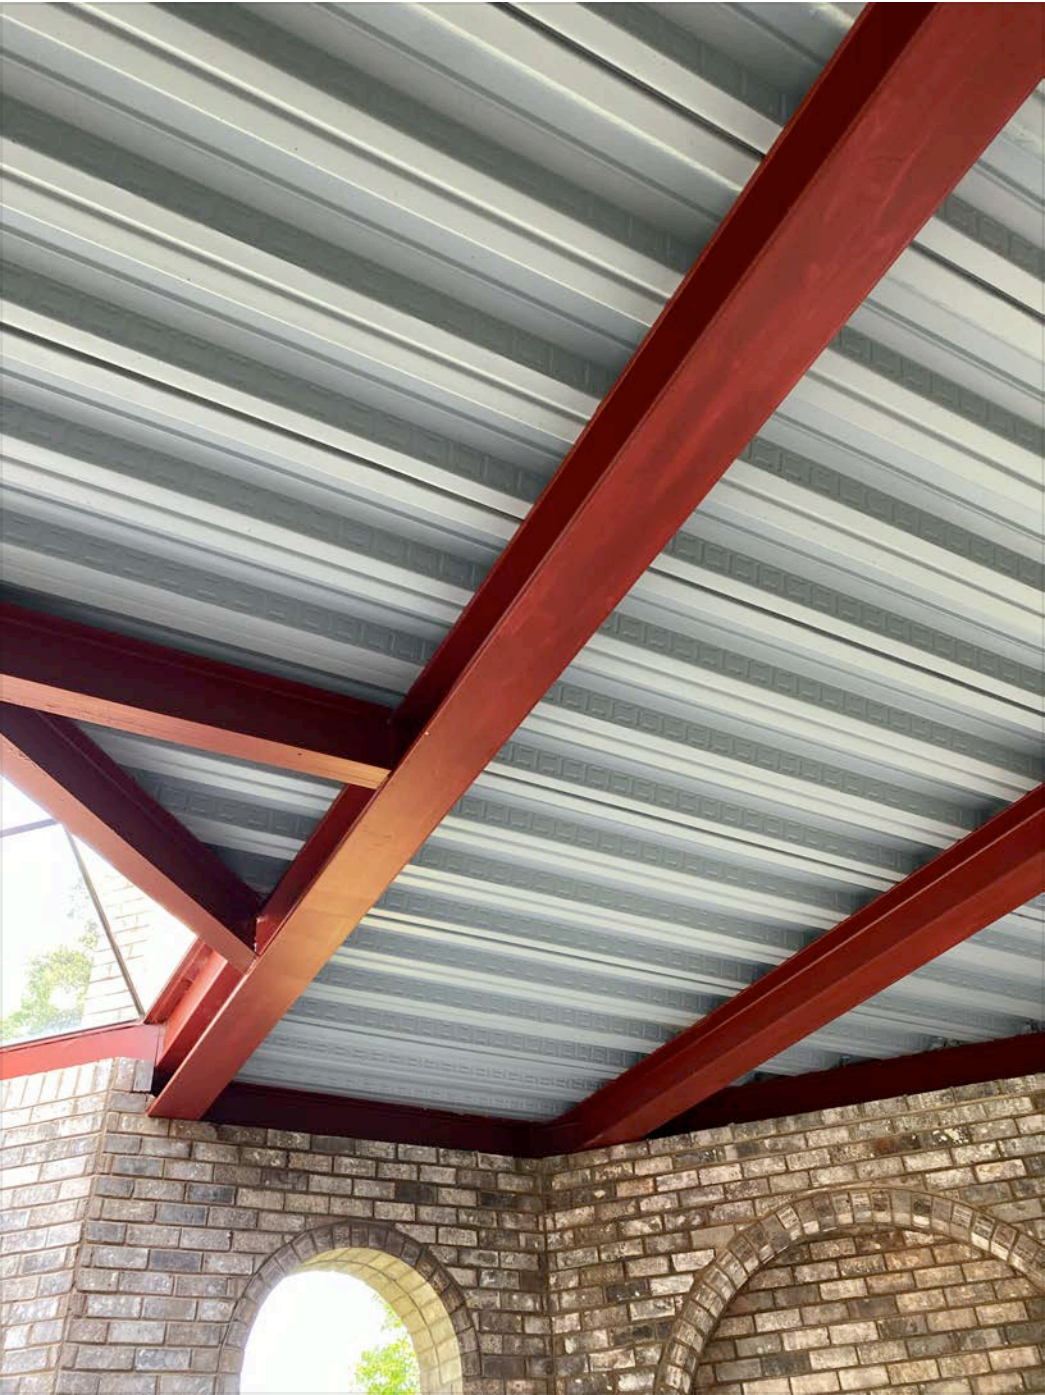
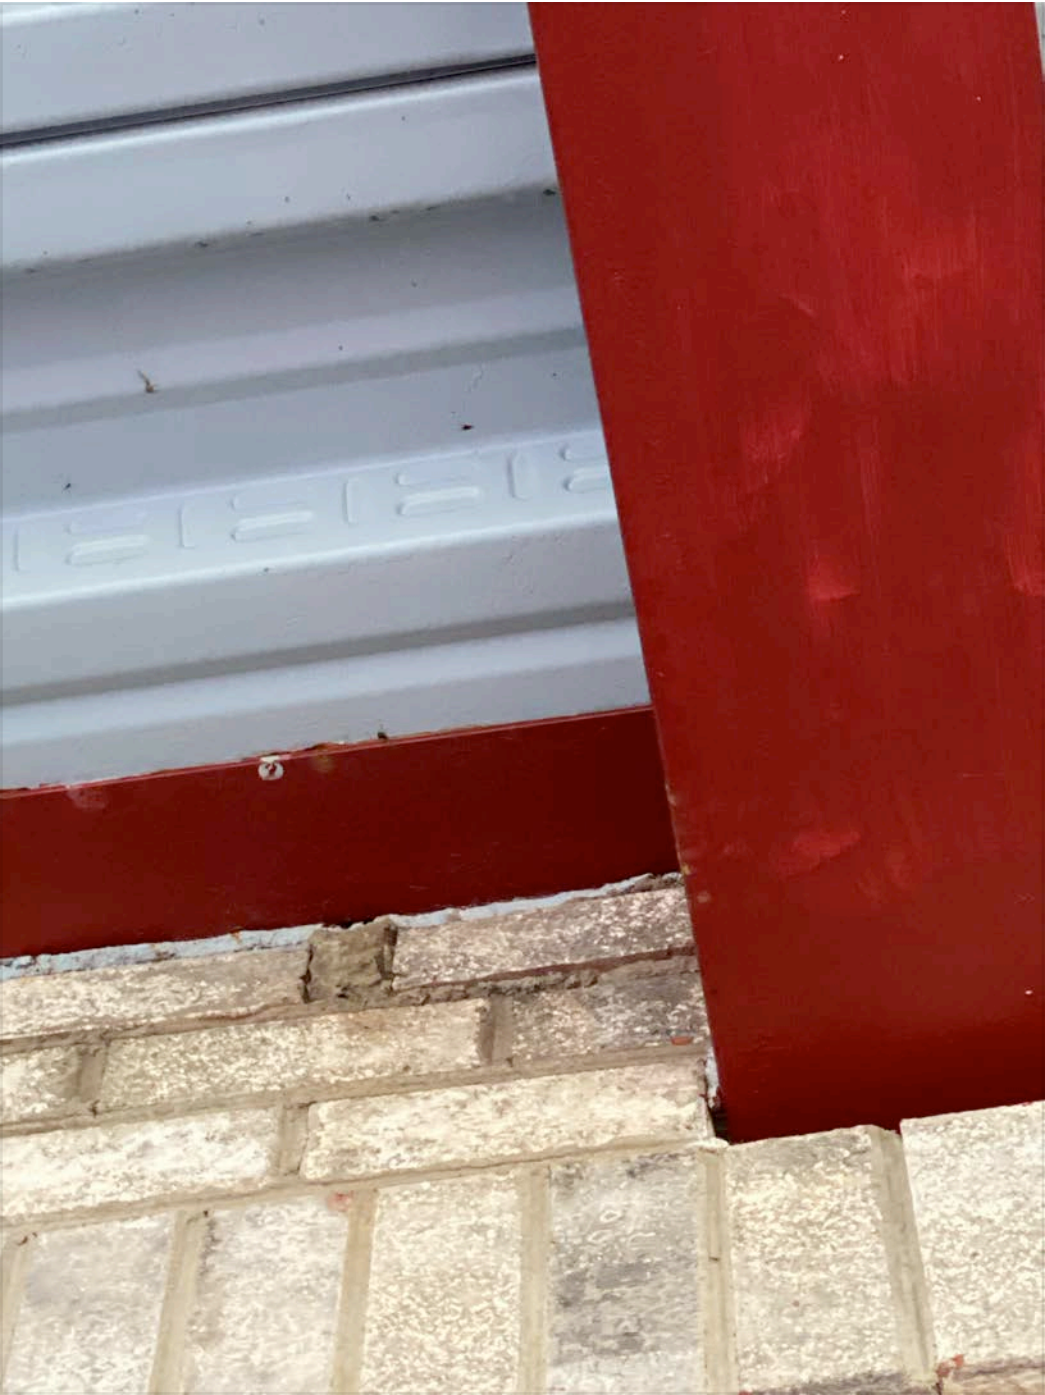
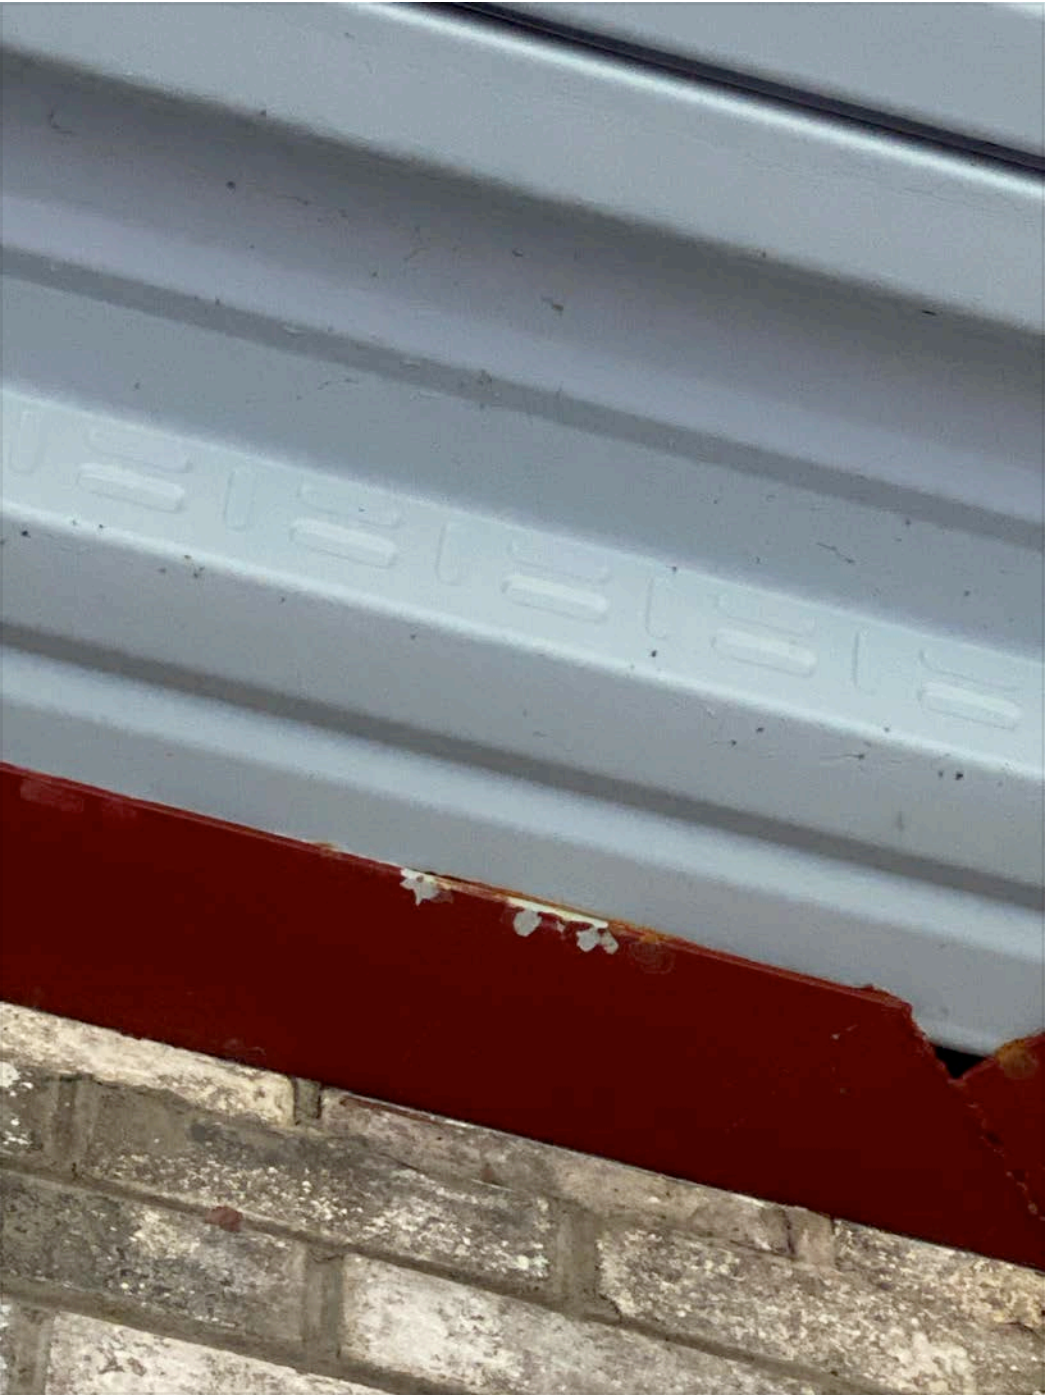
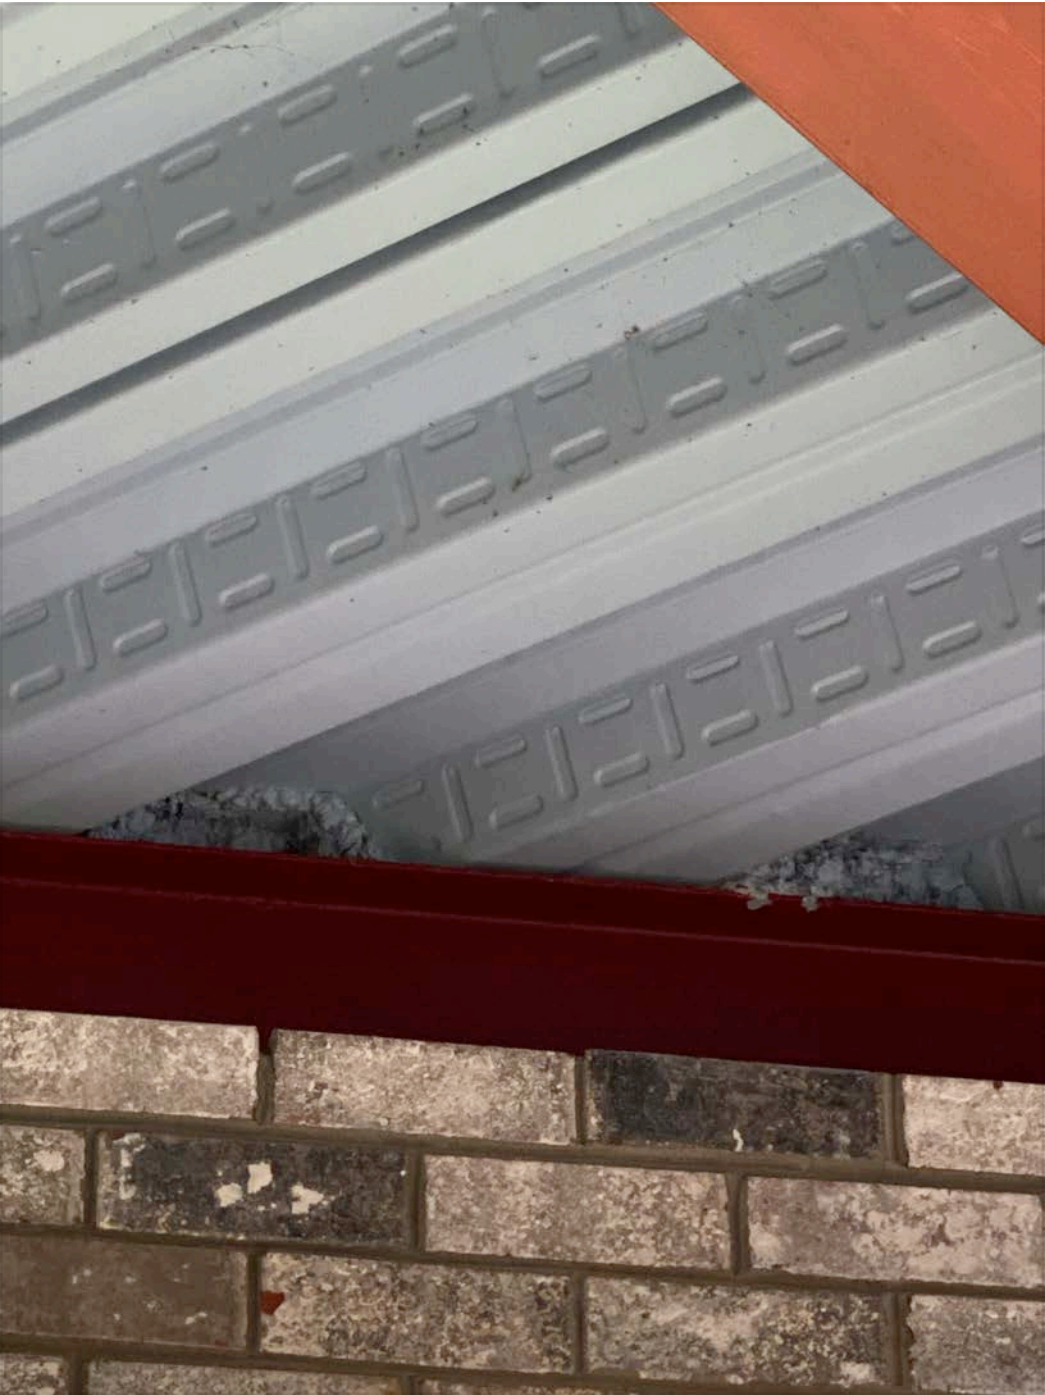
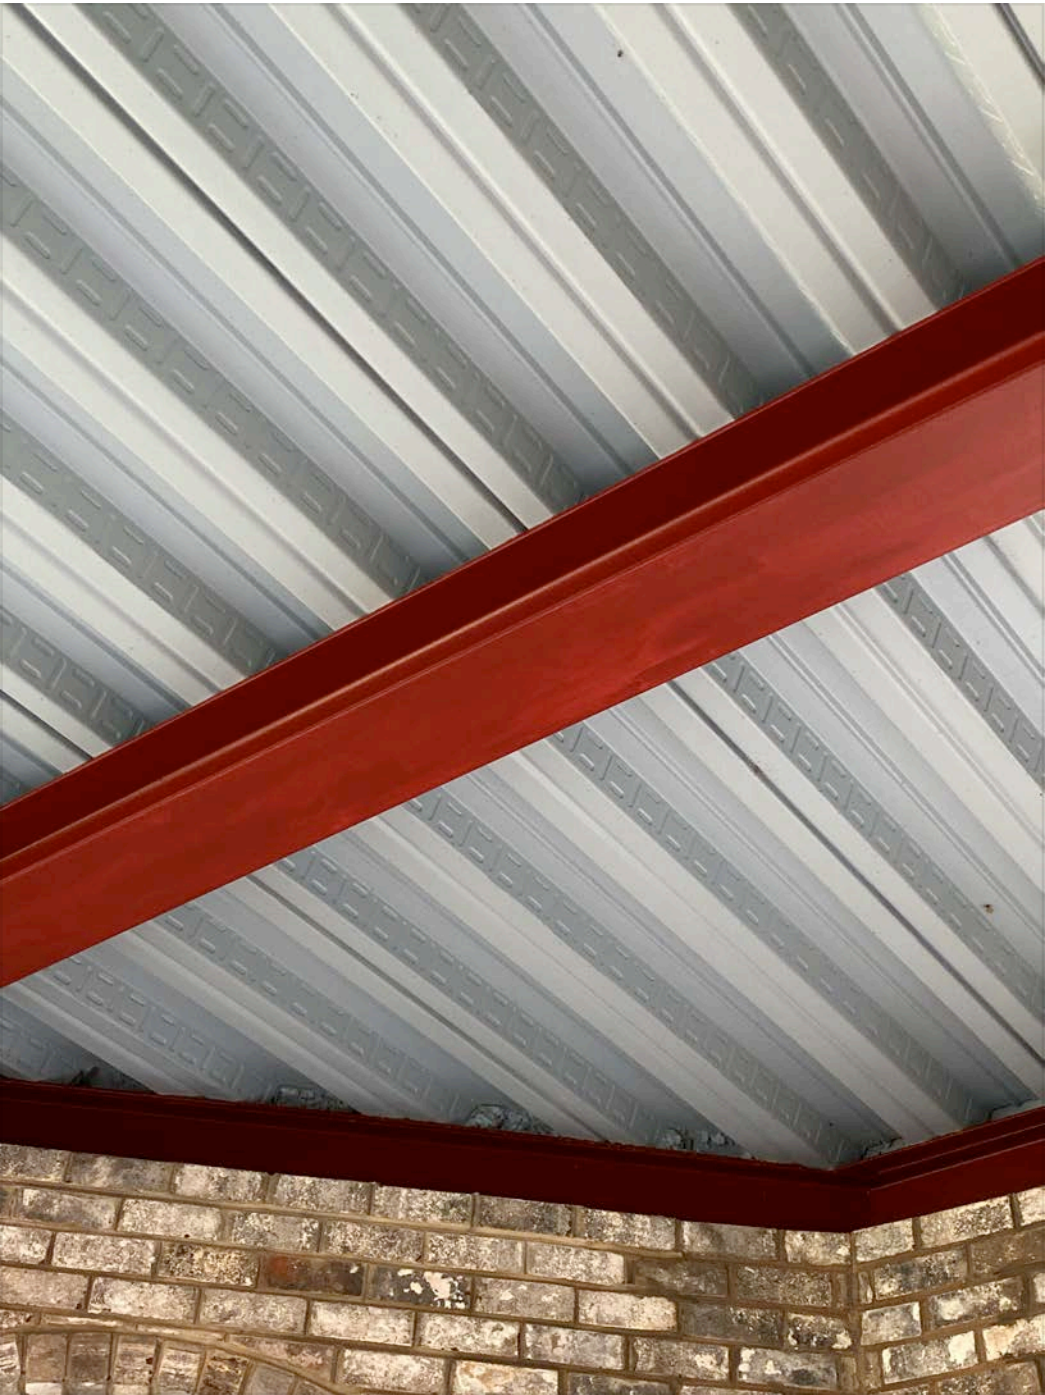
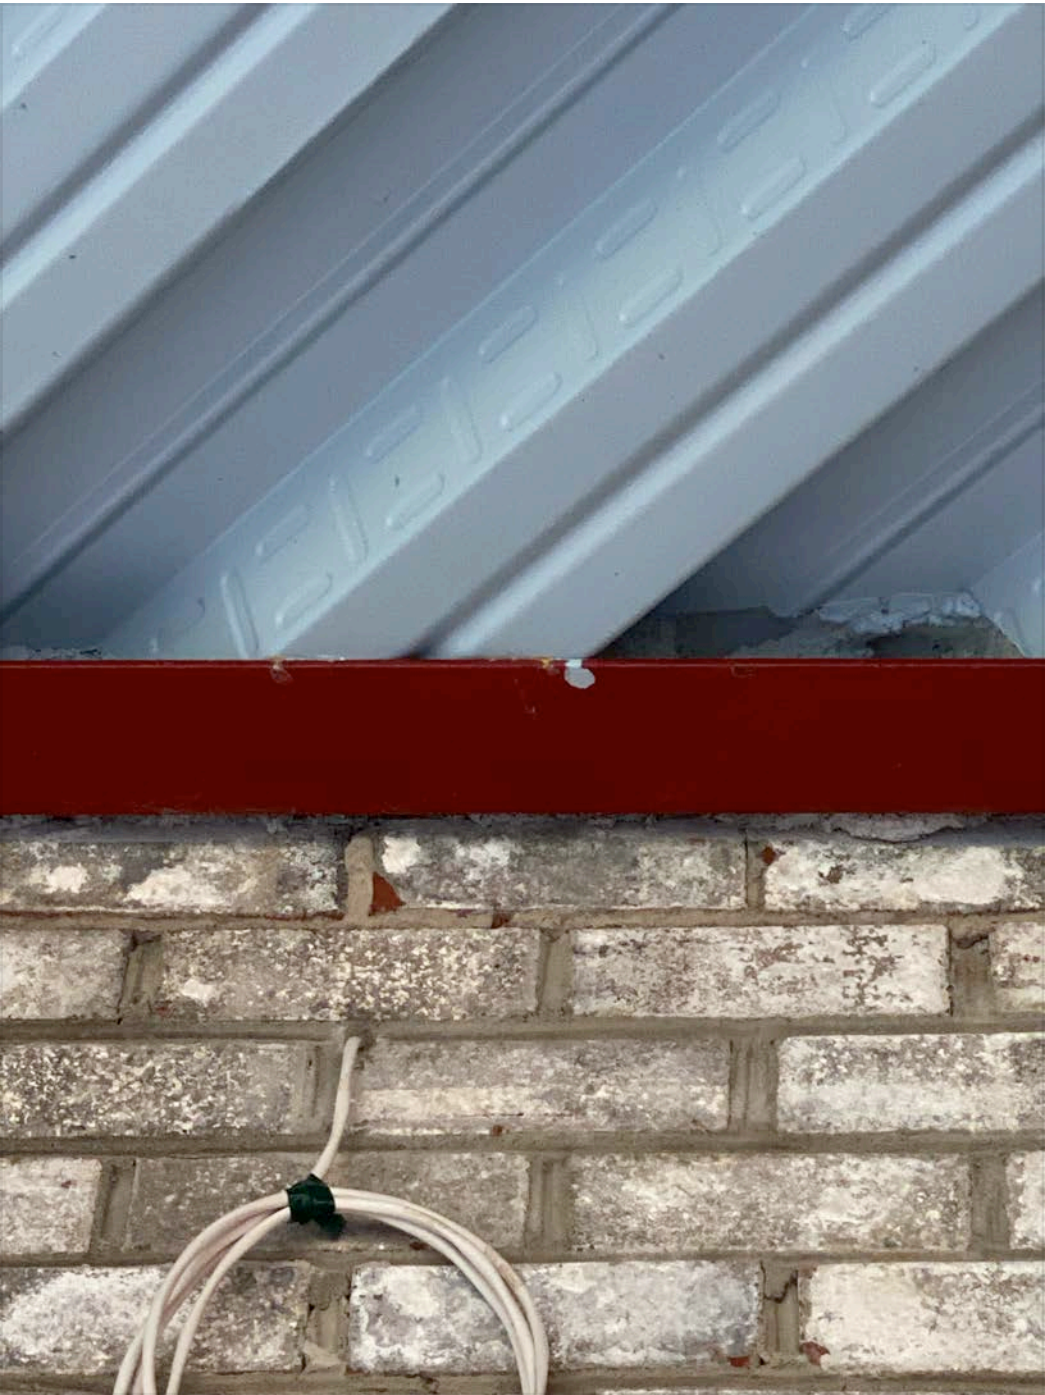
Lanai sandblast work to clean, mortar removal, plus the paint job:

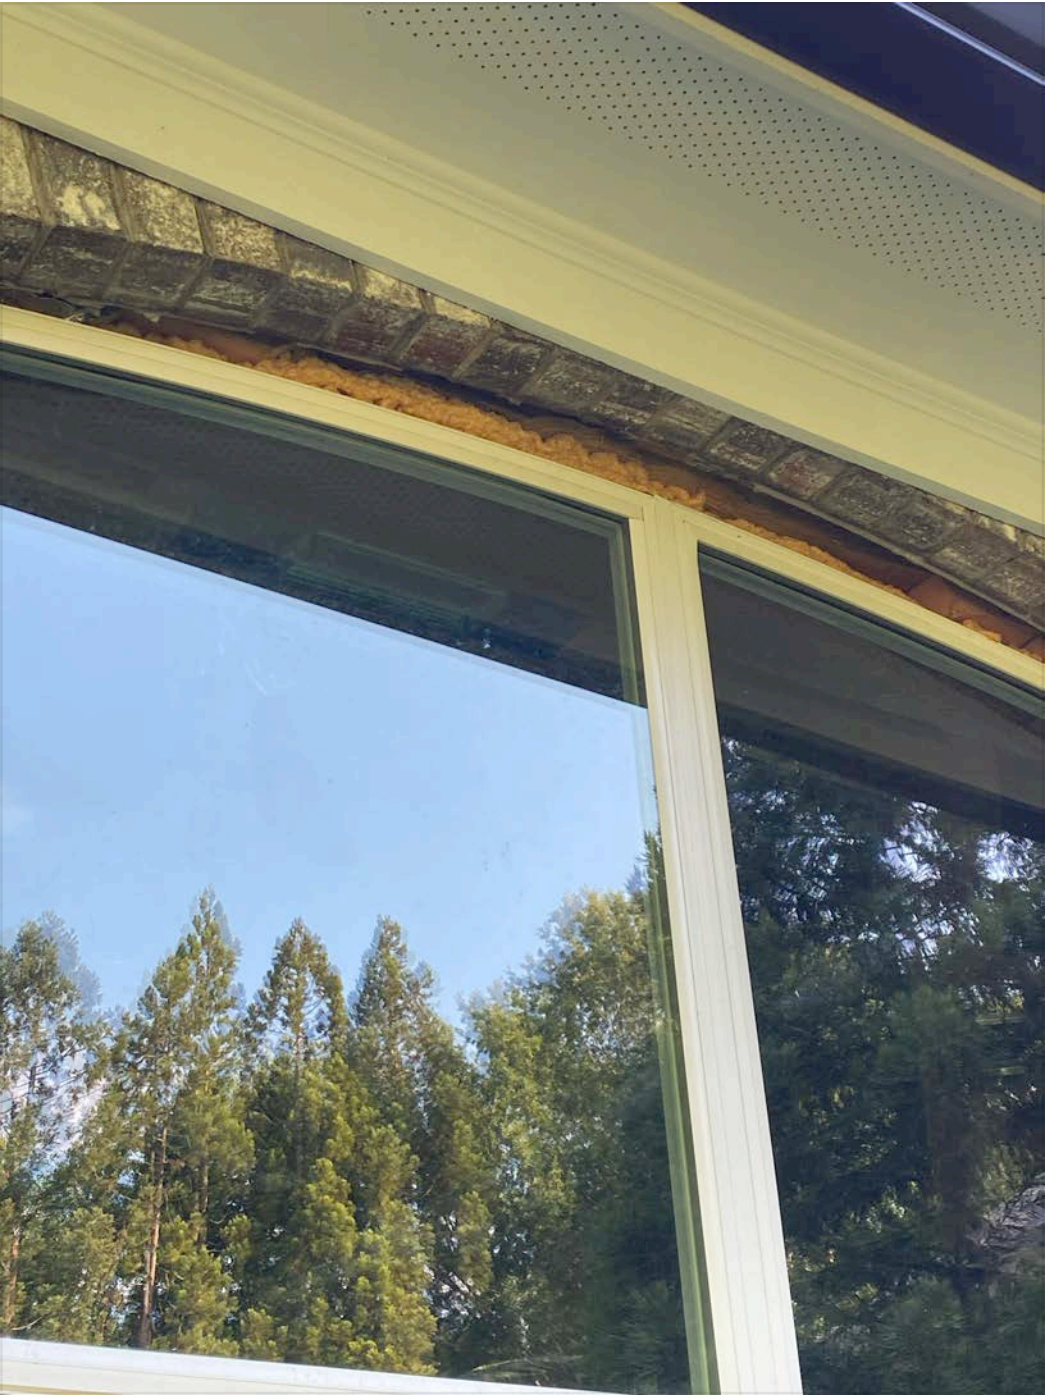
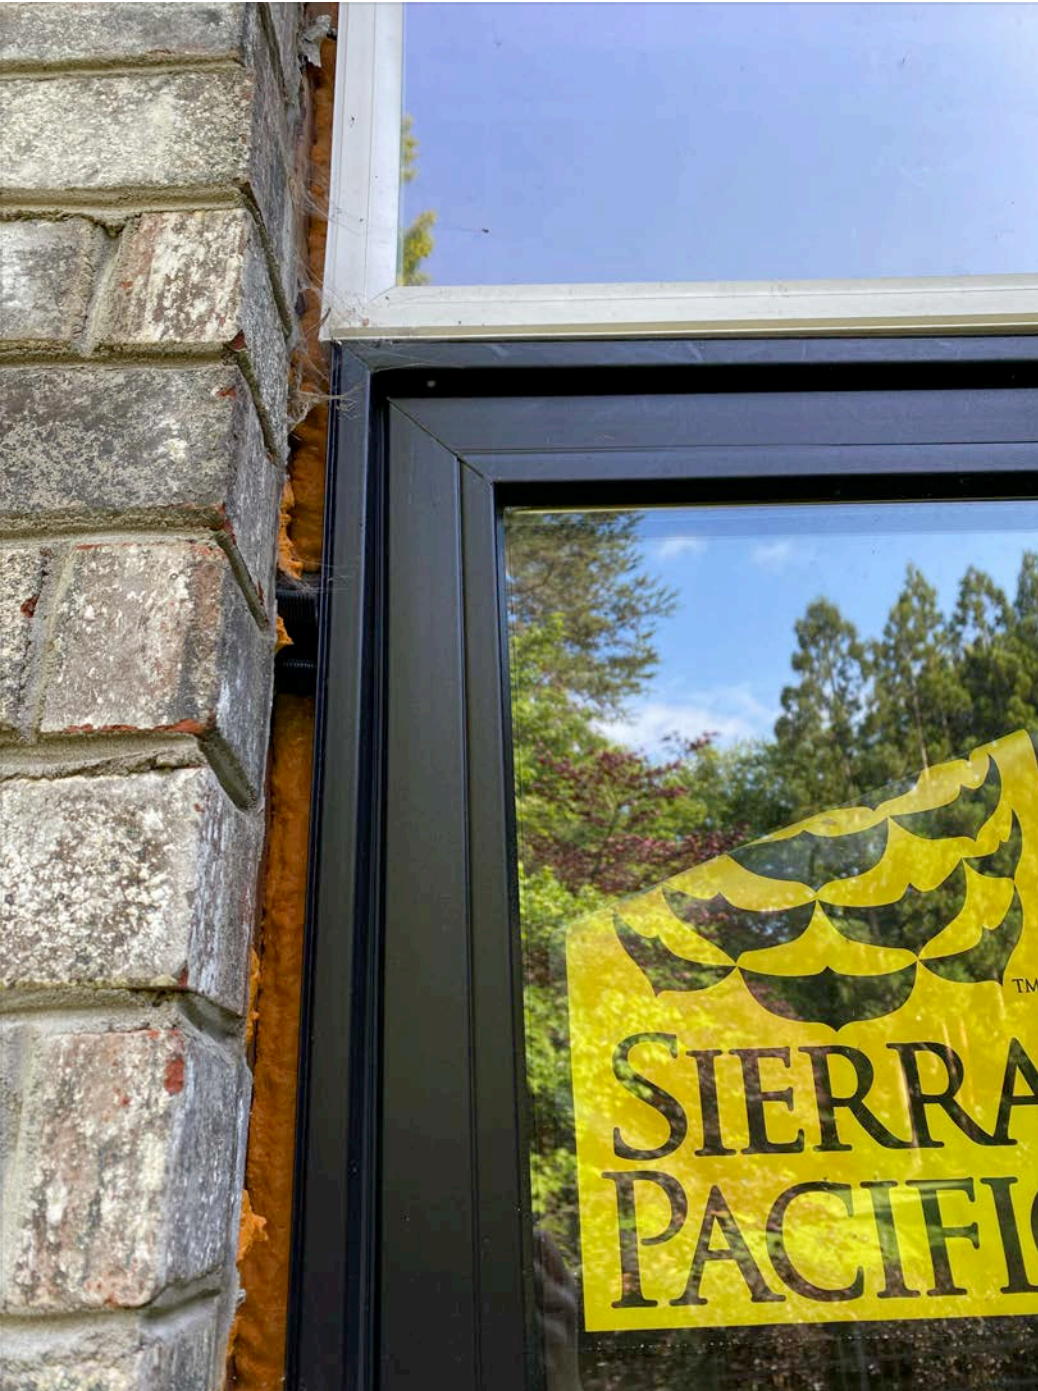
Window measurements off

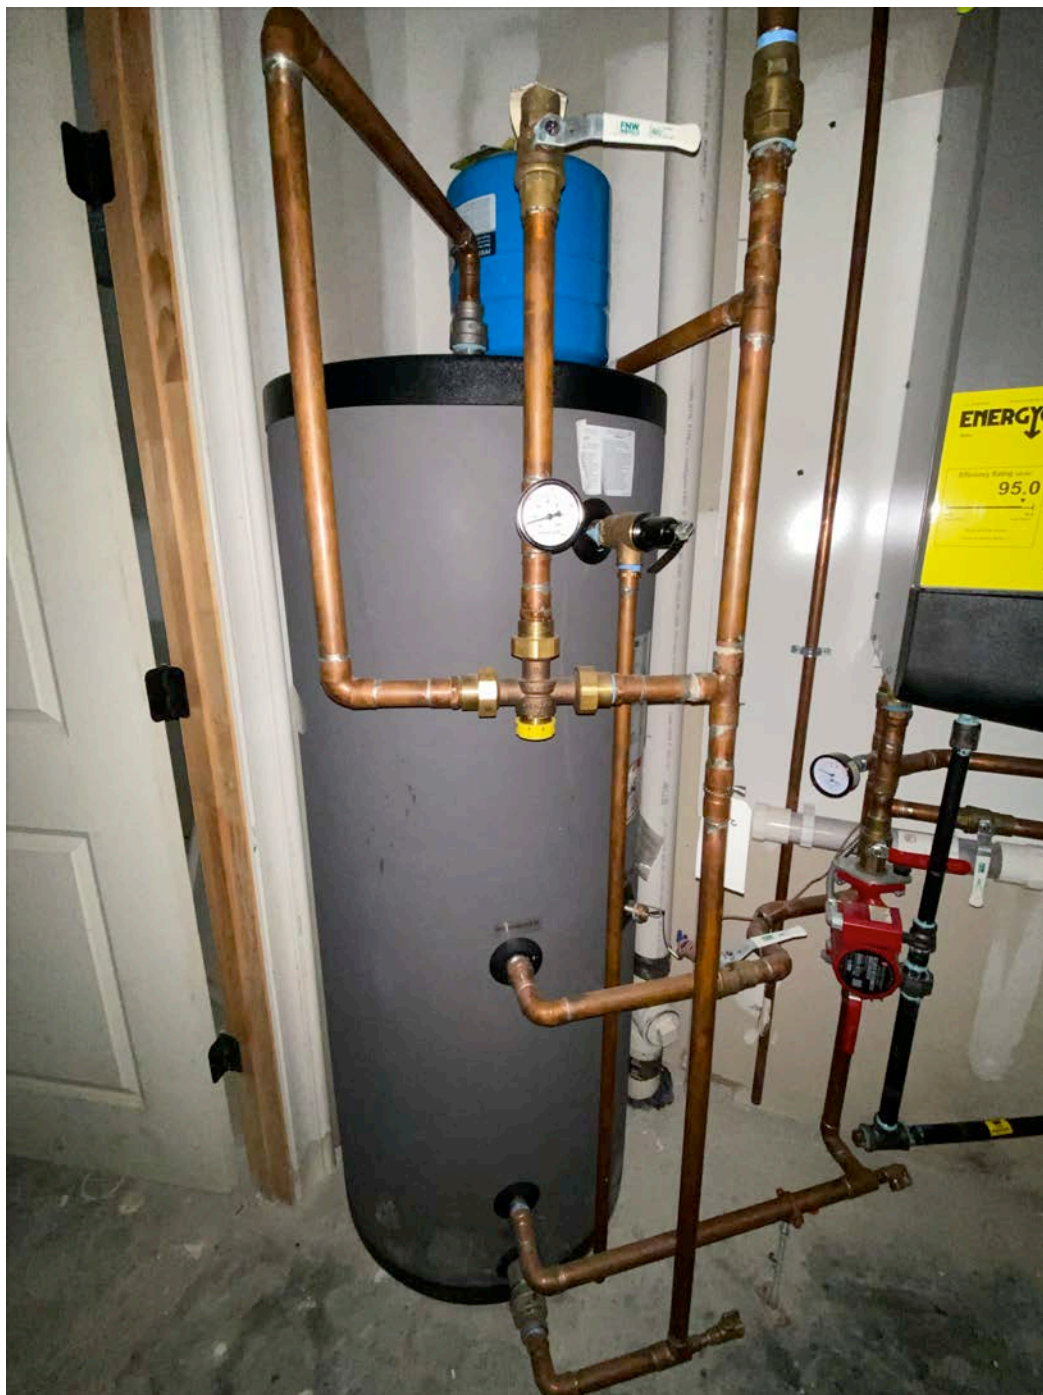
Told by worker that "Wrong size" was installed at first (Angela came over and found out it was being replaced). We need to verify this is the correct unit and that it is a new piece of equipment. It looks rather marked up and the sticker looks

worn.

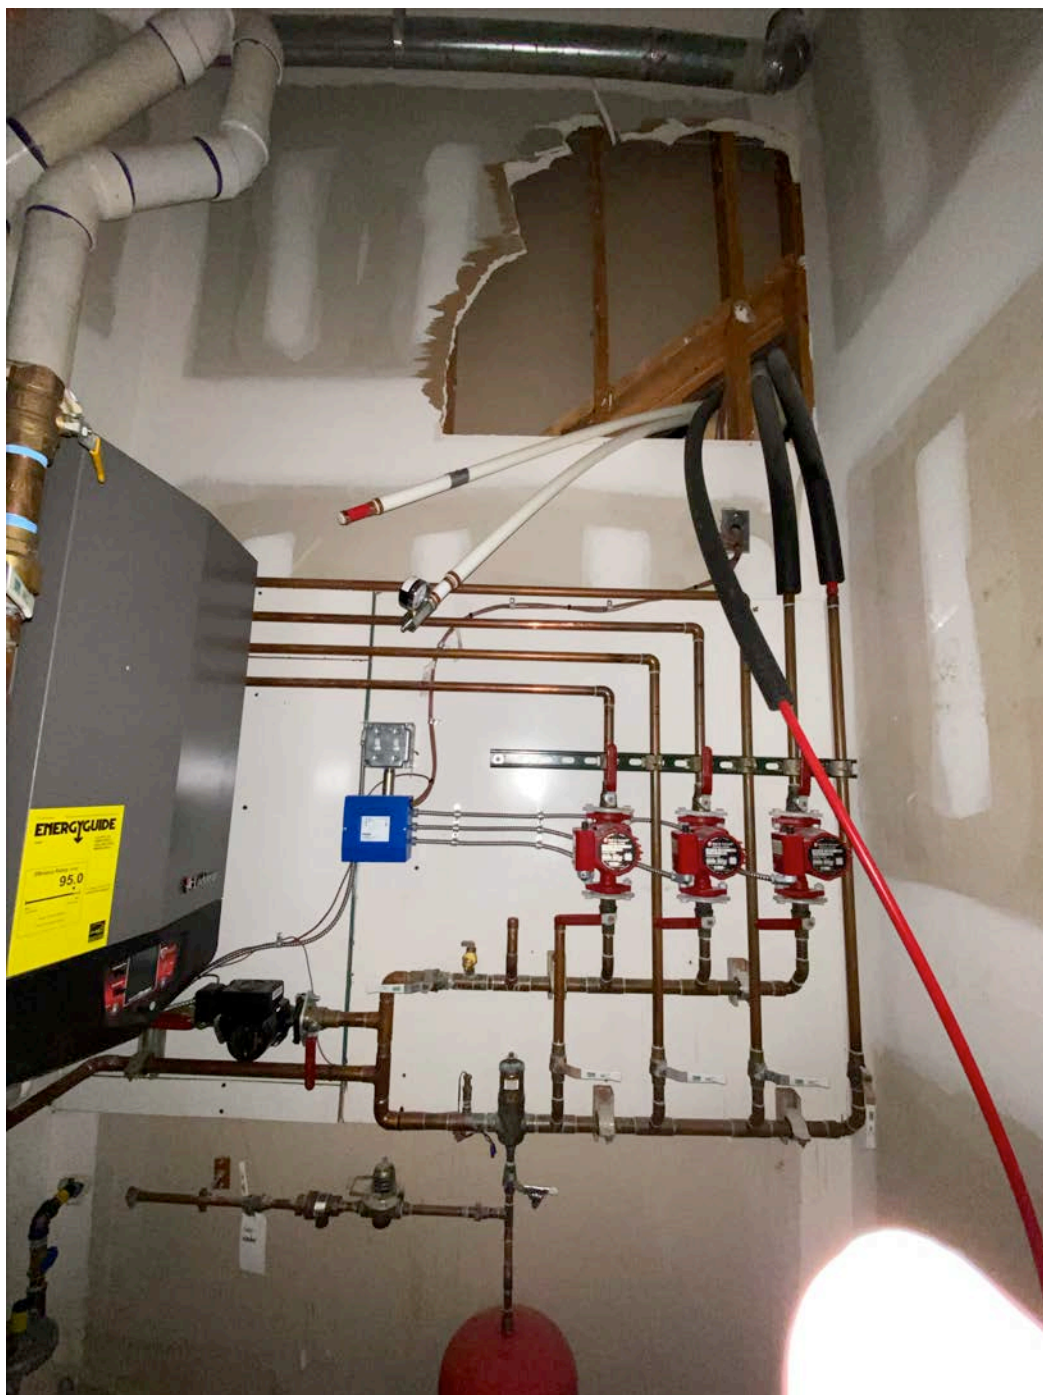
James B agreed to Angela that he would prep this wall prior to this install so the pipe work would look impressive. Instead, no prep was made to wall and misc cut pieces were put behind gorgeous copper work. Sad.

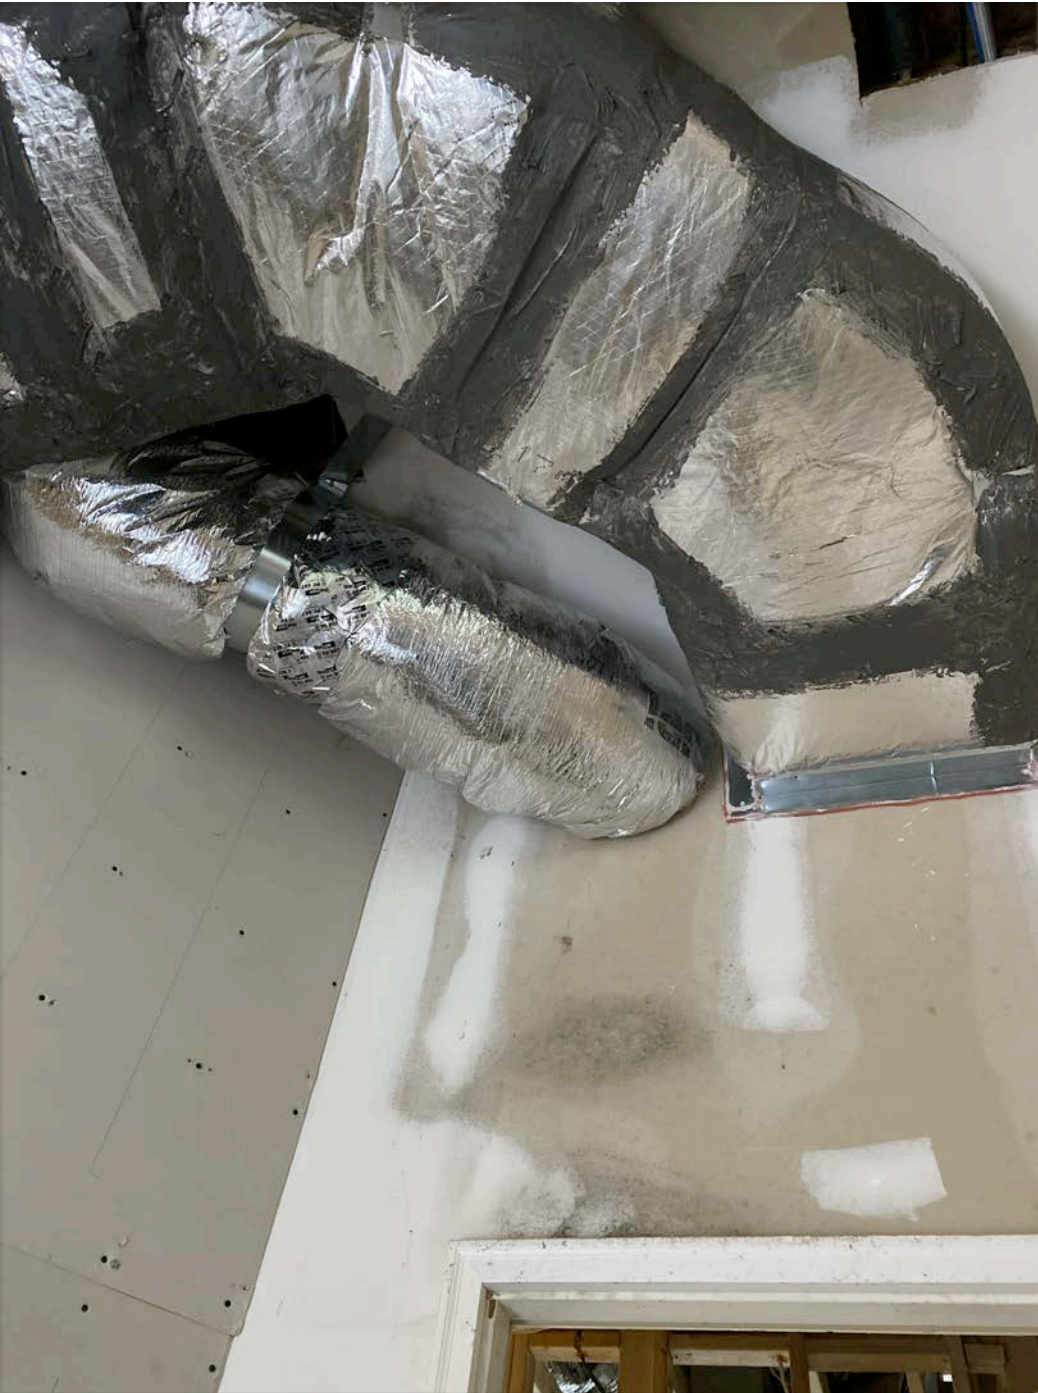
Mold remediation not done prior to hvac installation in gym garage thus increasing level of effort to remediate/replace since that mold is now oever the duct work. HVAC team said they will have to add extra supports prior as well as come back out after to secure / check once moldy drywall is torn out and area is treated.

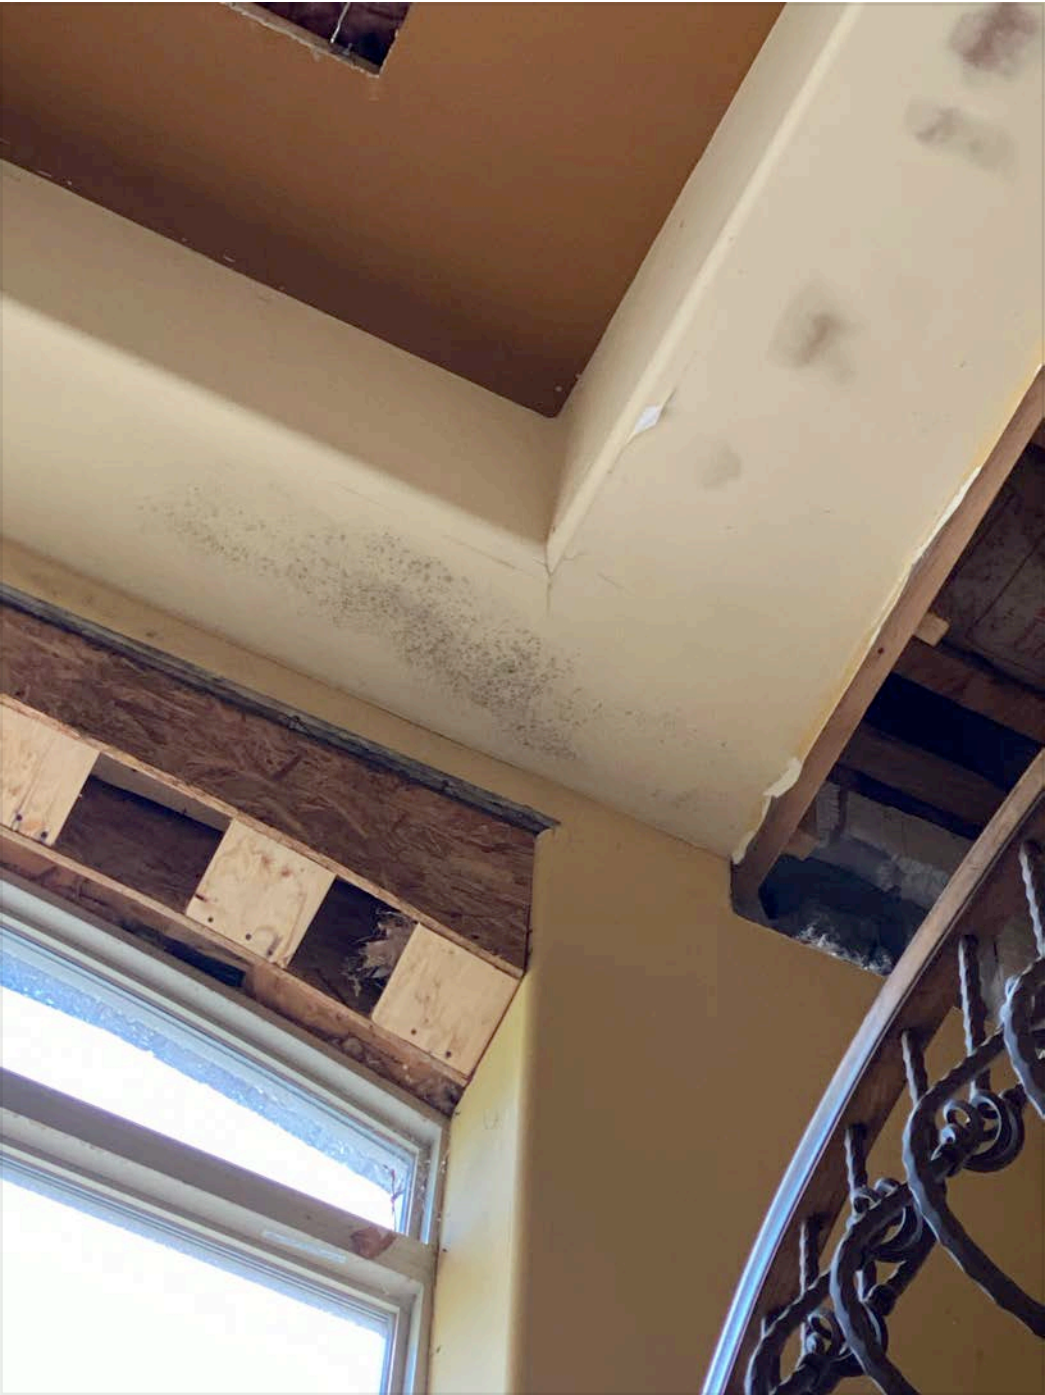
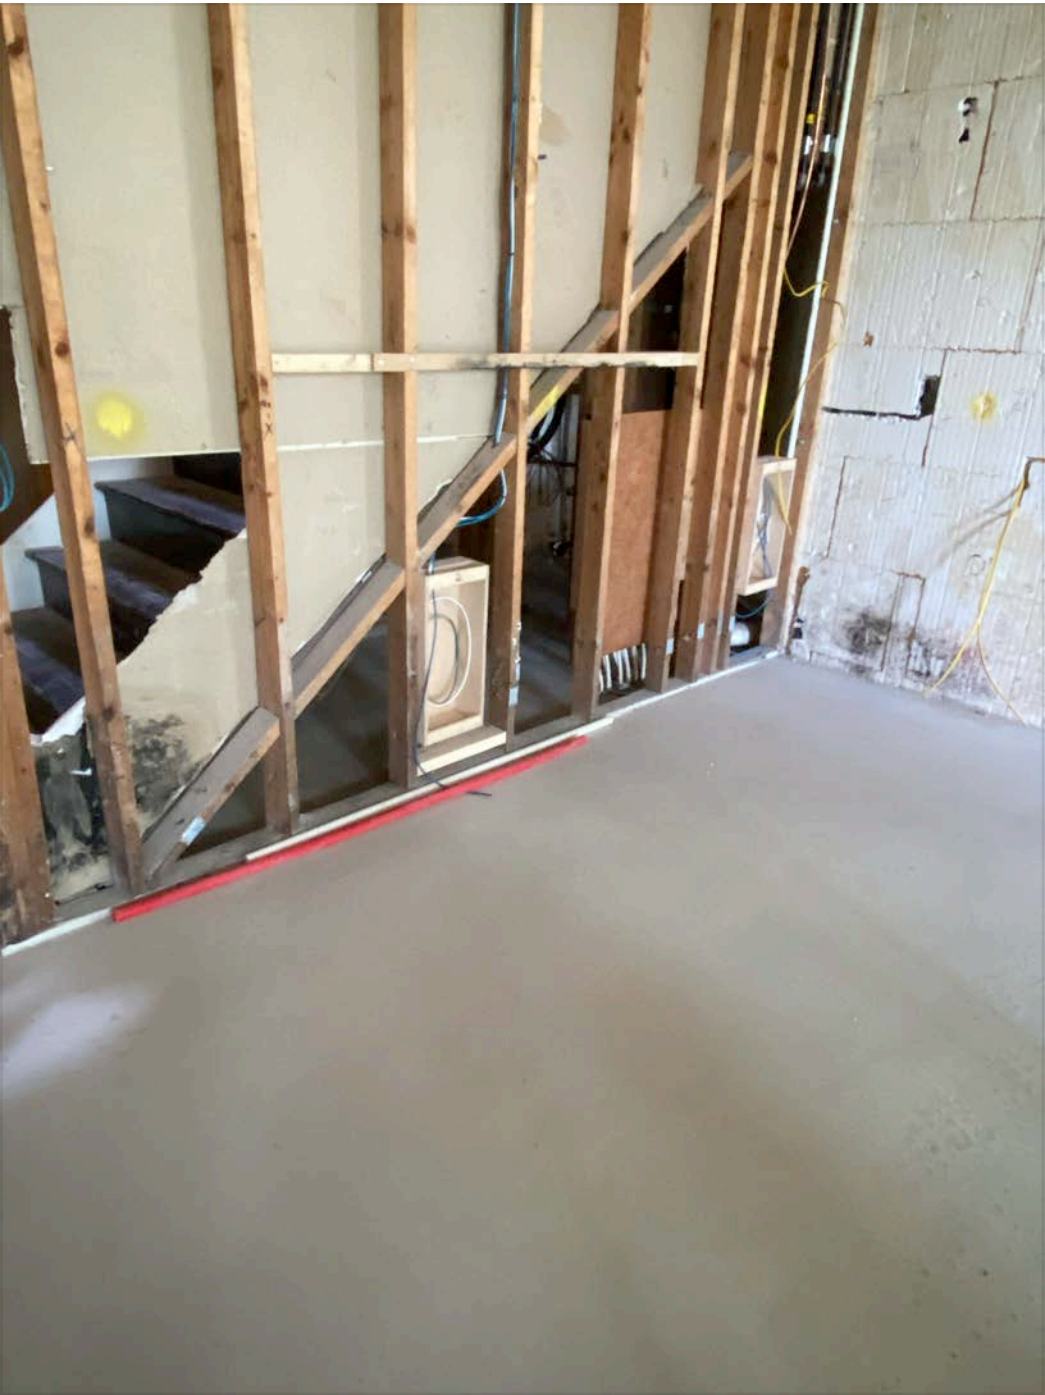
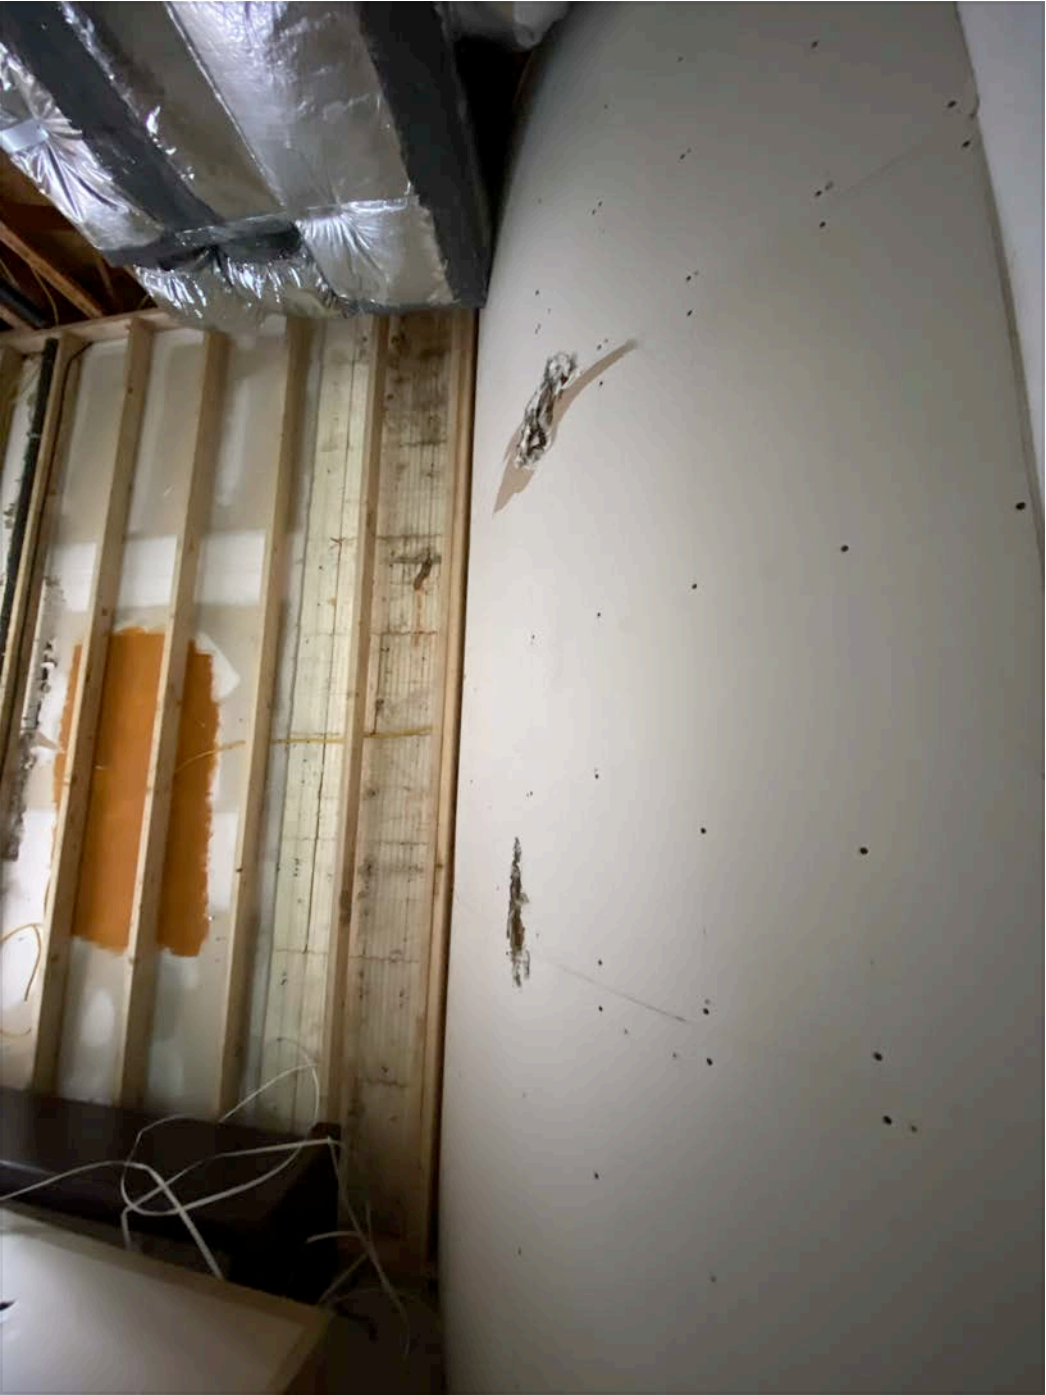
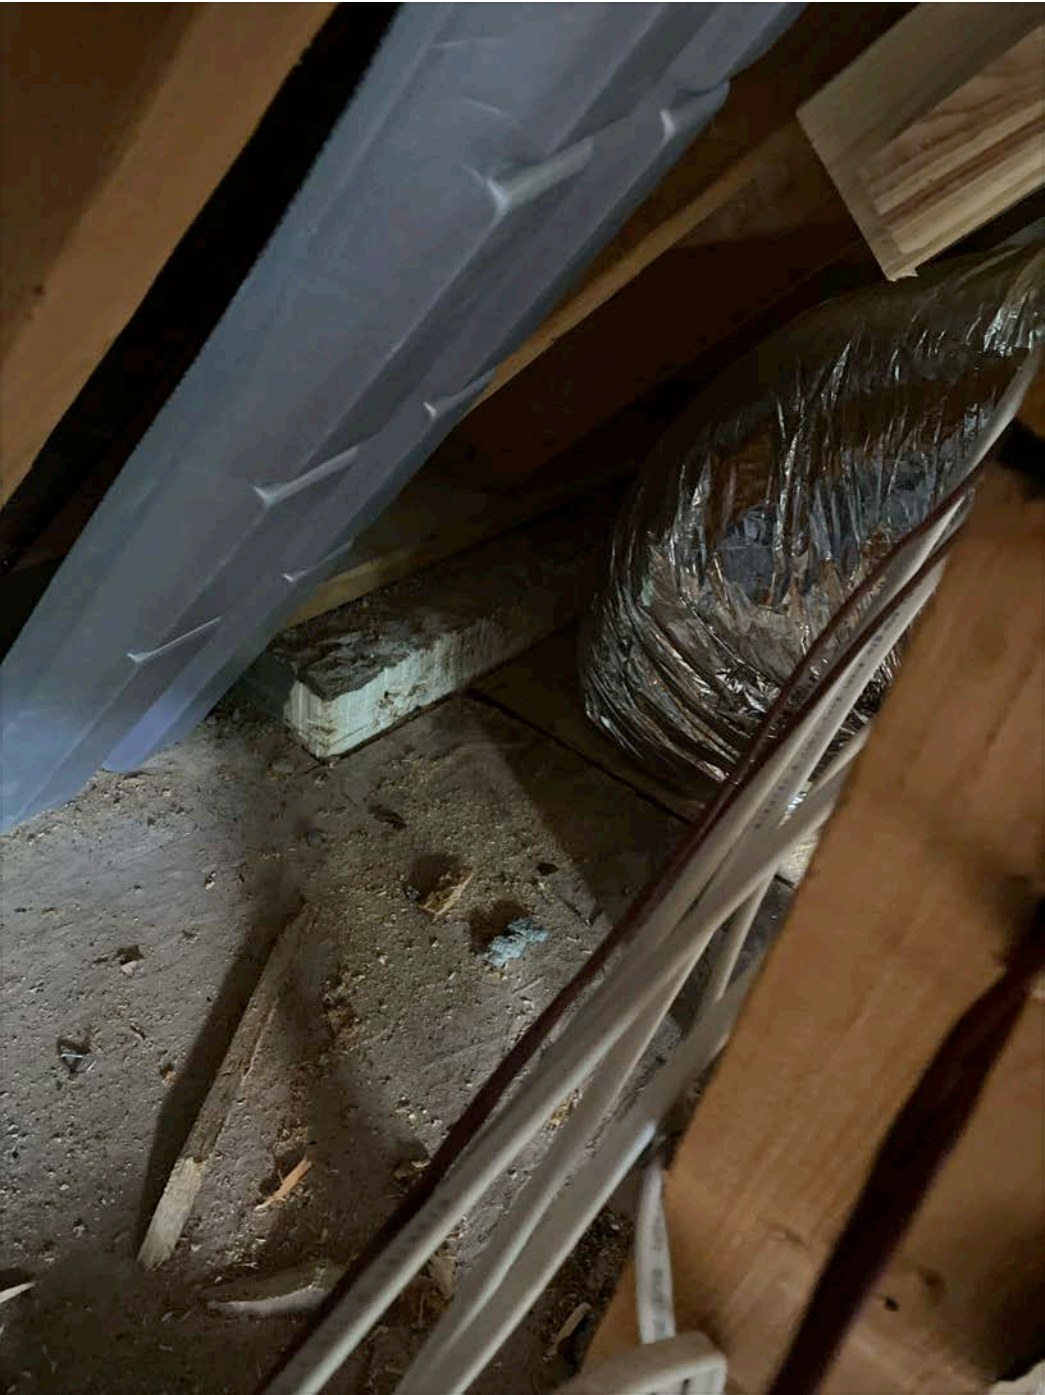
Multiple areas of home still evidence mold which must be fully remediated prior to drywall.
