Correction needed

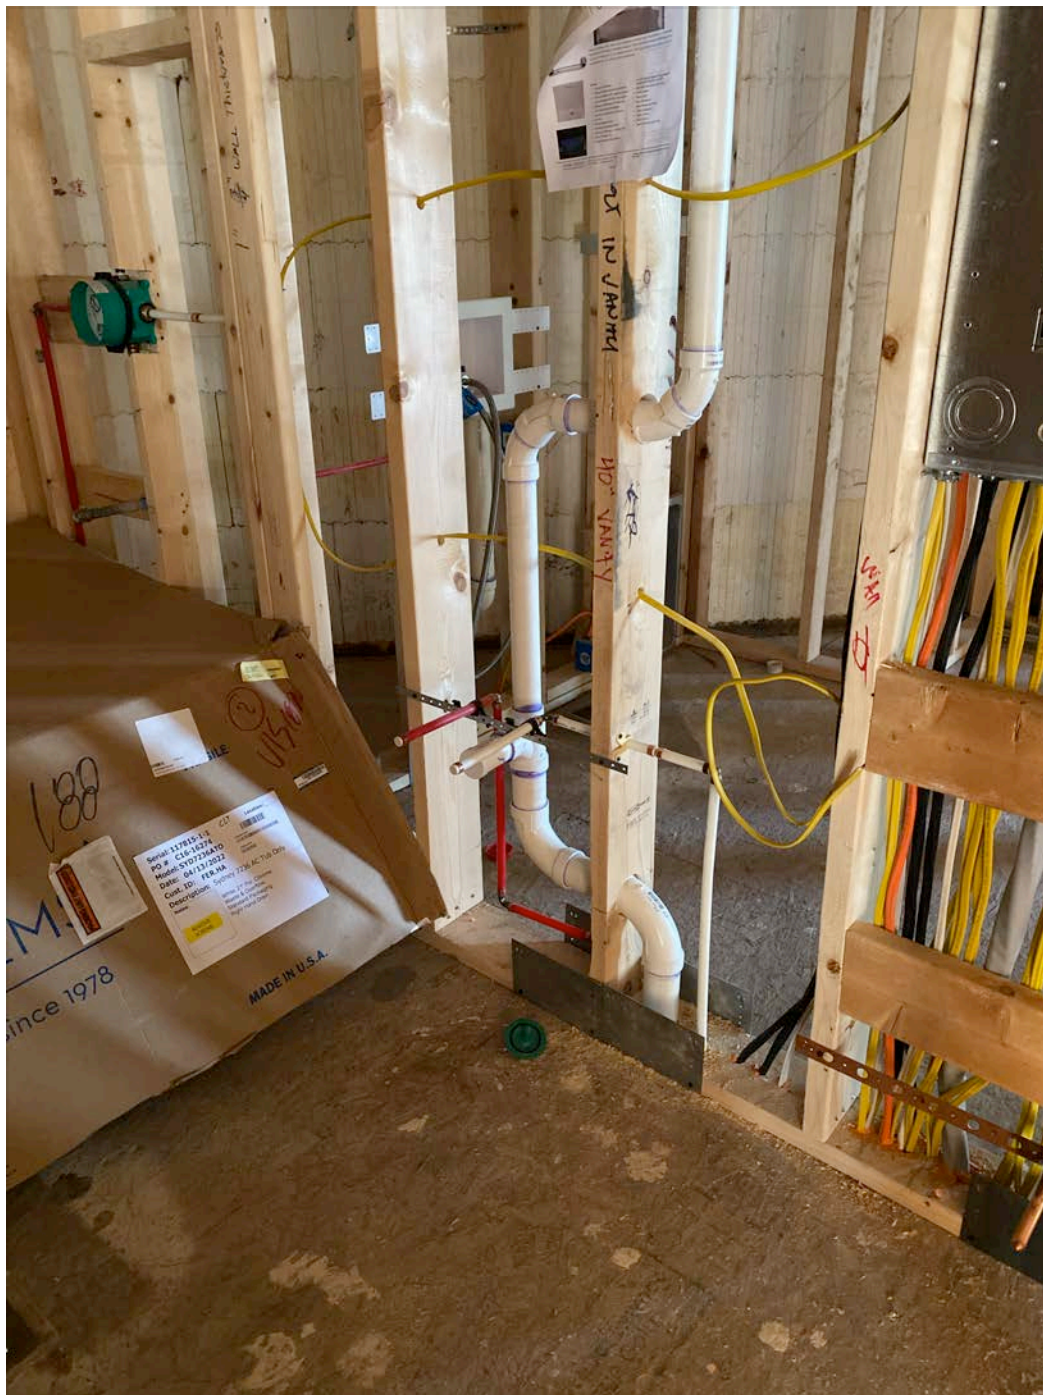
Patrick's bathroom sink plumbing needed to be moved since not aligned for pre specified floating sink.

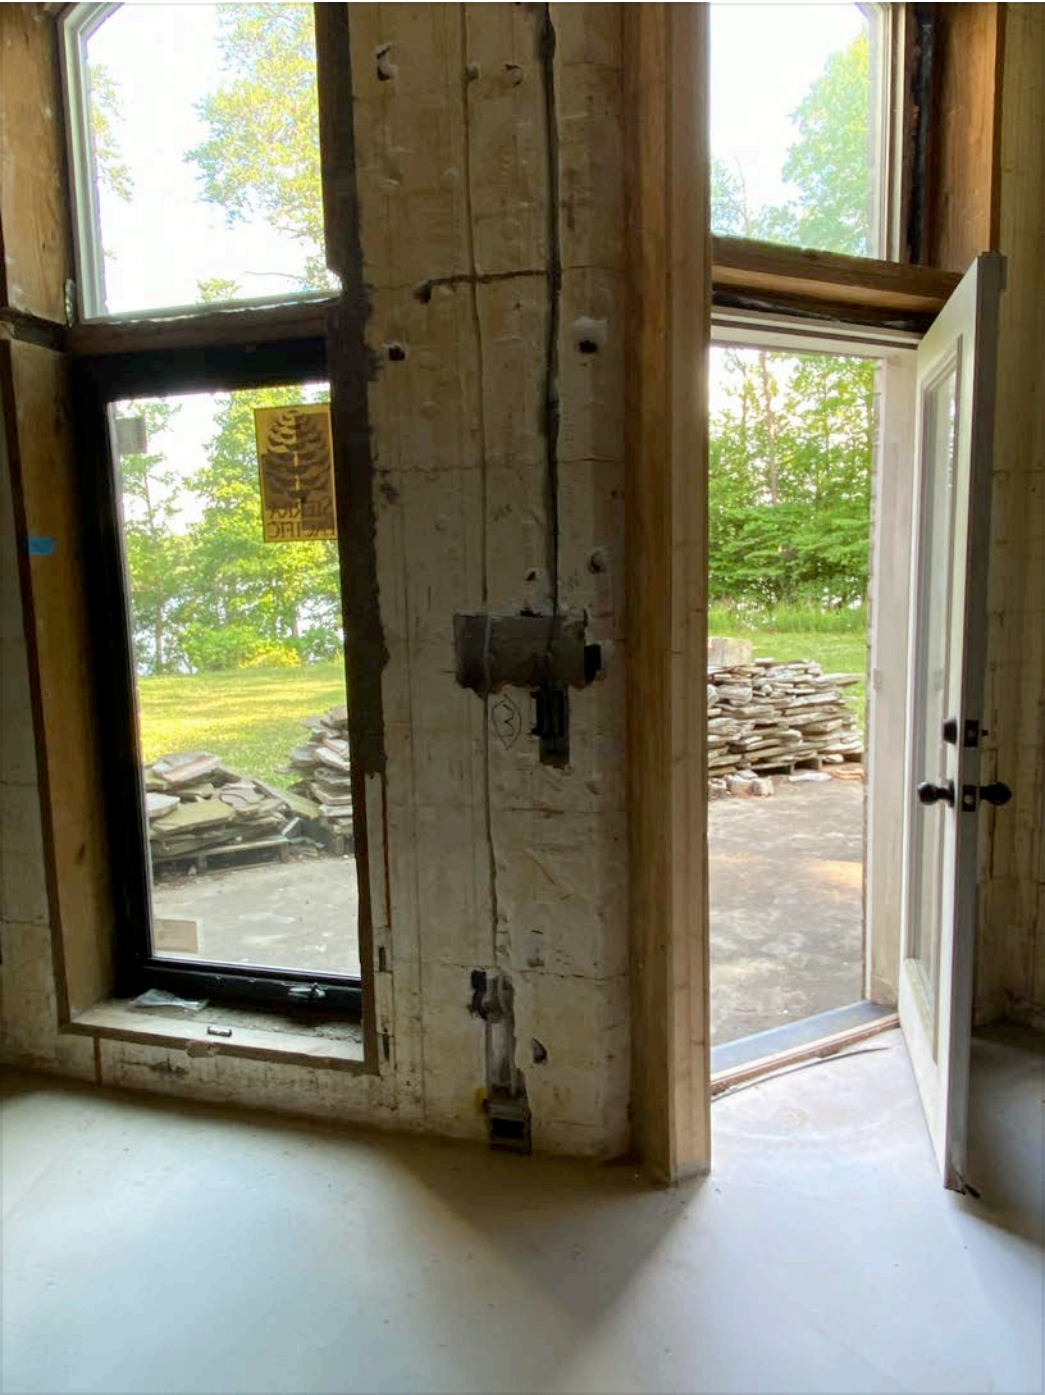
Jim Wolfe said he would have the door and window switched. Angela came over to see the window being installed where the door was expected. Later a quote was given for the work such would require.
