Inspection Report

Property Address:
5407 Eastern Shores Dr
Greensboro NC 27455

Brewer Home Inspections

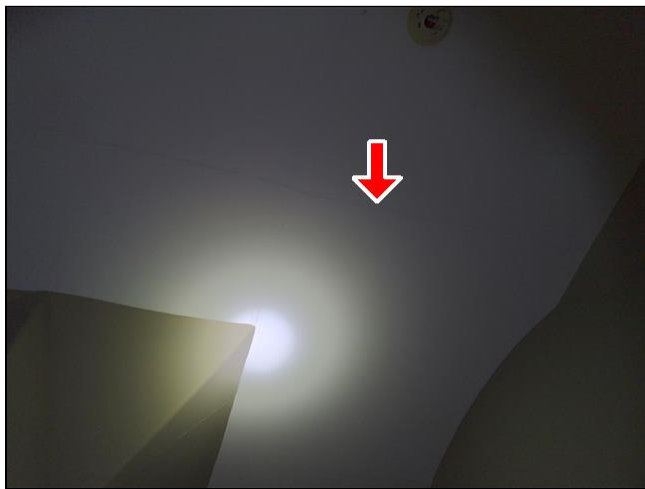
1.0 Item 1(Picture)

1.0 Cracks are present at the ceiling at 3rd floor. Cracks appear to be following tape seam at drywall. No adverse conditions noted at time of inspection. Recommend subsequent observation and all needed repairs to restore to original condition.

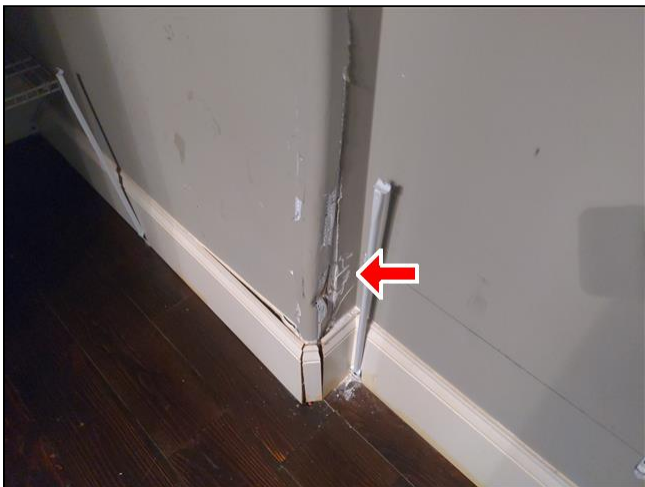
1.1 Item 1(Picture)

1.1 (1) Wall(s) damaged at bonus room closet, kitchen. Further deterioration may occur. A qualified contractor is recommended to evaluate and make all needed repairs.

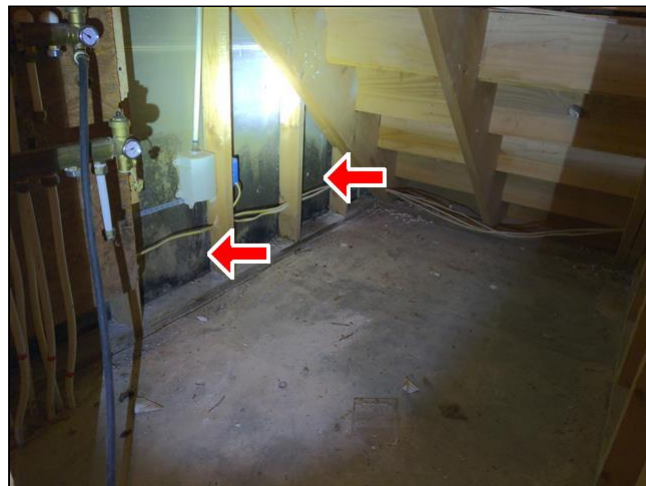
1.1 Item 6(Picture)

1.1 (4) Fungi growth is located at the wall at storage room. This may suggest prior or intermittent abnormal moisture concern. A qualified contractor is recommended to evaluate and make all needed repairs.

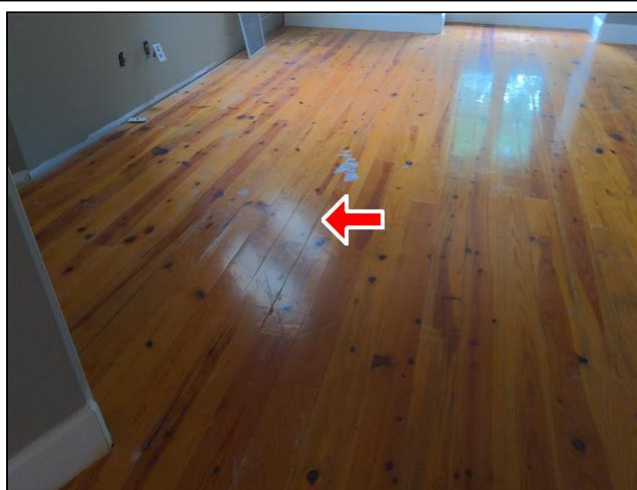
1.2 Item 2(Picture)

1.2 (2) There is sloping noted at the interior flooring at 3rd floor. This may suggest movement of the wall/floor structure components. Multiple sources could cause this affect. Further movement concern. A qualified contractor is recommended to evaluate for cause and make any needed repairs.

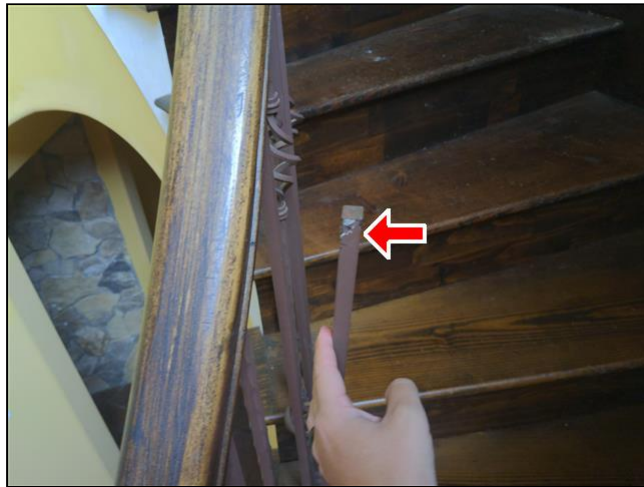
1.3 Item 2(Picture)

1.3 (2) There are loose spindles located at the interior staircase/railing at different areas. Safety concern. Failure may occur with added weight. A qualified contractor is recommended to evaluate and make all needed repairs.

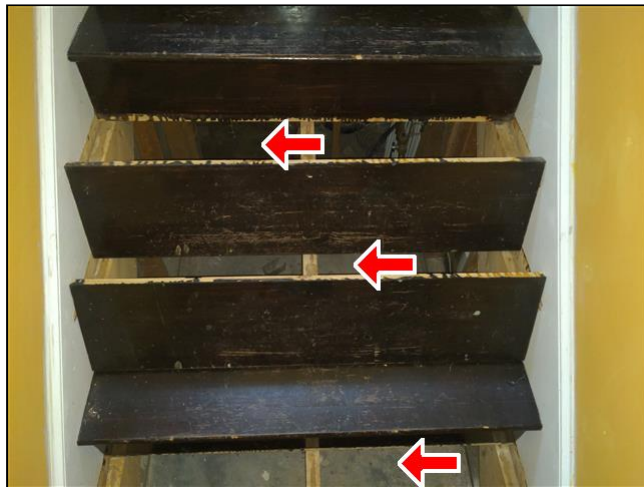
1.3 Item 3(Picture)

1.3 (3) Loose or damaged step(s) are present at the interior stairway. Further deterioration may occur. Potential fall hazard. A qualified contractor is recommended to evaluate and make all needed repairs.

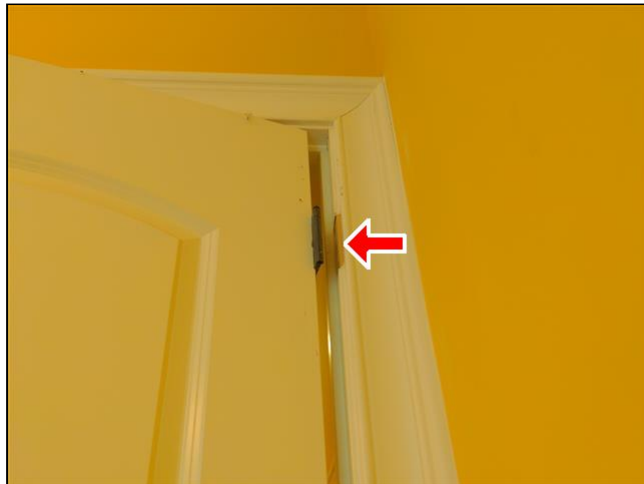
1.5 Item 1(Picture)

1.5 (1) Door(s) and or component(s) damaged at laundry room. Improper operation may occur. Recommend proper replacement to restore original condition.

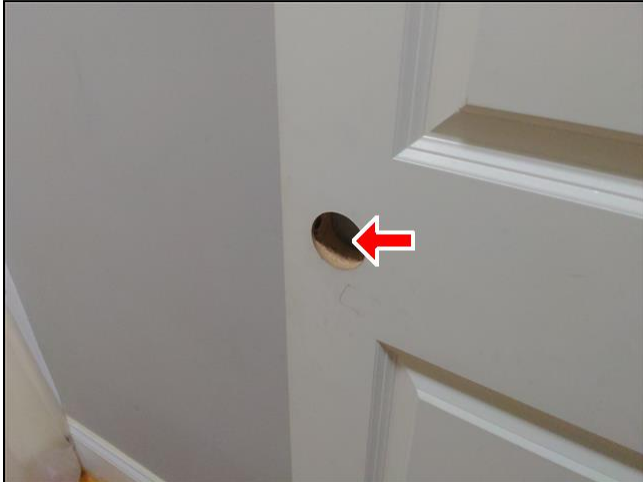
1.5 Item 2(Picture)

1.5 (2) Door(s) missing knob or handle at 3rd floor. Not doing job as intended. Door will not latch/close properly. A qualified contractor is recommended to evaluate and make all needed repairs.

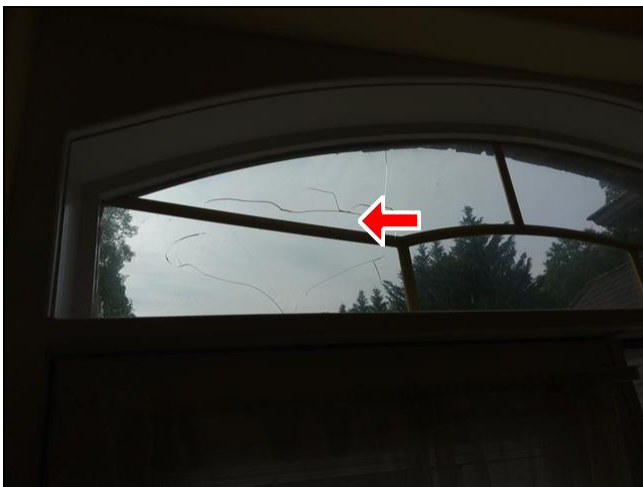
1.6 Item 1(Picture)

1.6 (1) Window pane(s) are cracked at upstairs left front bedroom, 3rd floor. Safety concern. Further deterioration concern. Qualified contractor is recommended to evaluate and make all needed repairs.

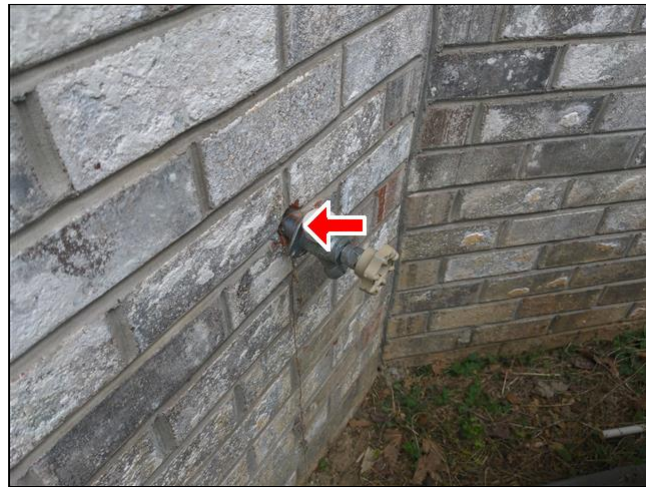
2.1 Item 1(Picture)

2.1 (1) Hose faucet(s) loose at left side. Movement of faucet and damage to plumbing lines may occur. Substandard install. Proper professional should evaluate and make all needed repairs.

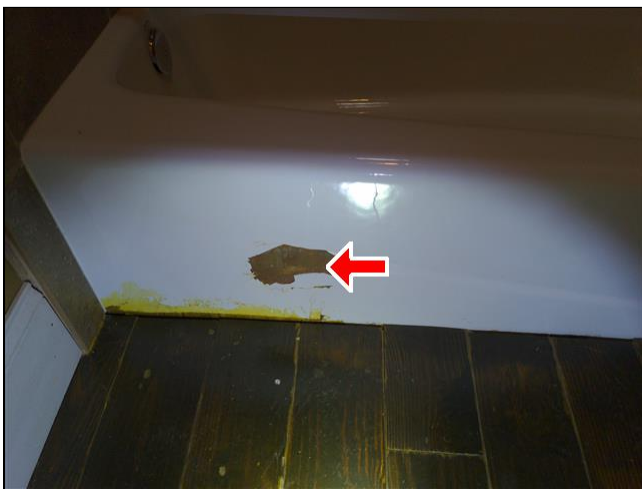
2.1 Item 2(Picture)

2.1 (2) Bathtub(s) damaged at shared bath, master bathroom. Further deterioration may occur and leaks could develop. A plumbing contractor is recommended to evaluate and make any needed repairs.

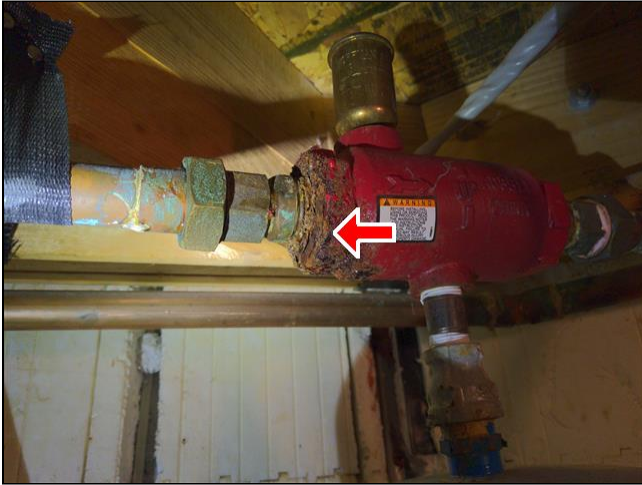
2.1 Item 4(Picture)

2.1 (3) Corrosion is present at supply lines at kitchen . Further evaluation and or repairs may be needed in the near future. Recommend subsequent observations and or further evaluation by a qualified plumbing contractor as desired by client.

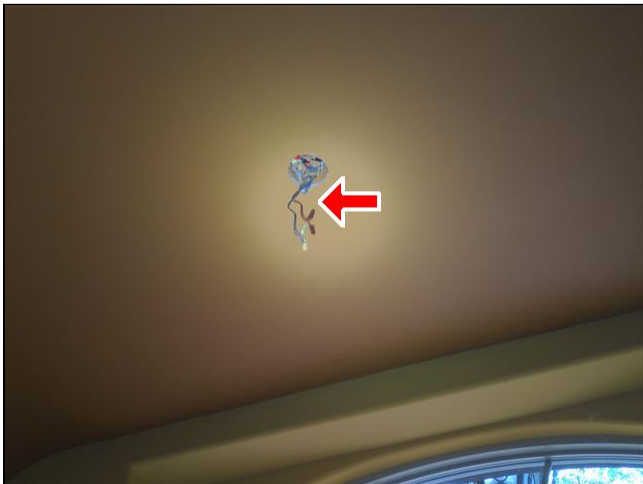
3.3 Item 2(Picture)

3.3 (2) Loose electrical wiring is present at foyer, 3rd floor, guest bedroom, garage closet. The wiring should be properly secured. Safety concern. Electrical issues are considered to be a hazard until repaired. An electrical contractor is recommended to evaluate and make all needed repairs.

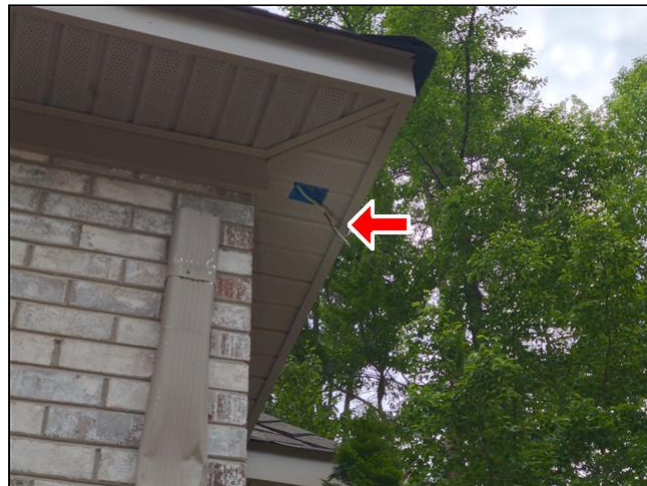
3.3 Item 6(Picture)

3.3 (3) Loose uncapped electrical wiring located at front exterior. Safety concern. Wiring should be removed or properly secured in junction boxes. An electrical contractor is recommended to evaluate and make all needed repairs.

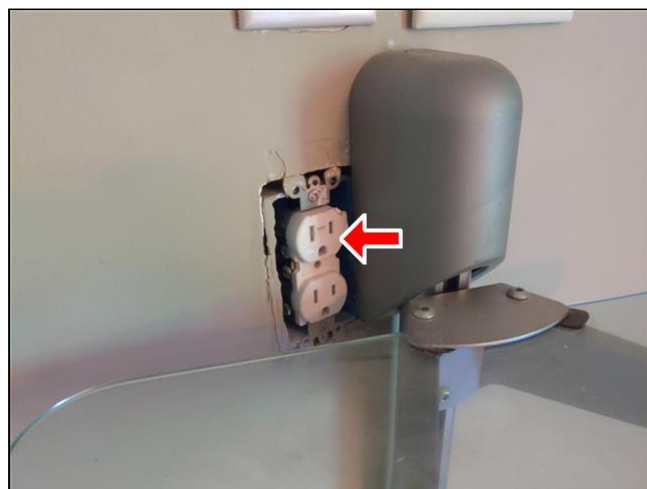
3.3 Item 7(Picture)

3.3 (4) Electrical cover plate(s) missing/damaged at bonus room and kitchen. This condition left energized electrical components exposed to touch, a shock hazard. The Inspector recommends a cover plate be installed by a qualified electrical contractor.

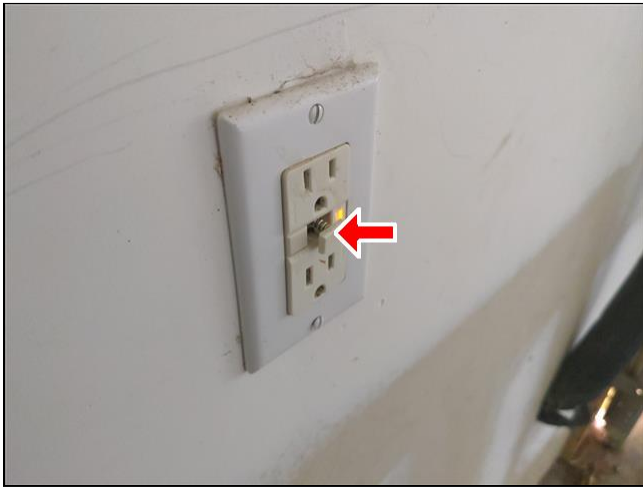
3.5 Item 1(Picture)

3.5 GFCI outlet(s) are nonfunctional and appear to stick in trip mode at garage. Safety concern. Not doing job as intended. An electrical contractor is recommended to evaluate and make all needed repairs.

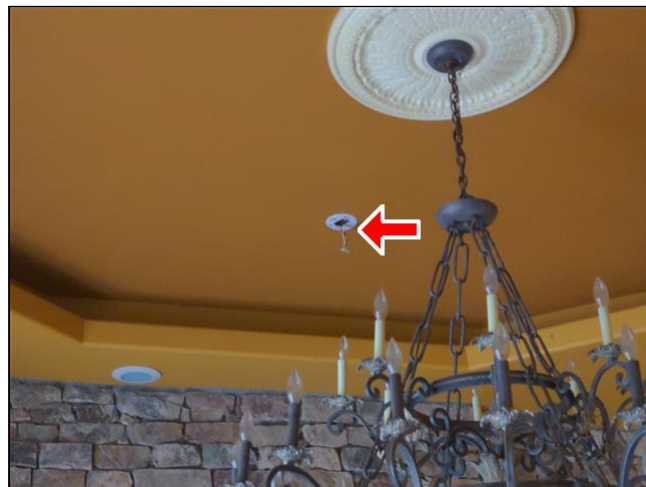
3.6 Item 1(Picture)

3.6 (1) Smoke detector(s) in the home are making beeping sound continuously. Possible battery concern/faulty smoke detector. In need of further evaluation by proper professional for all needed repairs.

3.6 (2) Smoke detector(s) disconnected at areas. Without a working smoke detector in your home you have no first alert to a possible fire. I recommend repair or replace as needed using a qualified person.

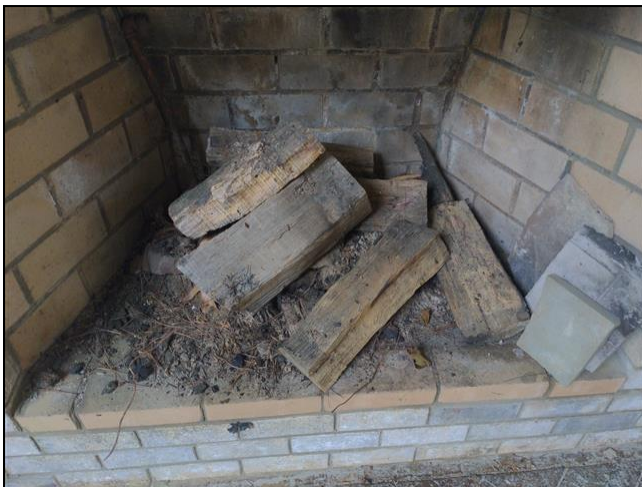
4.7 Item 1(Picture)

4.7 Fireplace(s) was dirty at the time of inspection. This limited access as areas were not visible. Recommend subsequent evaluation once cleaned.

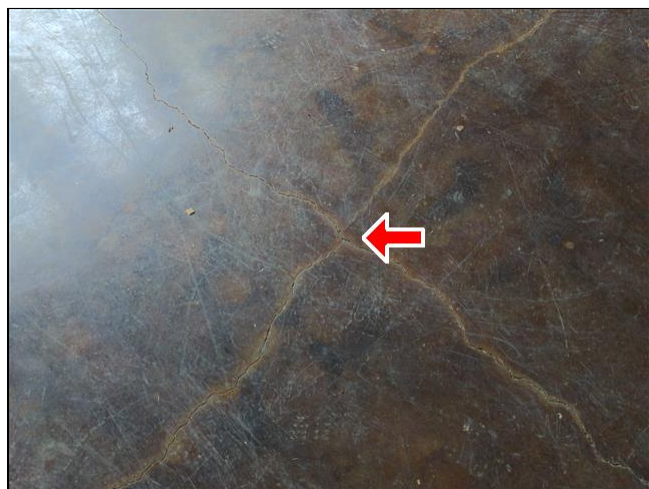
5.0 Item 1(Picture)

5.0 (1) Typical cracks noted at slab. Common causes are shrinkage during the curing process, soil conditions, and materials. Further cracking may occur. Recommend proper sealing and subsequent observation.

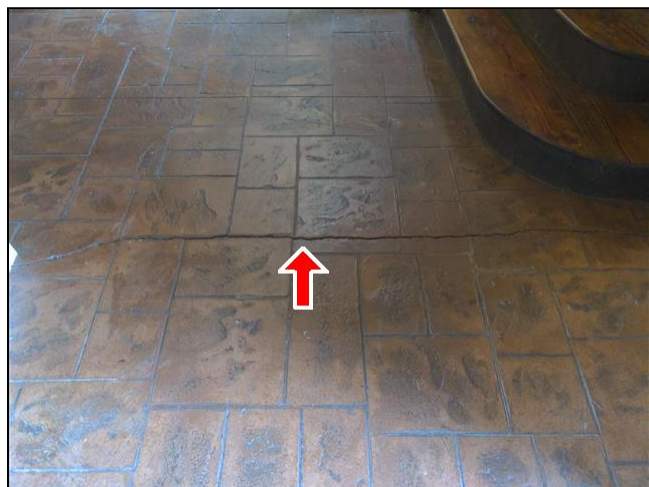
5.0 Item 3(Picture)

5.0 (2) Crack(s) present at slab at areas of the residence. It can not be determined as part of a home inspection if movement has stabilized or will continue. The area should be monitored and if significant movement is noted you should consult with a licensed general contractor.

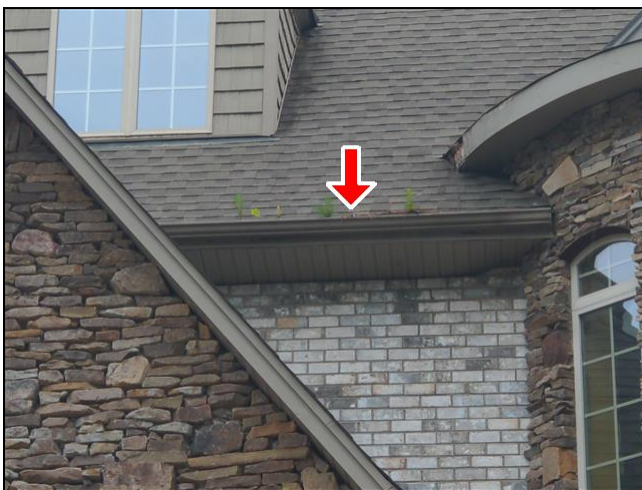
6.3 Item 1(Picture)

6.3 (1) Debris is present in areas of the gutters. The debris in gutters can also conceal rust, deterioration or leaks that are not visible until cleaned, and I am unable to determine if such conditions exist. Improper drainage at the gutters may occur. A qualified contractor is recommended to evaluate and make all needed repairs.

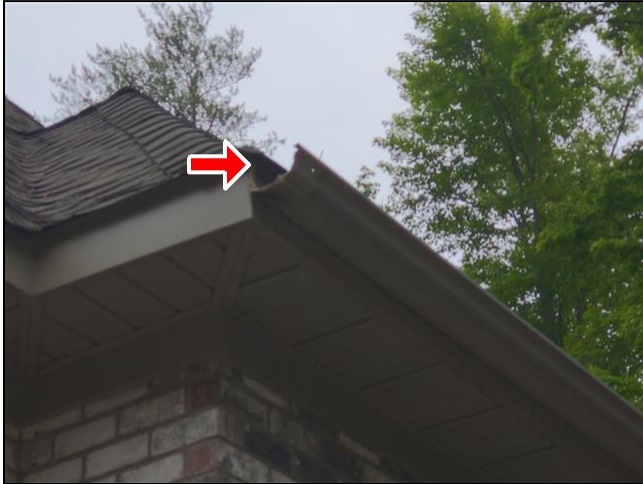
6.3 Item 3(Picture)

6.3 (2) Gutter(s) damaged and or bent at front and rear . Further deterioration and a lack of proper drainage may occur. A qualified contractor is recommend to evaluate and make all needed repairs.

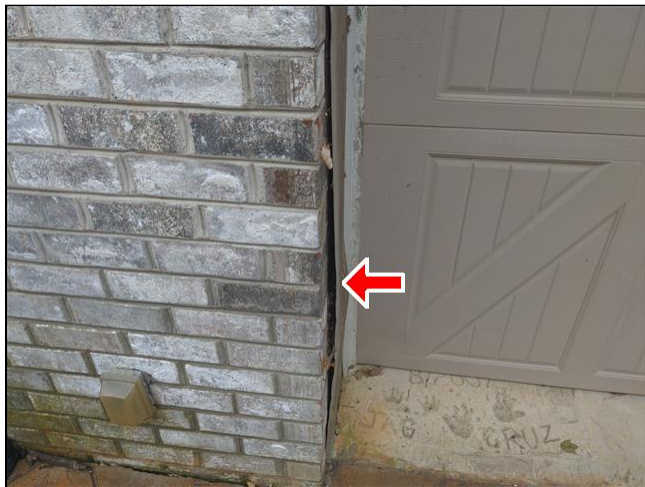
7.0 Item 1(Picture)

7.0 (1) Loose trim located at front . Further movement/ wind damage may occur. Not properly attached to the home. Recommend a qualified contractor to properly secure.

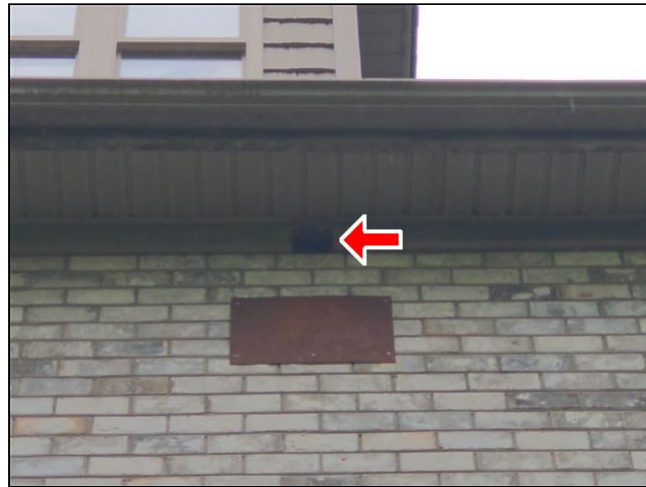
7.0 Item 3(Picture)

7.0 (2) A hole is present in the exterior veneer at the right side of the residence. Moisture and pest intrusion may occur. A qualified contractor is recommended to evaluate and make all needed repairs.

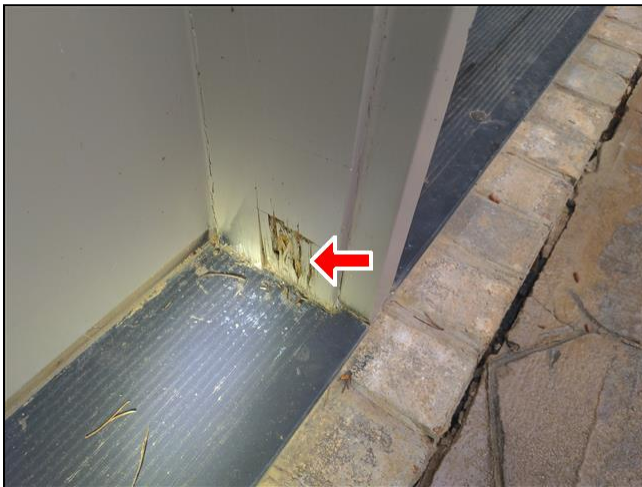
7.1 Item 1(Picture)

7.1 (1) Moisture damage at the exterior door casing(s) at front . Further damage may occur. A qualified contractor is recommended to evaluate and make all needed repairs.

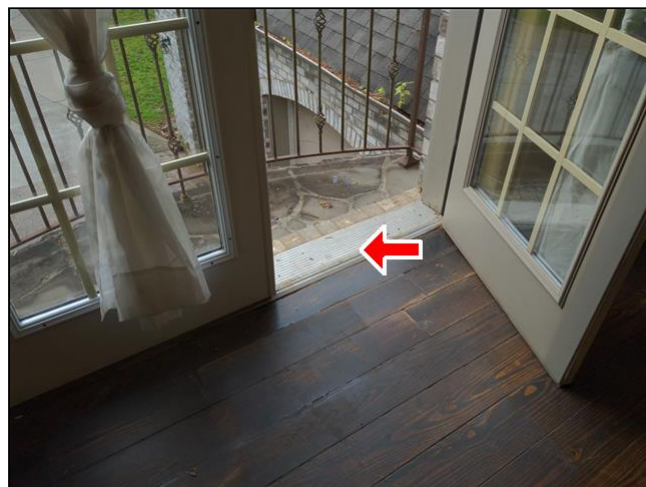
7.1 Item 3(Picture)

7.1 (2) Toe plate is damaged or loose at exterior door(s) at front . Further deterioration and or movement may occur. A qualified contractor is recommended to repair.

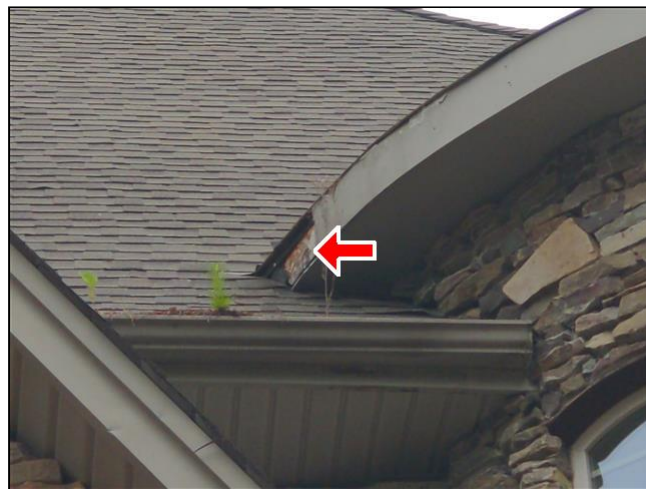
7.3 Item 2(Picture)

7.3 (2) Fascia cladding is missing at front . Further deterioration may occur. A qualified contractor is recommended to repair.

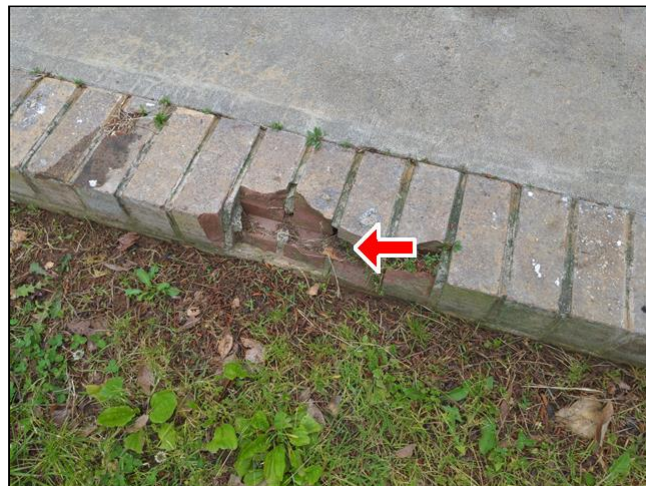
7.4 Item 1(Picture)

7.4 Damaged and or loose components located at rear patio. Further deterioration is likely to occur. A qualified contractor is recommended to evaluate and make all needed repairs.

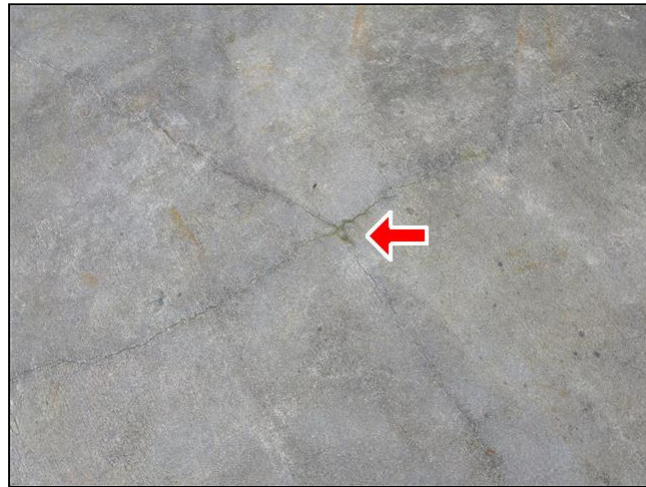
7.5 Item 1(Picture)

7.5 Typical crack(s) noted at patio.
Common causes are shrinkage during the curing process, soil conditions, and materials. Further cracking may occur. Recommend proper sealing and subsequent observations.

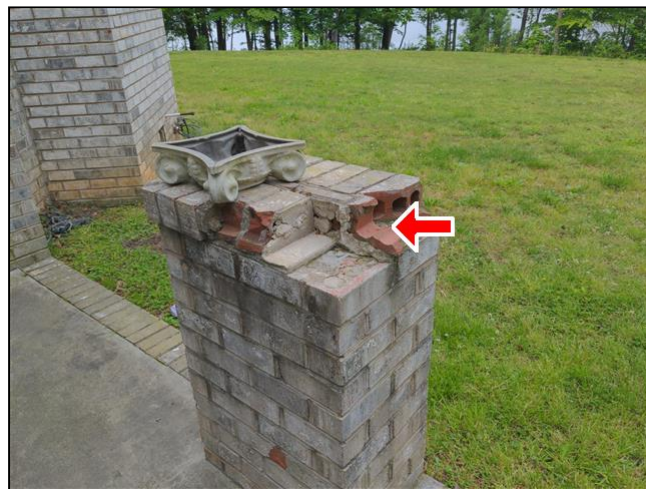
7.7 Item 1(Picture)

7.7 Column(s) are damaged at rear patio. Further deterioration may occur. Qualified contractor is recommended to evaluate and make all needed repairs.

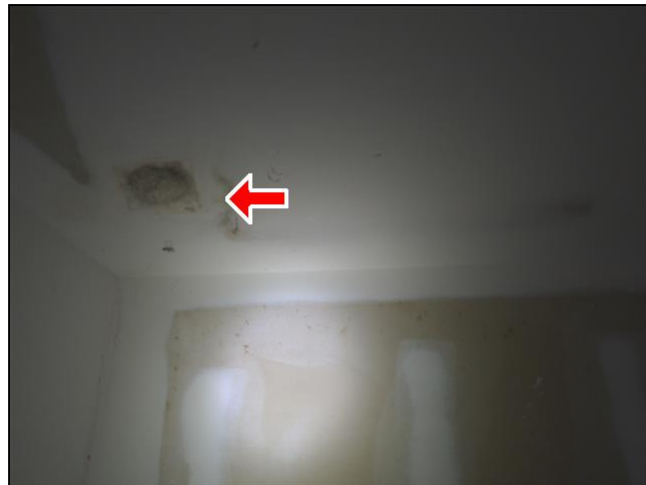
8.0 Item 1(Picture)

8.0 Fungi growth is located at garage ceiling. This may suggest prior or intermittent abnormal moisture concern. A qualified contractor is recommended to evaluate and make all needed repairs.

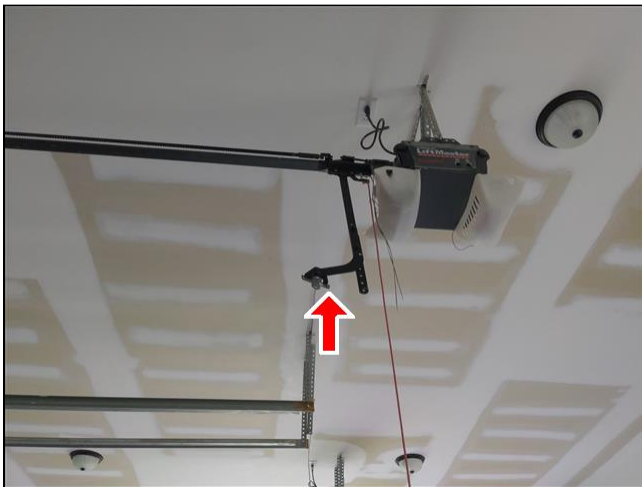
8.3 Item 1(Picture)

8.3 The following problems noted at garage door: disconnected. Further deterioration and or premature failure may occur. Not doing the job as intended. Garage door automatic safety reverse is only tested by electrical safety eyes if installed at the door to avoid possible damage to the garage door.

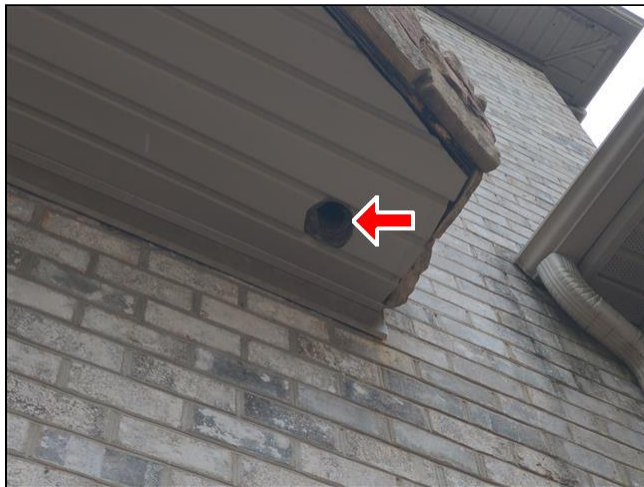
9.4 Item 1(Picture)

9.4 (1) Vent cover is loose/missing at front and left exterior. Movement and improper operation concern. Qualified contractor is recommended to evaluate and make all needed repairs.

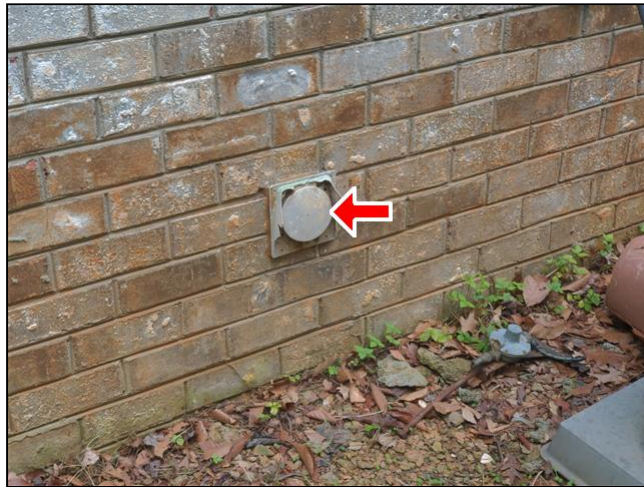
9.4 Item 3(Picture)

9.4 (2) There is a damaged exhaust vent cover at the right side. Not doing job as intended. Rodent/moisture entry may occur. A qualified contractor is recommended to evaluate and make all needed repairs.

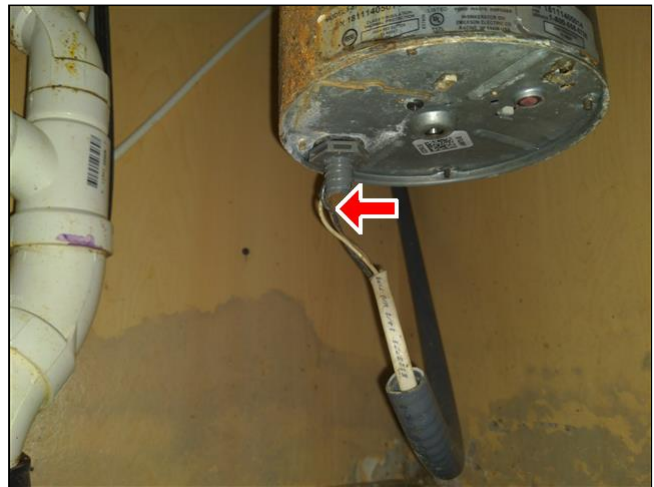
10.3 Item 1(Picture)

10.3 There is a missing electrical clamp located at the bottom of the kitchen sink disposal. Safety concern. Clamp missing where electrical wire enters the disposal. An electrical contractor is recommended to evaluate and make all needed repairs.

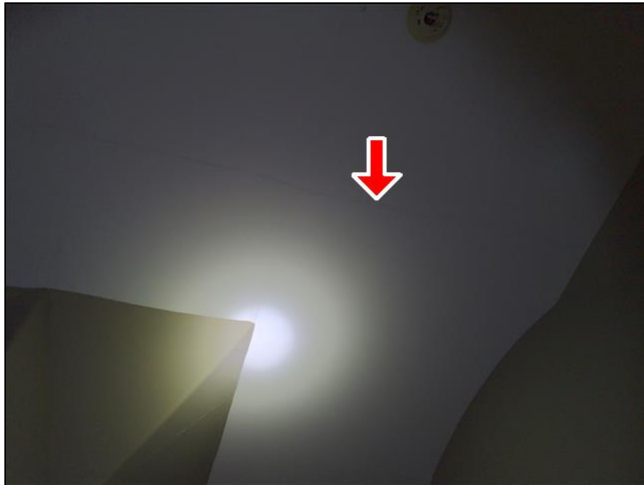
1.0 Item 1(Picture)

Cracks are present at the ceiling at 3rd floor. Cracks appear to be following tape seam at drywall. No adverse conditions noted at time of inspection. Recommend subsequent observation and all needed repairs to restore to original condition.

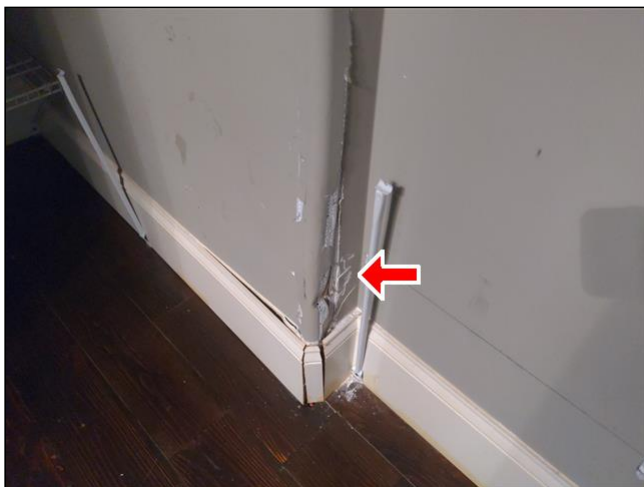
1.1 Item 1(Picture)

(1) Wall(s) damaged at bonus room closet, kitchen. Further deterioration may occur. A qualified contractor is recommended to evaluate and make all needed repairs.

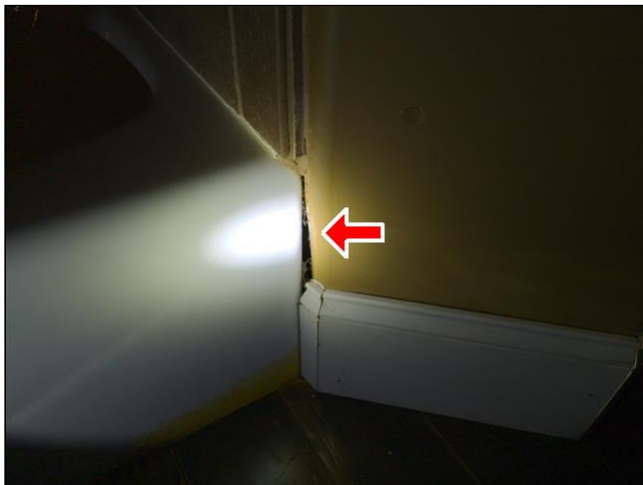
1.1 Item 5(Picture)

(3) Hole(s) present at the wall(s) at shared bathroom. Further deterioration may occur. A qualified contractor is recommended to evaluate and make all needed repairs.

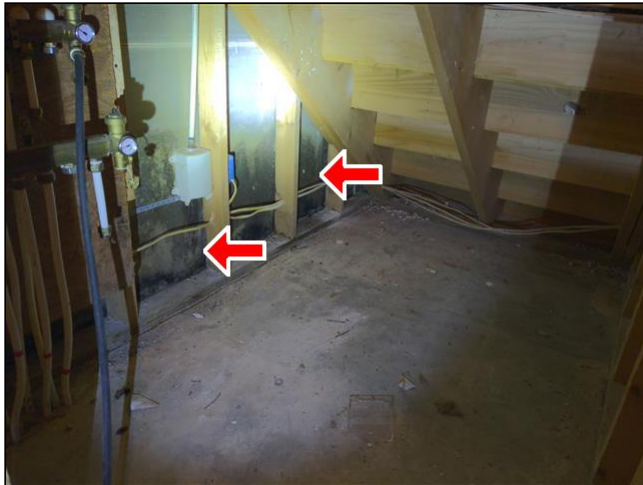
1.1 Item 6(Picture)

(4) Fungi growth is located at the wall at storage room. This may suggest prior or intermittent abnormal moisture concern. A qualified contractor is recommended to evaluate and make all needed repairs.

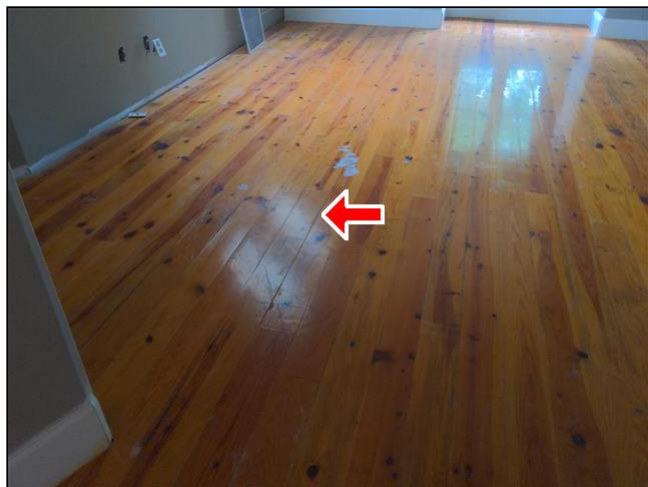
1.2 Item 2(Picture)

(2) There is sloping noted at the interior flooring at 3rd floor. This may suggest movement of the wall/floor structure components. Multiple sources could cause this affect. Further movement concern. A qualified contractor is recommended to evaluate for cause and make any needed repairs.

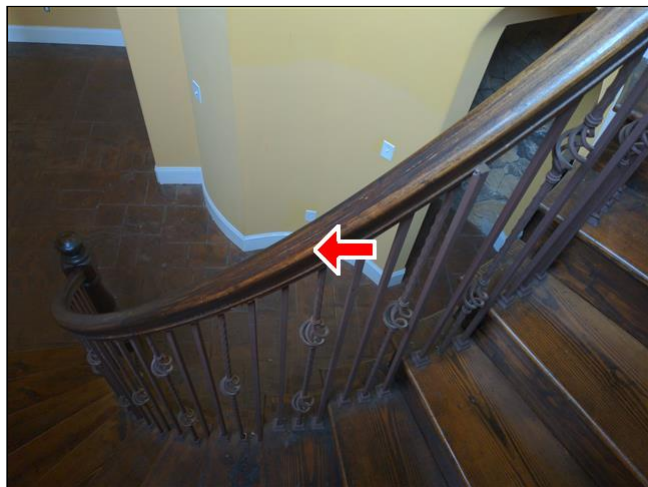
1.3 Item 1(Picture)

(1) Handrail(s) loose at interior stairway. Safety concern. Further movement may occur and is a potential fall hazard. A qualified contractor is recommended to repair.

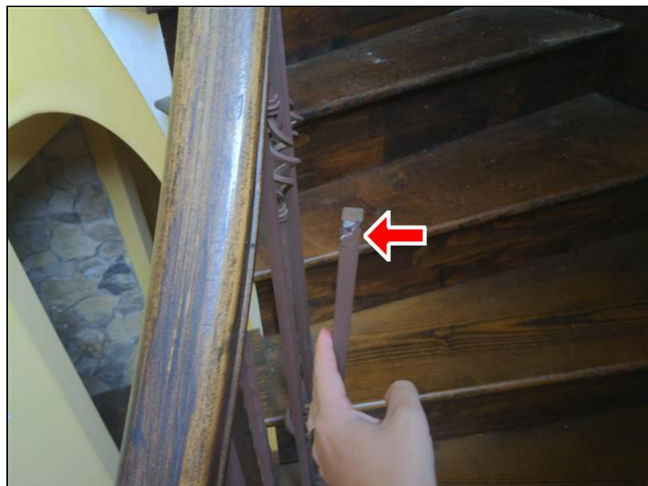
1.3 Item 2(Picture)

(2) There are loose spindles located at the interior staircase/railing at different areas. Safety concern. Failure may occur with added weight. A qualified contractor is recommended to evaluate and make all needed repairs.

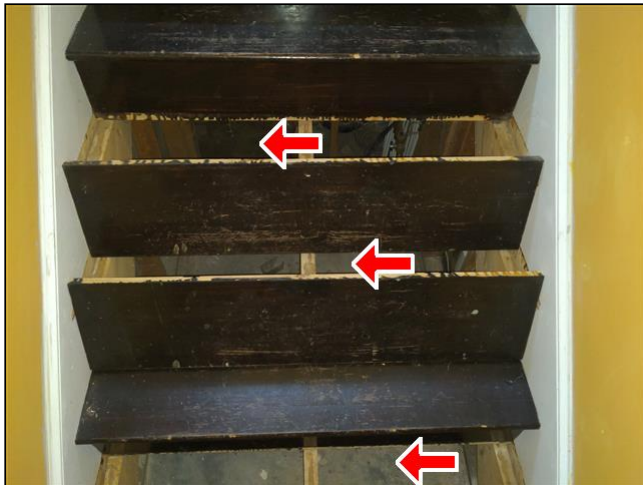
1.3 Item 3(Picture)

(3) Loose or damaged step(s) are present at the interior stairway. Further deterioration may occur. Potential fall hazard. A qualified contractor is recommended to evaluate and make all needed repairs.

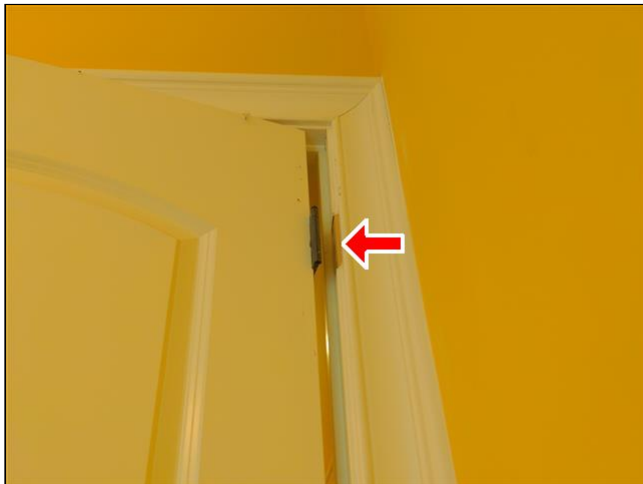
1.5 Item 1(Picture)

(1) Door(s) and or component(s) damaged at laundry room. Improper operation may occur. Recommend proper replacement to restore original condition.

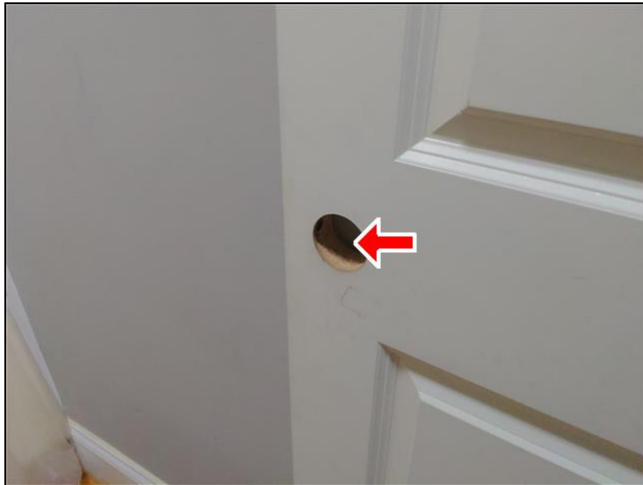
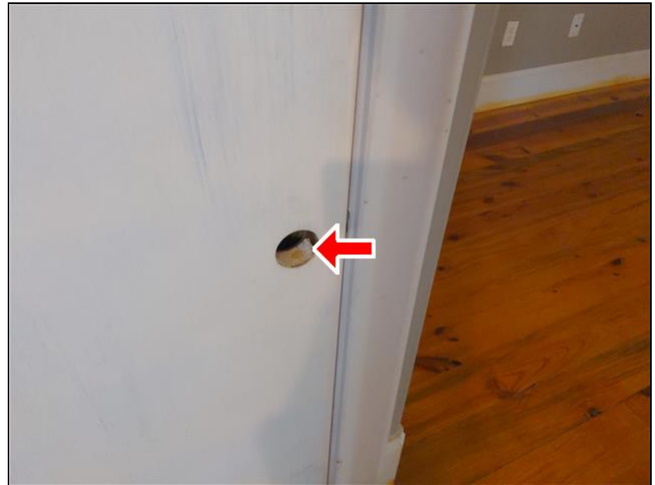
1.5 Item 2(Picture)

(2) Door(s) missing knob or handle at 3rd floor. Not doing job as intended. Door will not latch/close properly. A qualified contractor is recommended to evaluate and make all needed repairs.

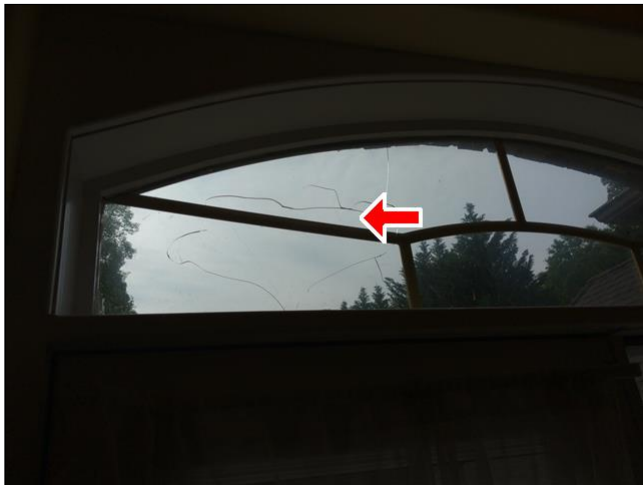
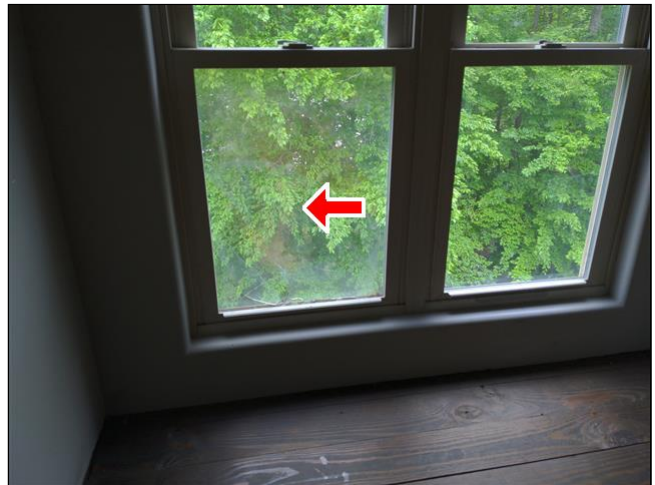
1.6 Item 1(Picture)

(1) Window pane(s) are cracked at upstairs left front bedroom, 3rd floor. Safety concern. Further deterioration concern. Qualified contractor is recommended to evaluate and make all needed repairs.

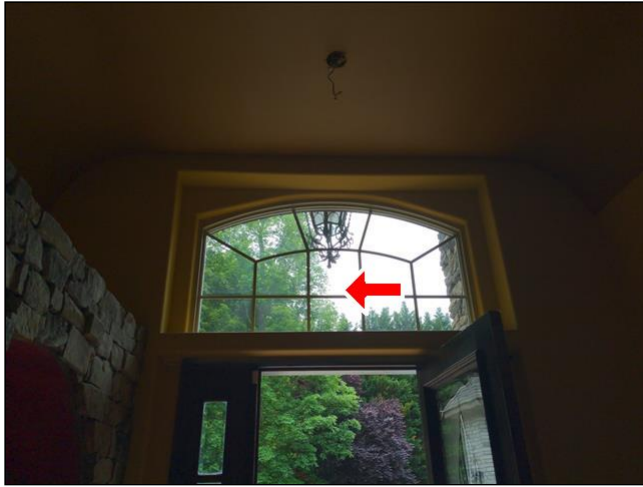
1.6 Item 4(Picture)

(3) Dual pane fogged window(s) at foyer. Condensation is forming between the window panes. Unable to properly view out window panes and further fogging may occur. It is sometimes difficult to determine if additional windows may also have damaged seals due to but not limited to weather conditions, window cleanliness and etc. A qualified contractor is recommended to evaluate and make all needed repairs.

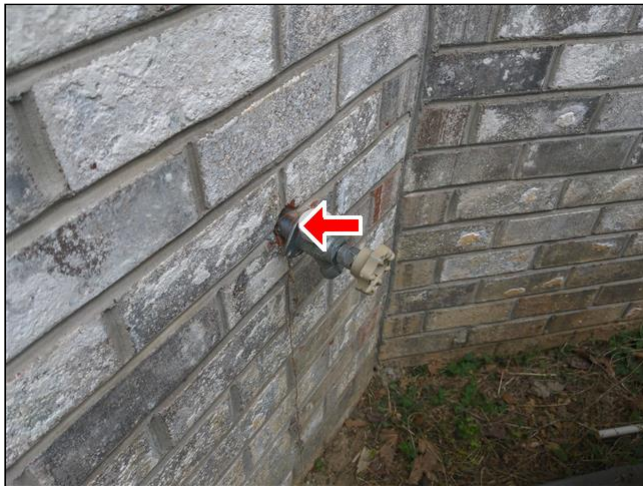
2.1 Item 1(Picture)

(1) Hose faucet(s) loose at left side. Movement of faucet and damage to plumbing lines may occur. Substandard install. Proper professional should evaluate and make all needed repairs.

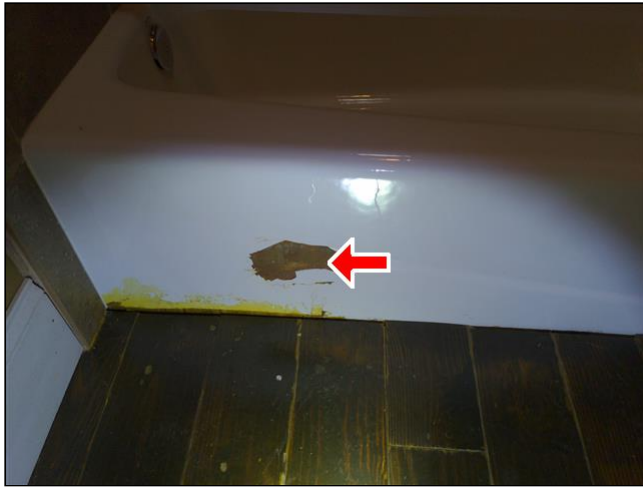
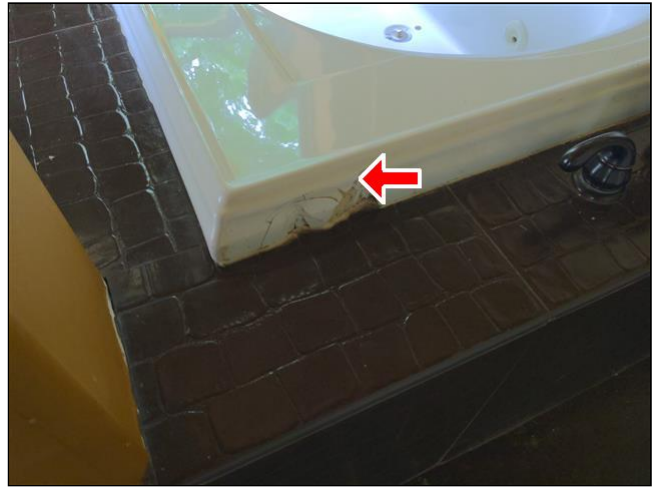
2.1 Item 2(Picture)

(2) Bathtub(s) damaged at shared bath, master bathroom. Further deterioration may occur and leaks could develop. A plumbing contractor is recommended to evaluate and make any needed repairs.

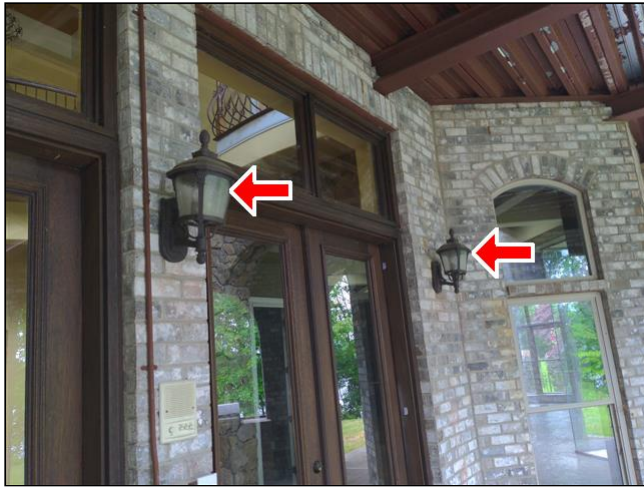
3.3 Item 1(Picture)

(1) Loose light fixture located at rear. Safety concern and further movement may occur. Electrical issues are considered a hazard until repaired. An electrical contractor is recommended to evaluate and make all needed repairs.

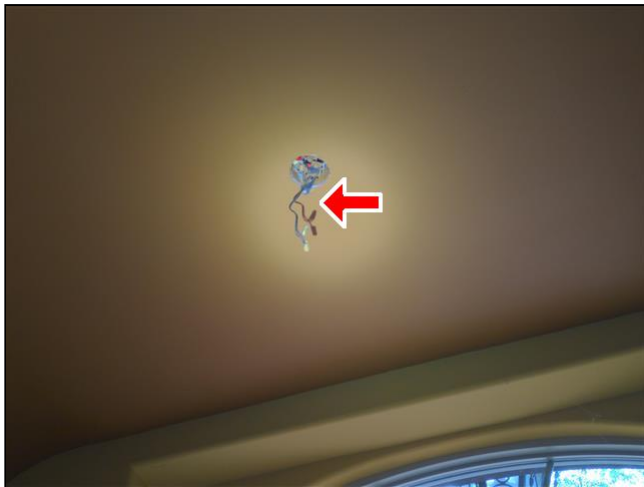
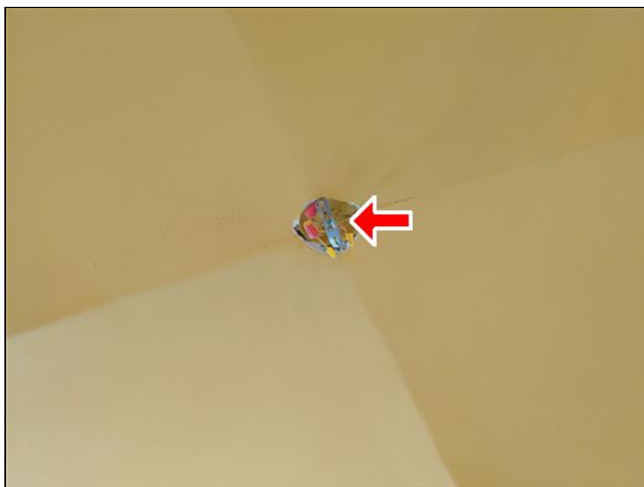
3.3 Item 2(Picture)

(2) Loose electrical wiring is present at foyer, 3rd floor, guest bedroom, garage closet. The wiring should be properly secured. Safety concern. Electrical issues are considered to be a hazard until repaired. An electrical contractor is recommended to evaluate and make all needed repairs.

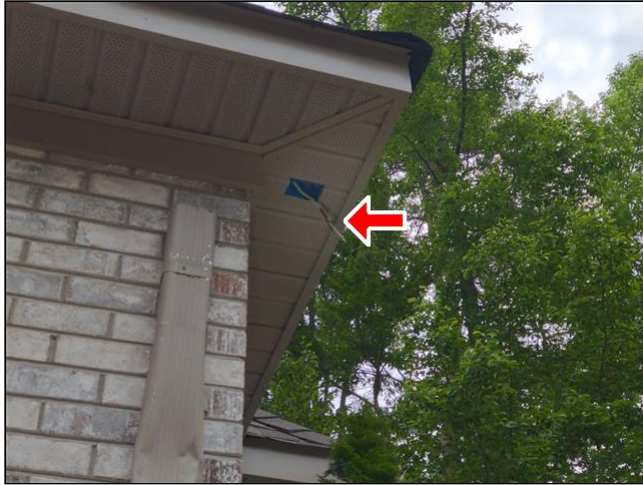
3.3 Item 6(Picture)

(3) Loose uncapped electrical wiring located at front exterior. Safety concern. Wiring should be removed or properly secured in junction boxes. An electrical contractor is recommended to evaluate and make all needed repairs.

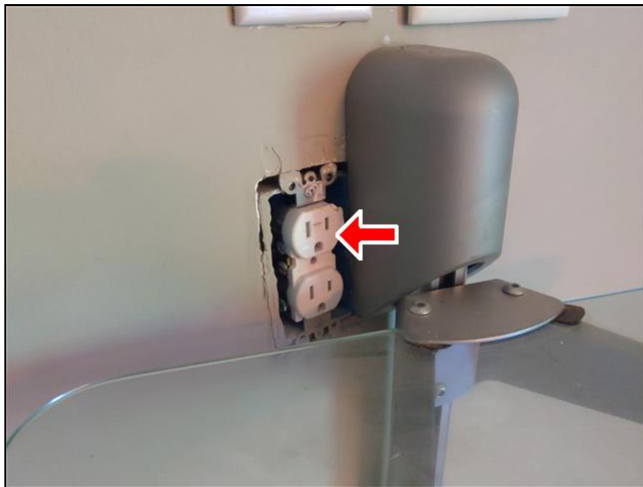
3.3 Item 7(Picture)

(4) Electrical cover plate(s) missing/ damaged at bonus room and kitchen. This condition left energized electrical components exposed to touch, a shock hazard. The Inspector recommends a cover plate be installed by a qualified electrical contractor.

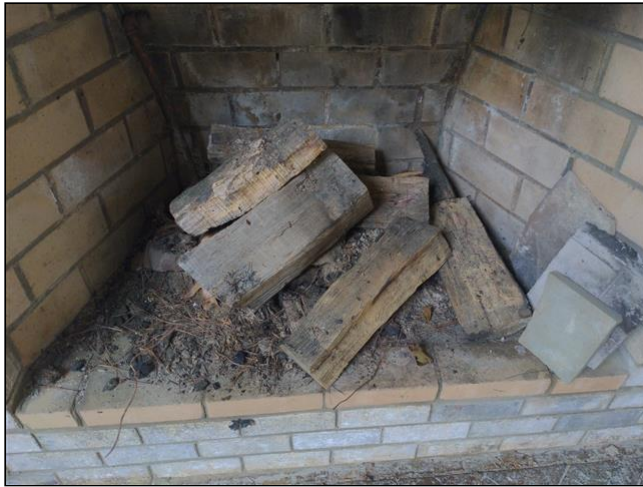
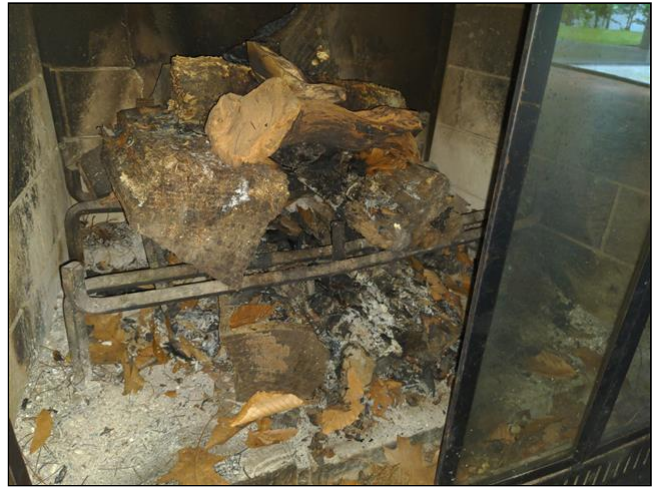
4.7 Item 1(Picture)

Fireplace(s) was dirty at the time of inspection. This limited access as areas were not visible. Recommend subsequent evaluation once cleaned.

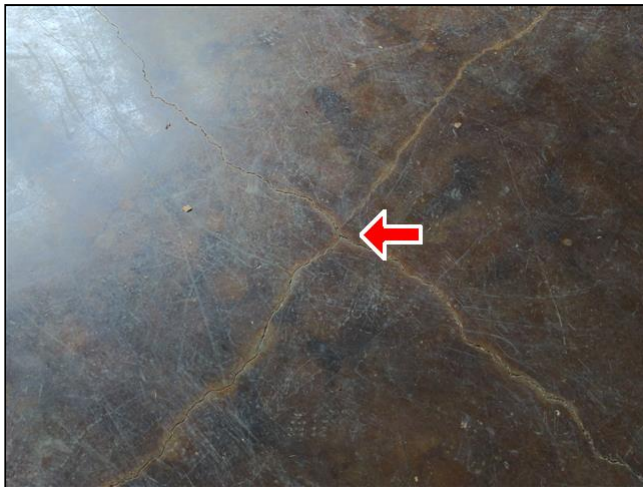
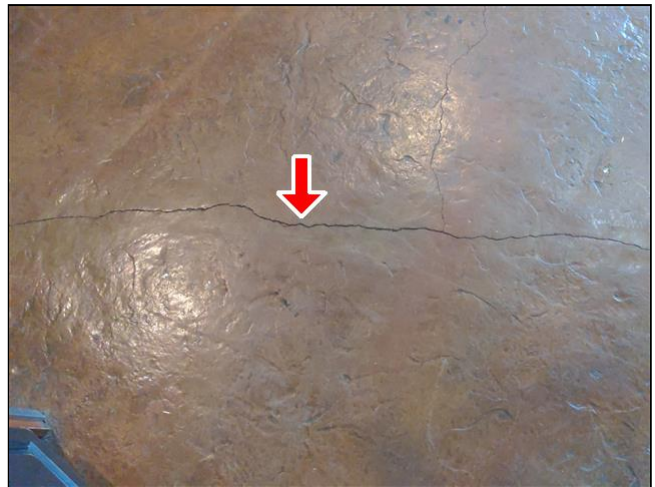
5.0 Item 1(Picture)

(1) Typical cracks noted at slab. Common causes are shrinkage during the curing process, soil conditions, and materials. Further cracking may occur. Recommend proper sealing and subsequent observation.
