Inspection Report

Property Address:
5407 Eastern Shores Dr
Greensboro NC 27455

Brewer Home Inspections

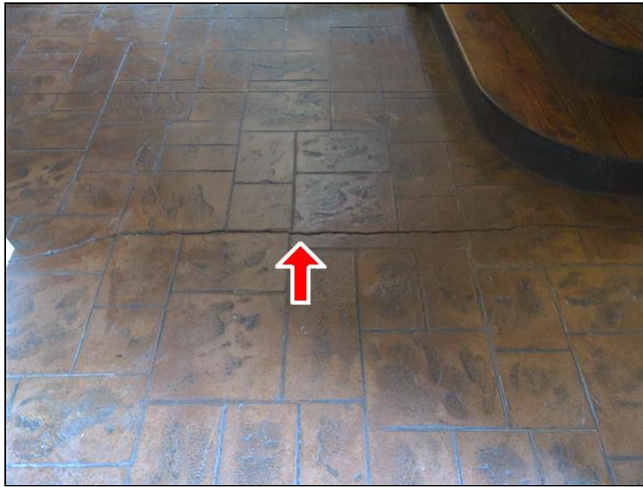
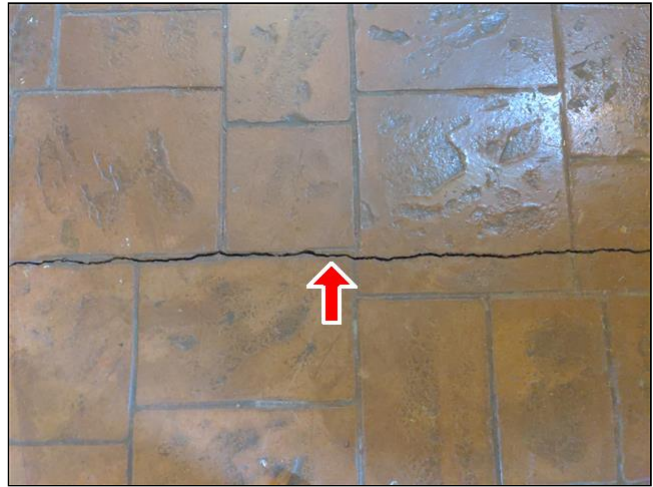
5.0 Item 3(Picture)

(2) Crack(s) present at slab at areas of the residence. It can not be determined as part of a home inspection if movement has stabilized or will continue. The area should be monitored and if significant movement is noted you should consult with a licensed general contractor.

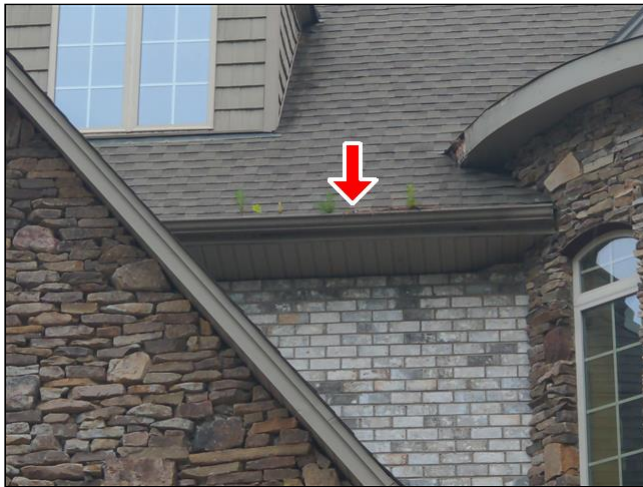
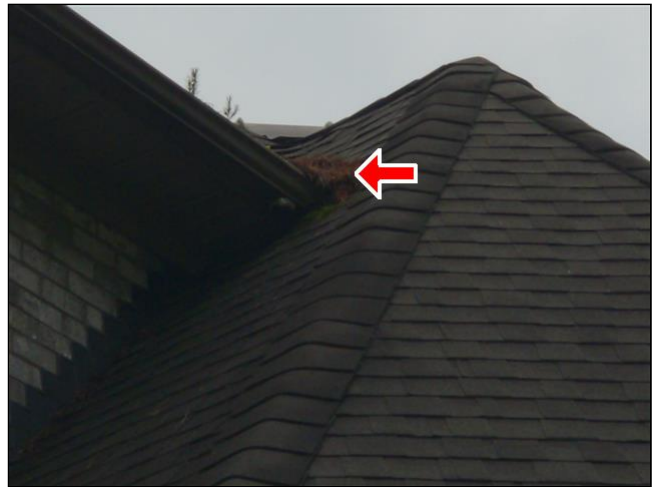
6.3 Item 1(Picture)

(1) Debris is present in areas of the gutters. The debris in gutters can also conceal rust, deterioration or leaks that are not visible until cleaned, and I am unable to determine if such conditions exist. Improper drainage at the gutters may occur. A qualified contractor is recommended to evaluate and make all needed repairs.

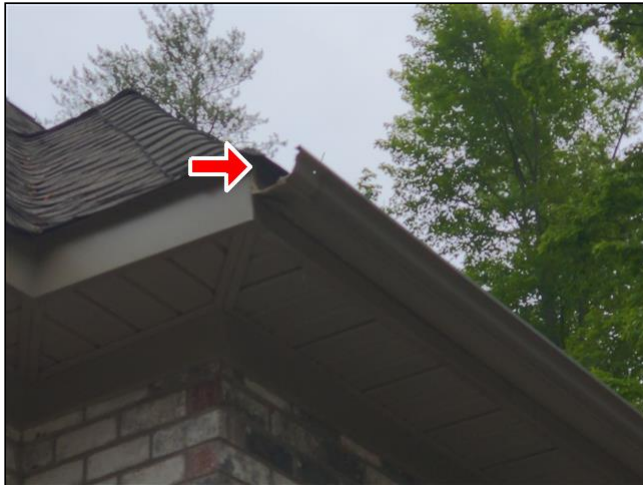
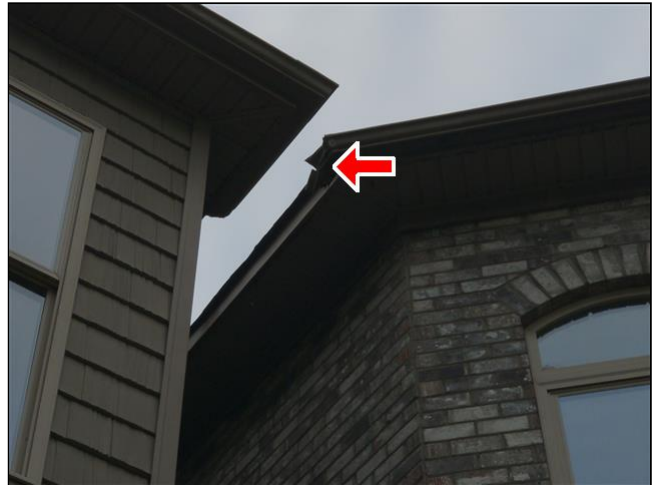
6.3 Item 3(Picture)

(2) Gutter(s) damaged and or bent at front and rear . Further deterioration and a lack of proper drainage may occur. A qualified contractor is recommended to evaluate and make all needed repairs.

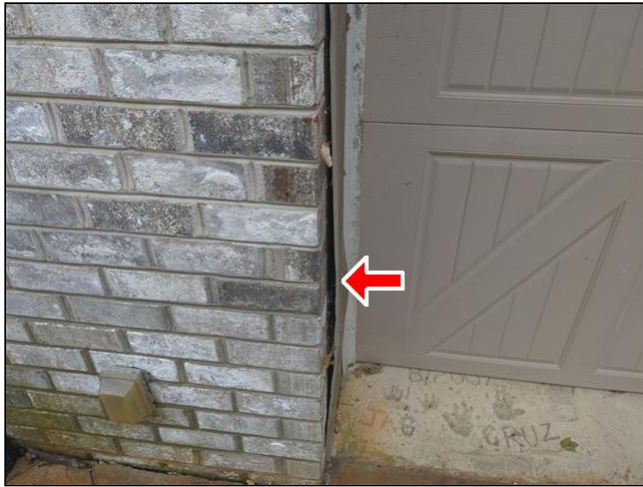
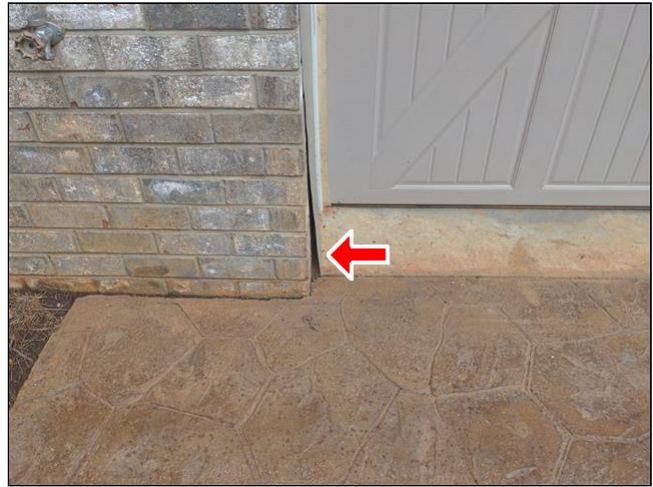
7.0 Item 1(Picture)

(1) Loose trim located at front . Further movement/ wind damage may occur. Not properly attached to the home. Recommend a qualified contractor to properly secure.

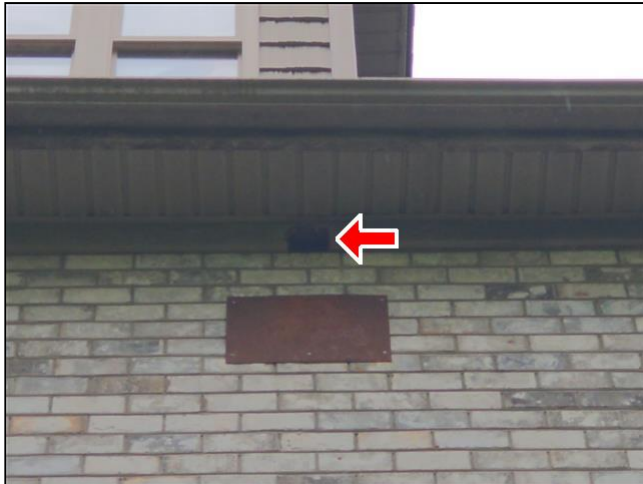
7.0 Item 3(Picture)

(2) A hole is present in the exterior veneer at the right side of the residence. Moisture and pest intrusion may occur. A qualified contractor is recommended to evaluate and make all needed repairs.

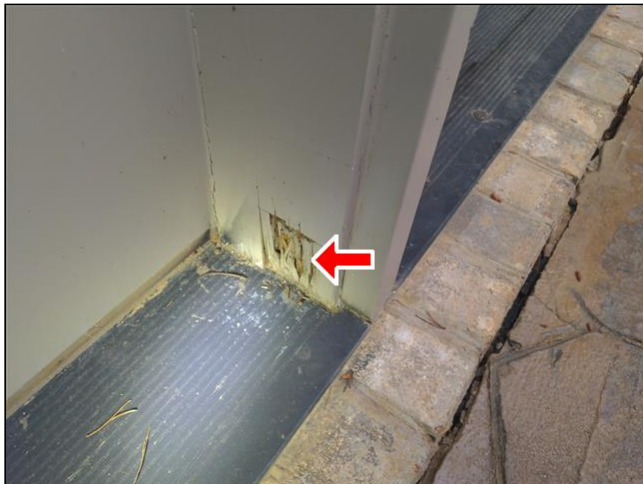
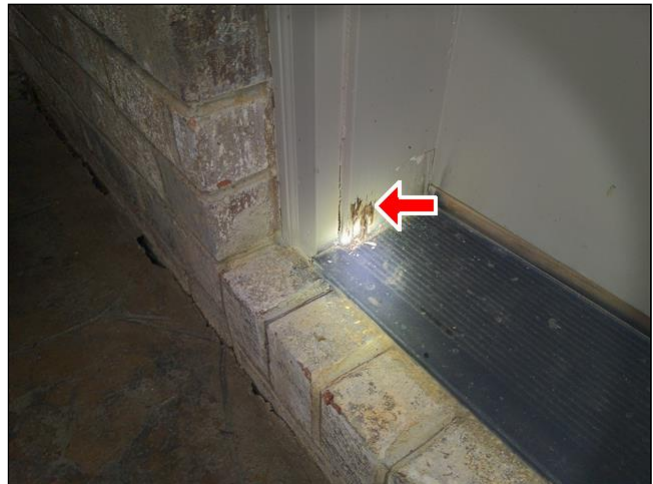
7.1 Item 1(Picture)

(1) Moisture damage at the exterior door casing(s) at front . Further damage may occur. A qualified contractor is recommended to evaluate and make all needed repairs.

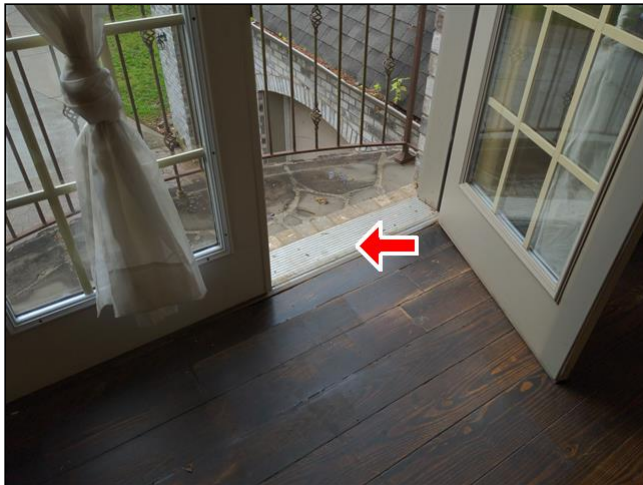
7.1 Item 3(Picture)

(2) Toe plate is damaged or loose at exterior door(s) at front . Further deterioration and or movement may occur. A qualified contractor is recommended to repair.

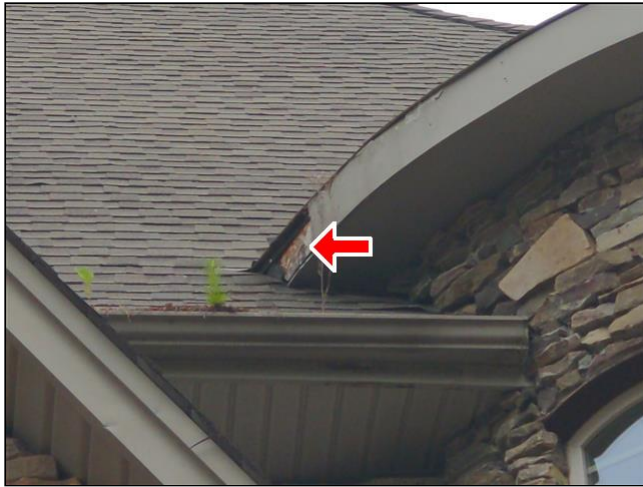
7.3 Item 2(Picture)

(2) Fascia cladding is missing at front . Further deterioration may occur. A qualified contractor is recommended to repair.

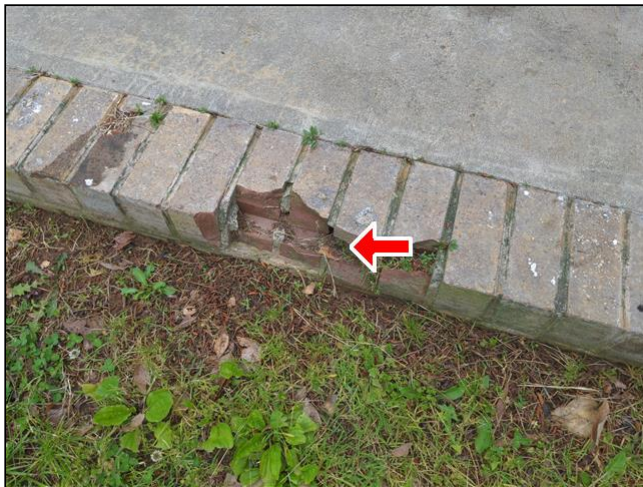
7.4 Item 1(Picture)

Damaged and or loose components located at rear patio. Further deterioration is likely to occur. A qualified contractor is recommended to evaluate and make all needed repairs.

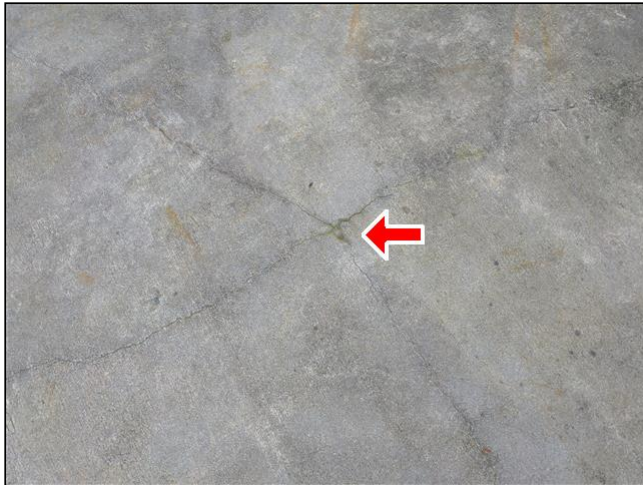
7.5 Item 1(Picture)

Typical crack(s) noted at patio. Common causes are shrinkage during the curing process, soil conditions, and materials. Further cracking may occur. Recommend proper sealing and subsequent observations.

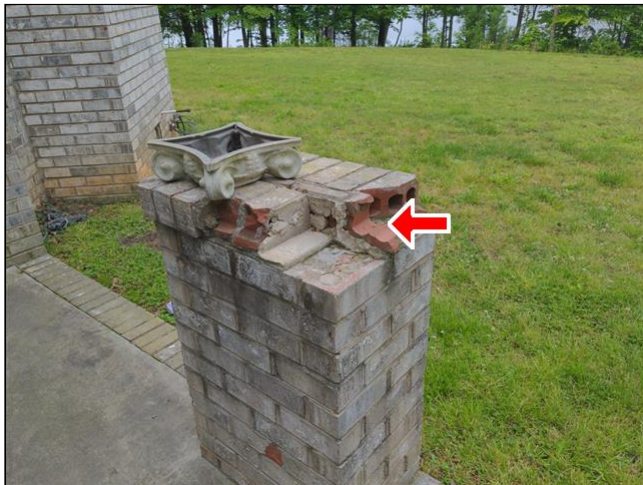
7.7 Item 1(Picture)

Column(s) are damaged at rear patio. Further deterioration may occur. Qualified contractor is recommended to evaluate and make all needed repairs.

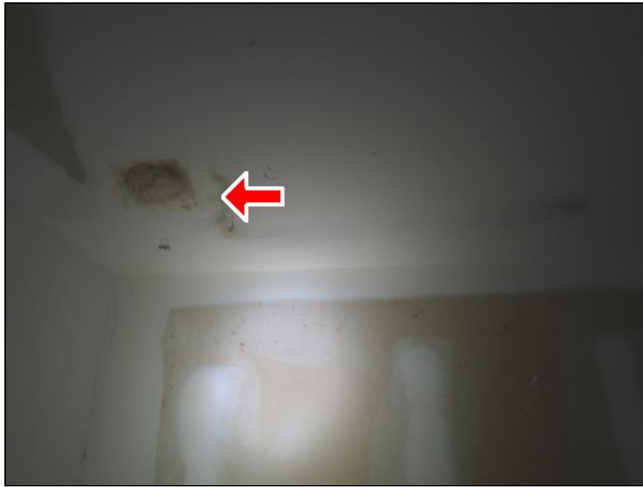
8.0 Item 1(Picture)

Fungi growth is located at garage ceiling. This may suggest prior or intermittent abnormal moisture concern. A qualified contractor is recommended to evaluate and make all needed repairs.

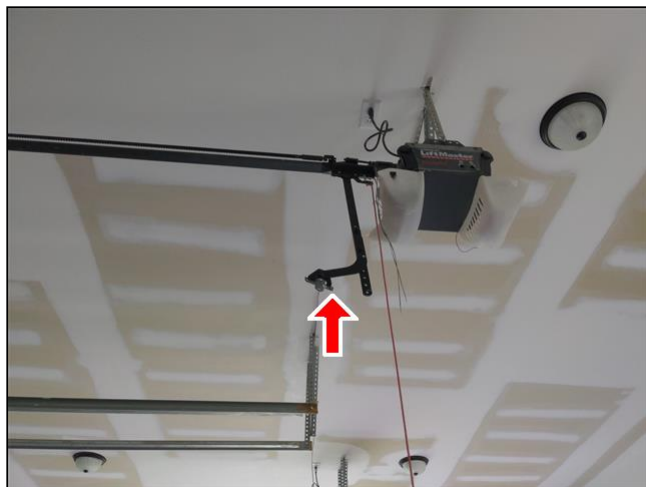
8.3 Item 1(Picture)

The following problems noted at garage door: disconnected. Further deterioration and or premature failure may occur. Not doing the job as intended. Garage door automatic safety reverse is only tested by electrical safety eyes if installed at the door to avoid possible damage to the garage door.

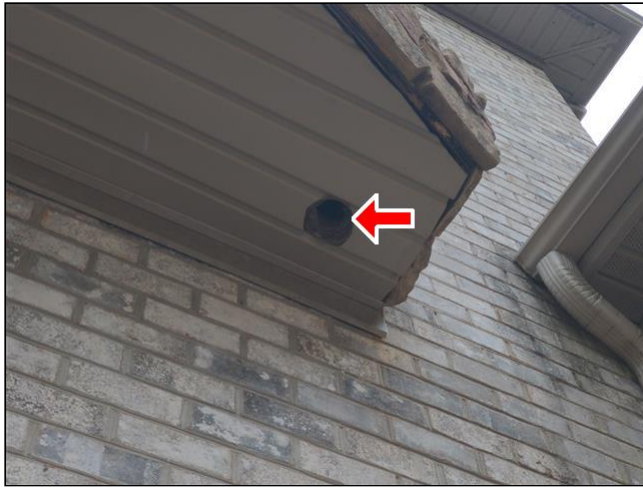
9.4 Item 1(Picture)

(1) Vent cover is loose/missing at front and left exterior. Movement and improper operation concern. Qualified contractor is recommended to evaluate and make all needed repairs.

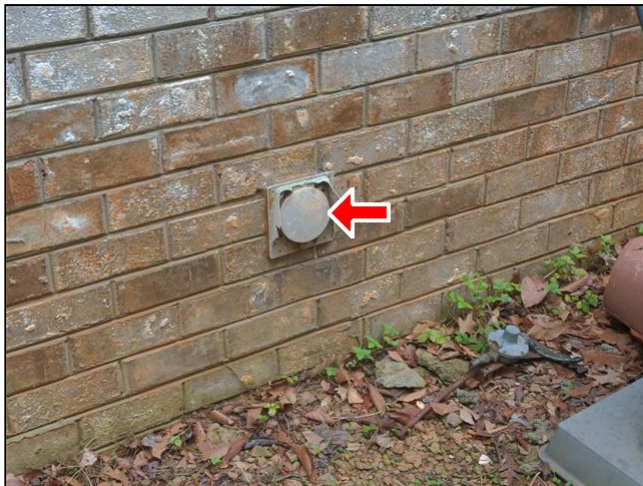
9.4 Item 3(Picture)

(2) There is a damaged exhaust vent cover at the right side. Not doing job as intended. Rodent/moisture entry may occur. A qualified contractor is recommended to evaluate and make all needed repairs.

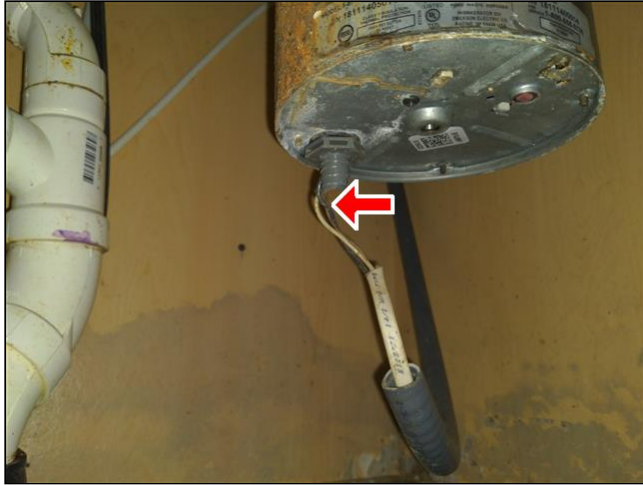
10.3 Item 1(Picture)

There is a missing electrical clamp located at the bottom of the kitchen sink disposal. Safety concern. Clamp missing where electrical wire enters the disposal. An electrical contractor is recommended to evaluate and make all needed repairs.
