Property Inspection Report

Report Number: 24175

5407 Eastern Shores Dr
Greensboro, North Carolina 27455

Date of Inspection: Monday, July 29, 2024

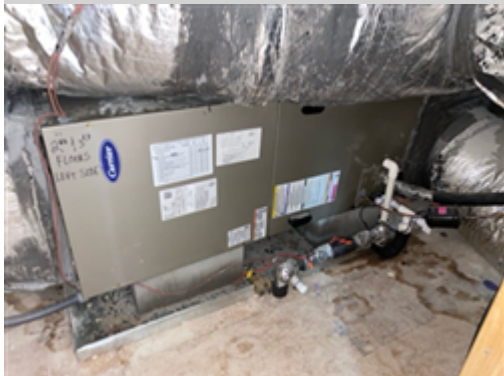
(F1 - 3.1) Heating and Cooling Unit #3

Photo - Heating and Cooling (interior) Unit #3

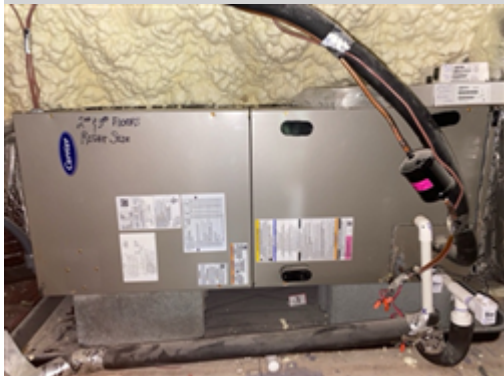
(F1 - 4.1) Heating and Cooling Unit #4

Photo - Heating and Cooling (interior) Unit #4

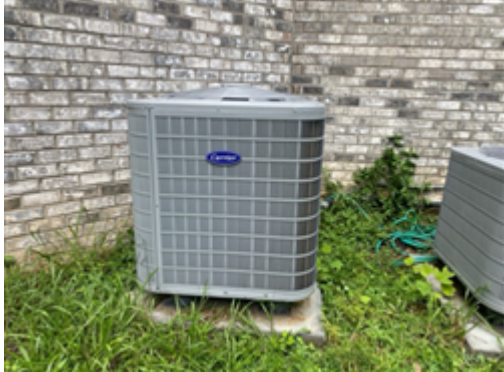
(G1 - 1.1) Heating and Cooling Unit #1

Photo - Heating and Cooling (exterior) Unit #1

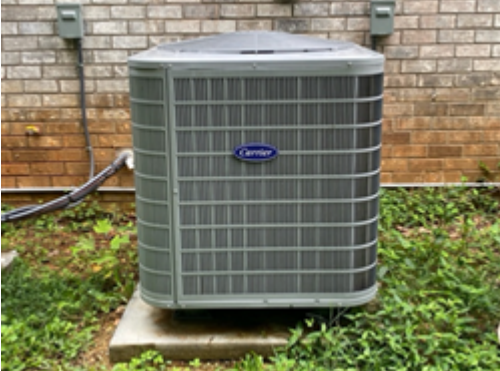
(G1 - 2.1) Heating and Cooling Unit #2

Photo - Heating and Cooling (exterior) Unit #2

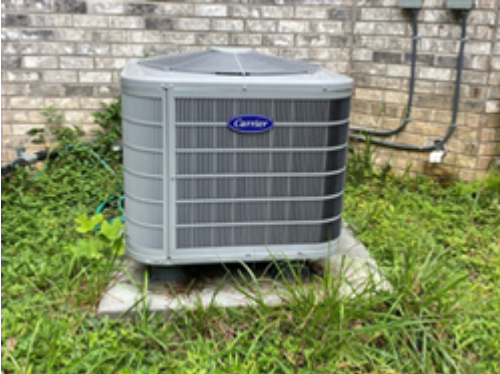
(G1 - 3.1) Heating and Cooling Unit #3

Photo - Heating and Cooling (exterior) Unit #3

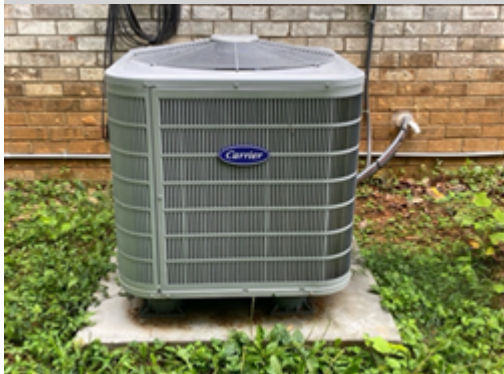
(G1 - 4.1) Heating and Cooling Unit #4

Photo - Heating and Cooling (exterior) Unit #4

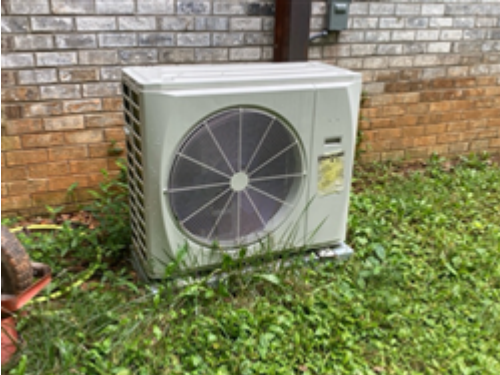
(G1 - 5.1) Heating and Cooling Unit #5

Photo - Heating and Cooling (exterior) Unit #5

Limitation: unable to operate, no remote
