Correction needed

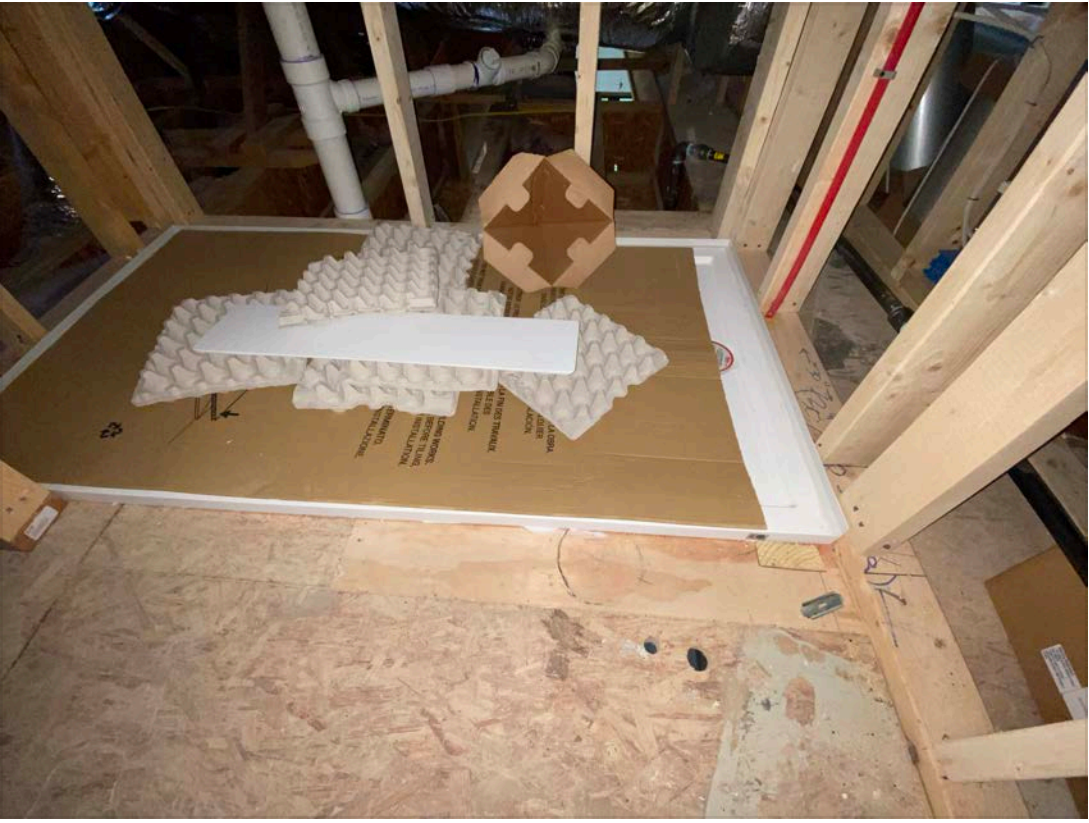
Third floor shower pan installed over circular cut portion of mismatched subfloor without consideration of adjacent marble flooring and what is necessary to exist underneath to support that:

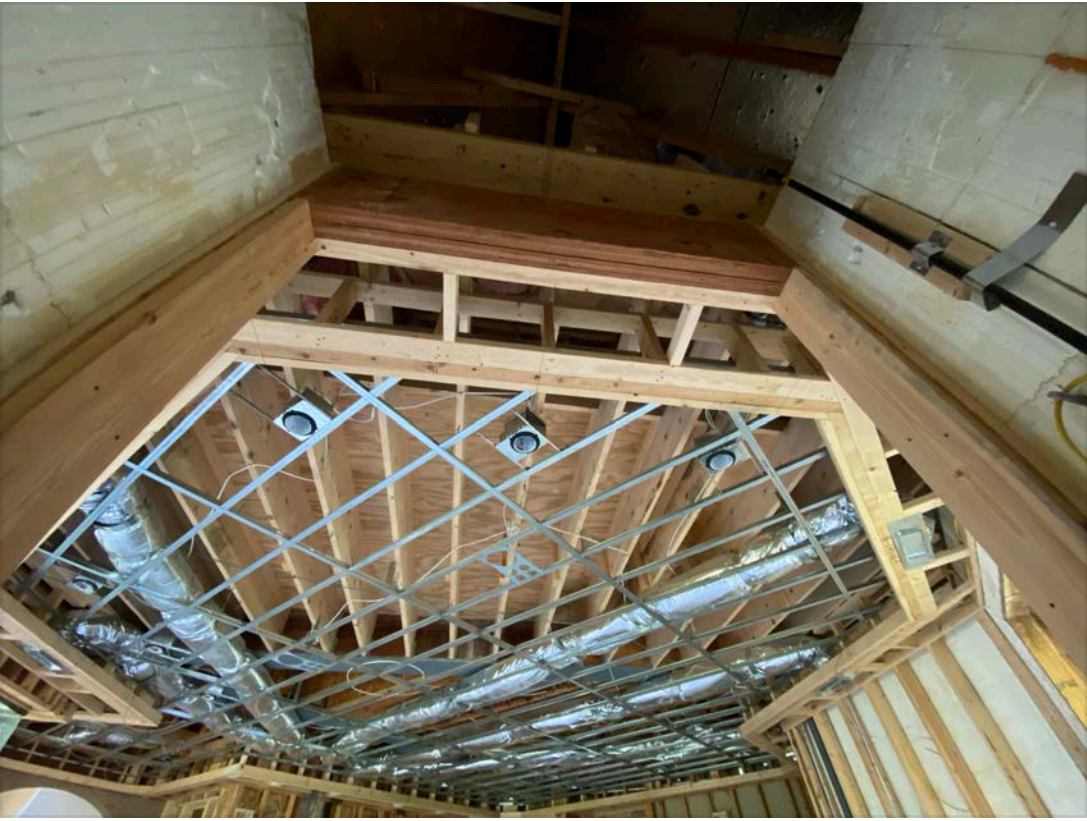
The engineered beam in the fireplace area is not sized appropriately to the space and the area is not framed in a way that sufficiently supports the load above (according to the neighborhood architect I brought in who looked at it):

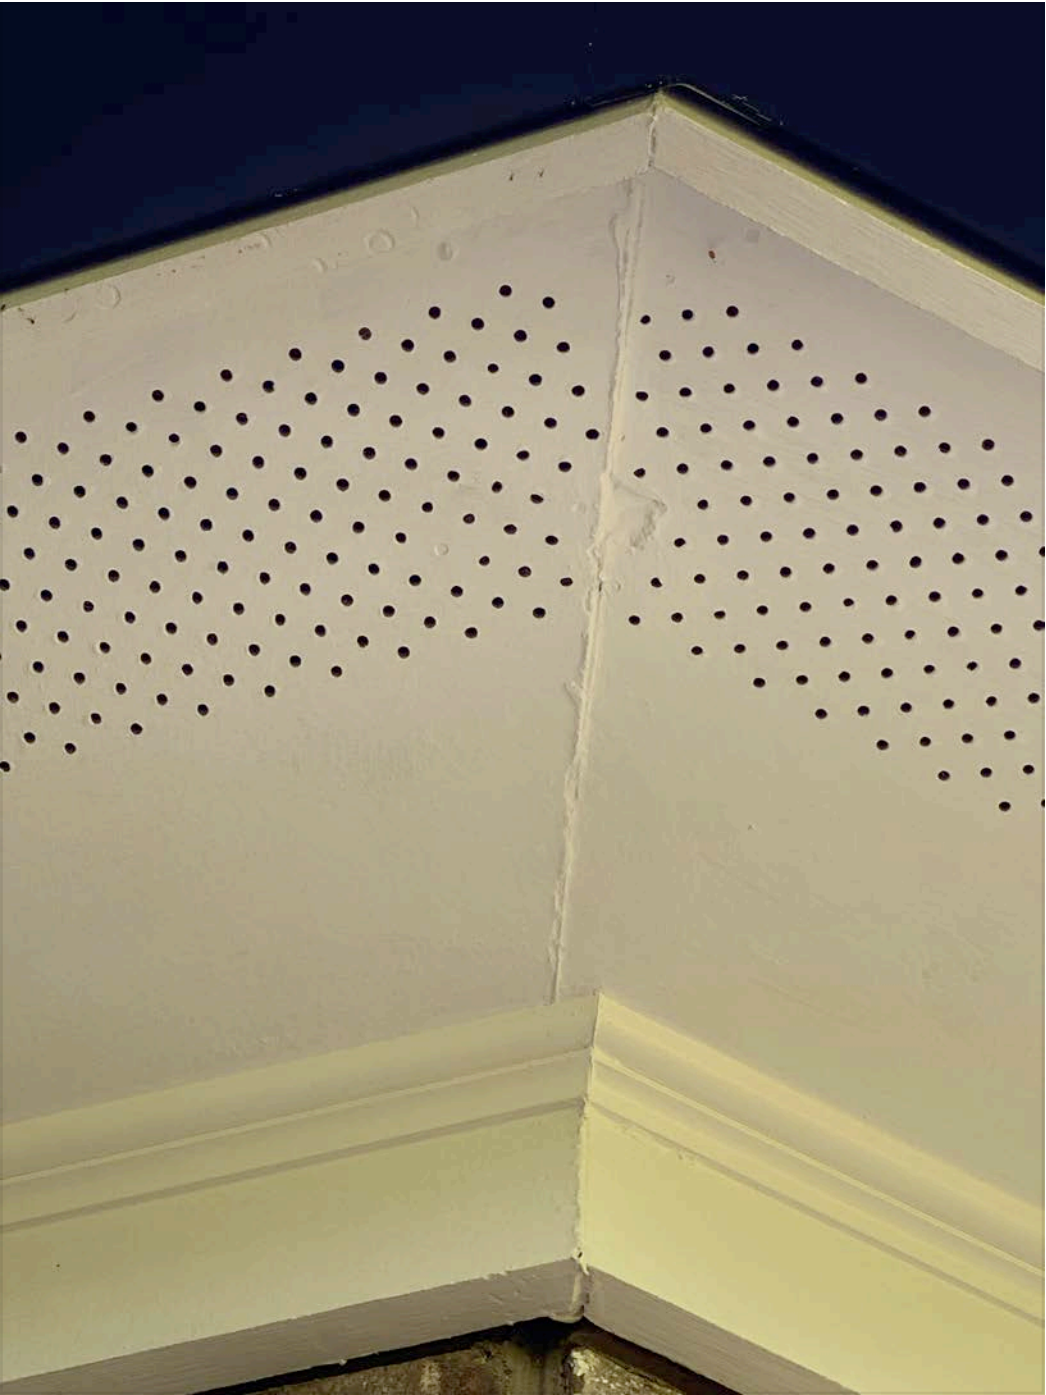
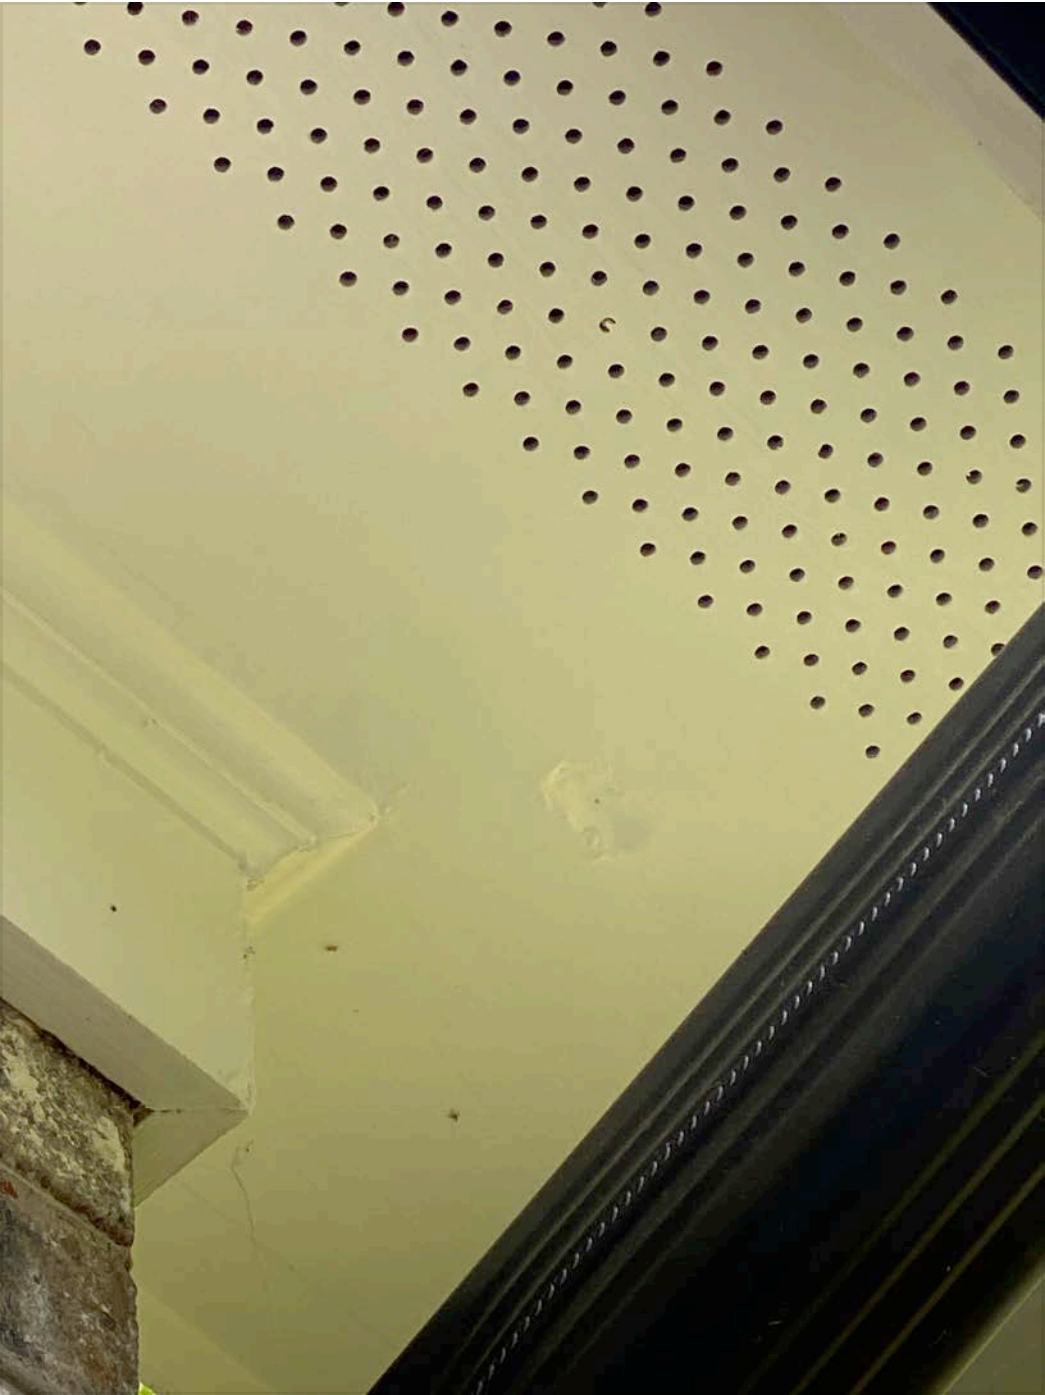
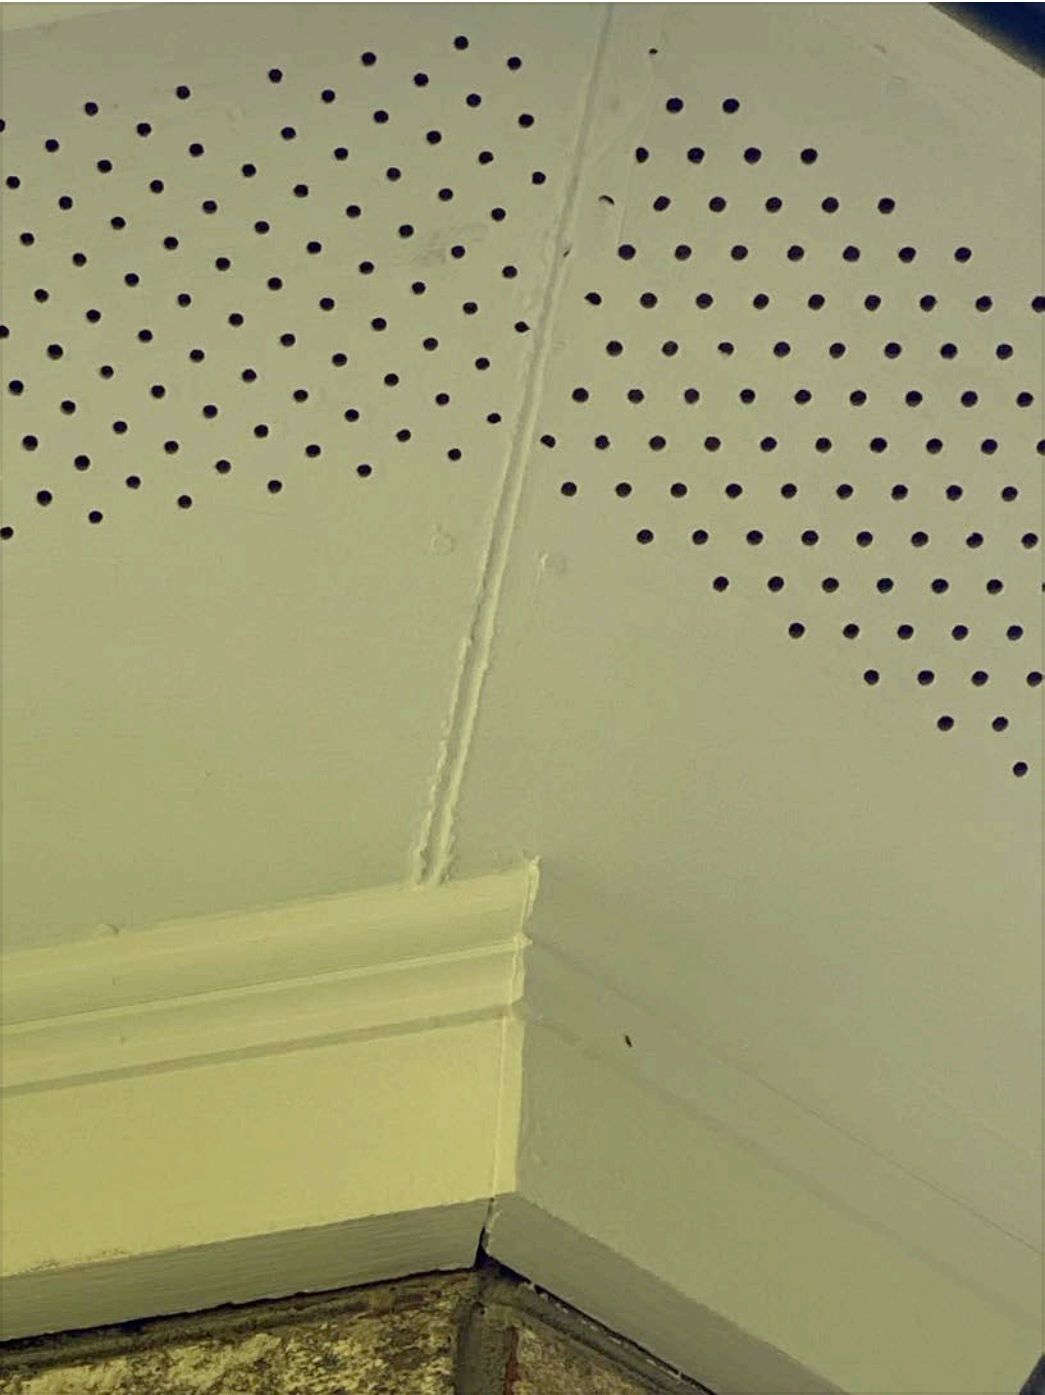
By garage door:

Outside soffit and fascia fasteners seem to be inconsistent type and some are already popping, plus there are multiple gouged areas filled with caulk:

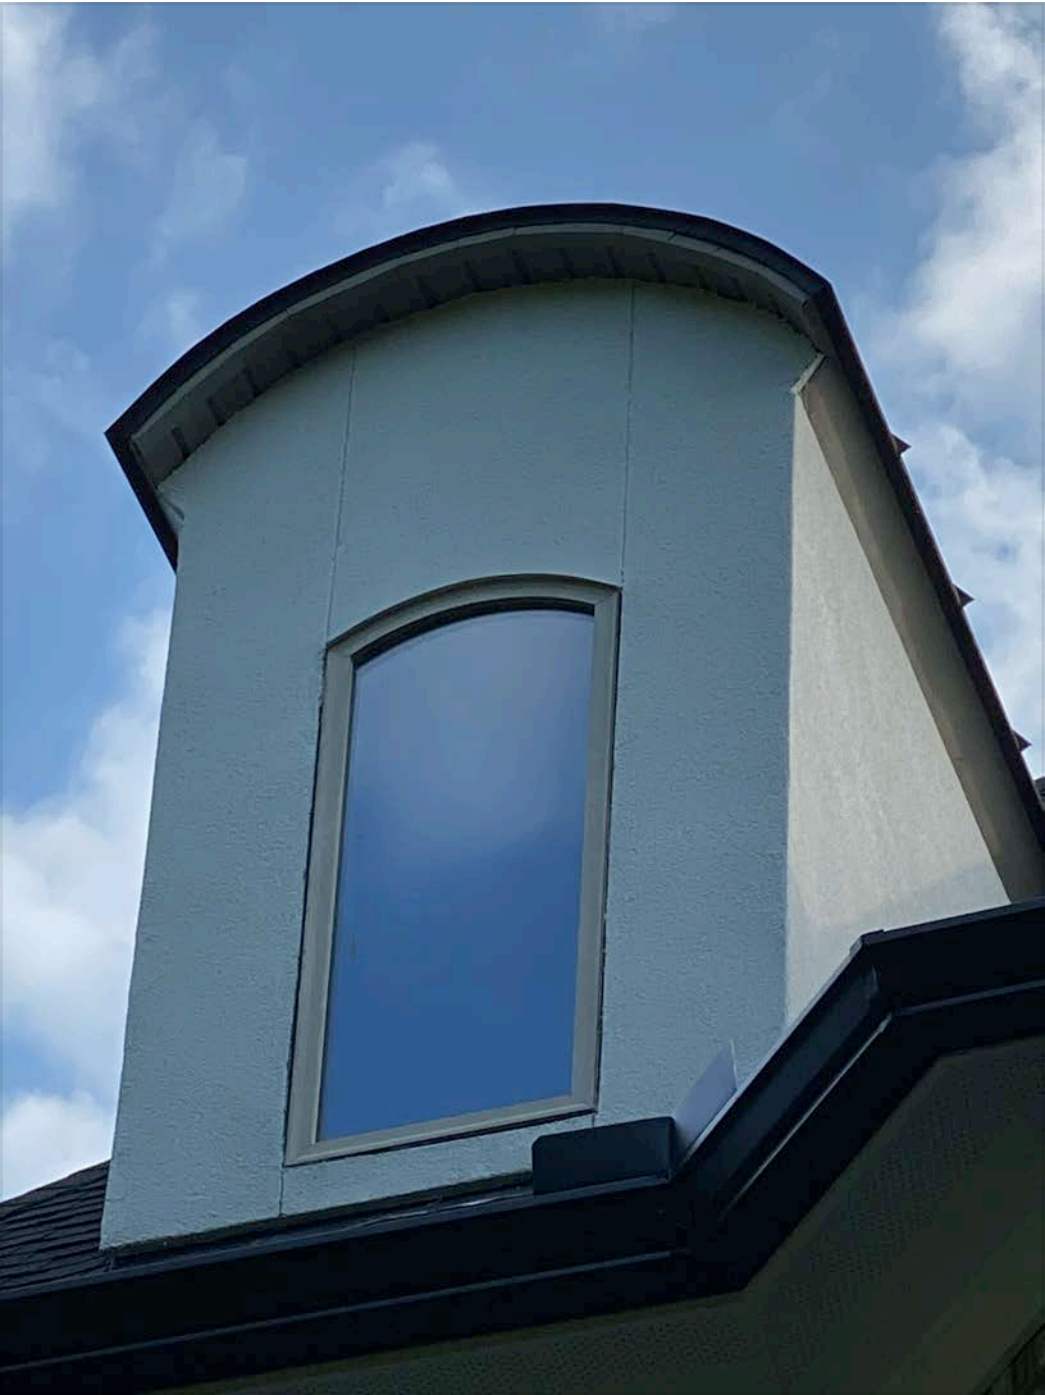
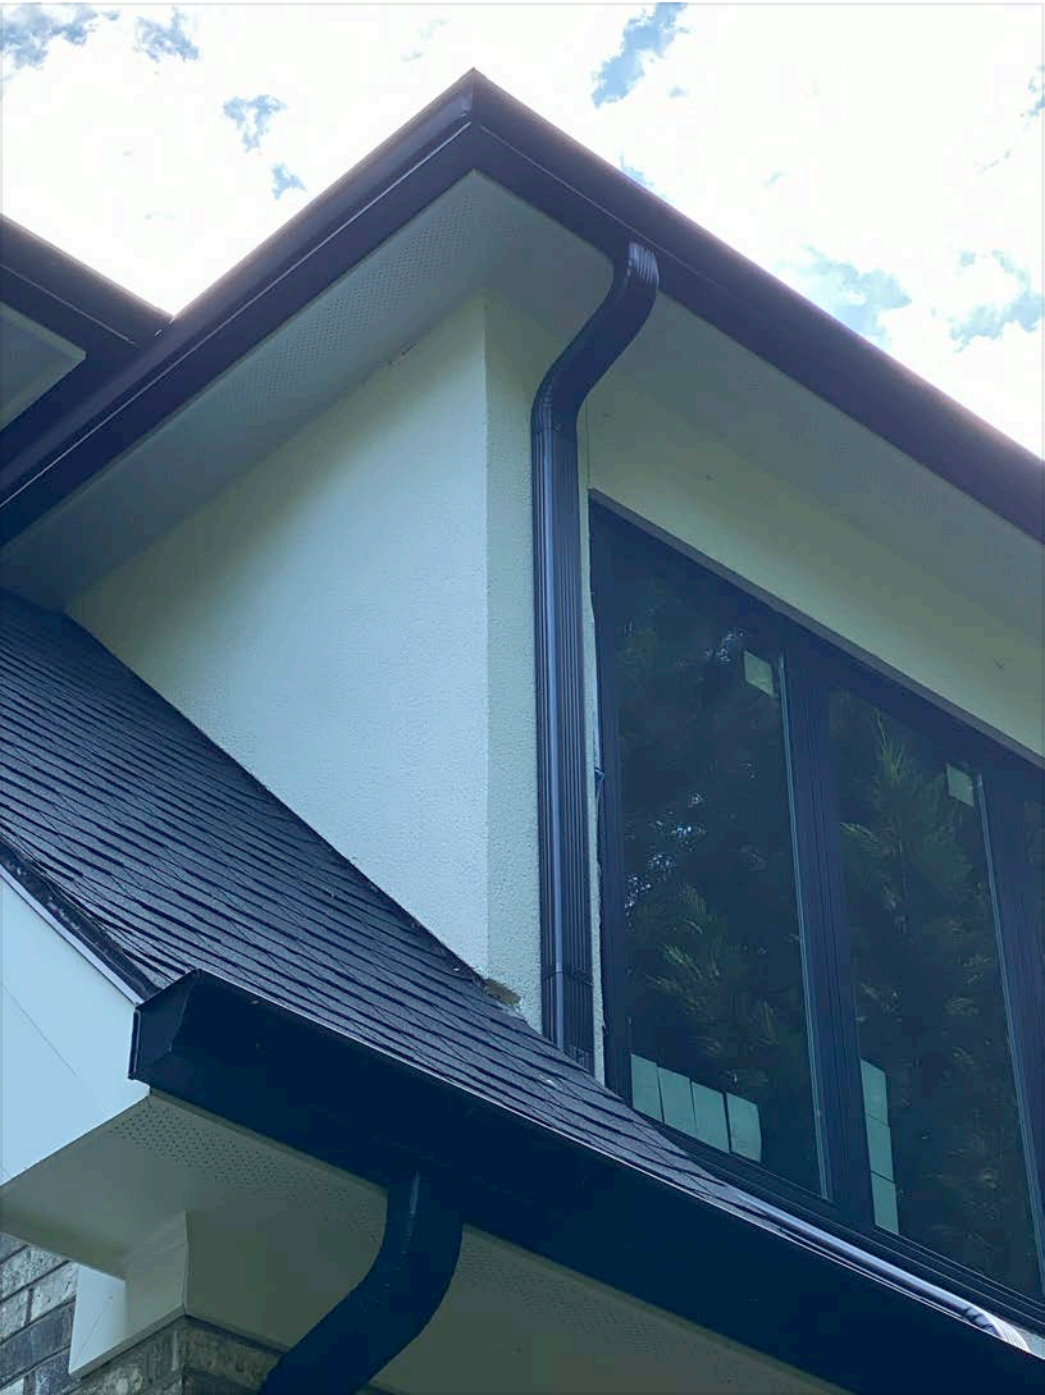
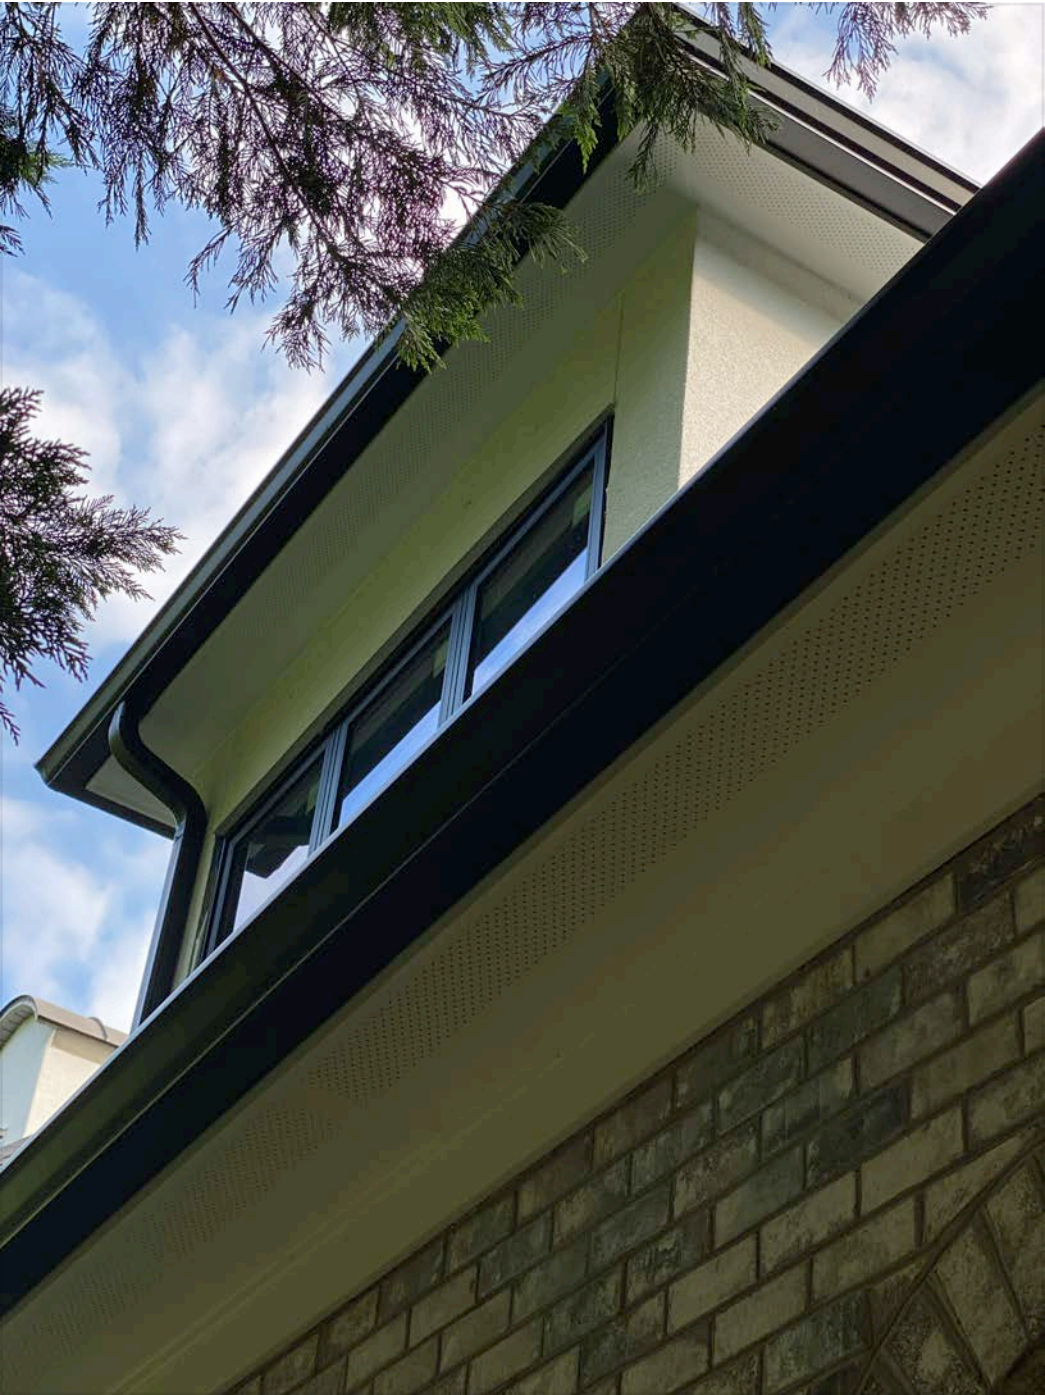
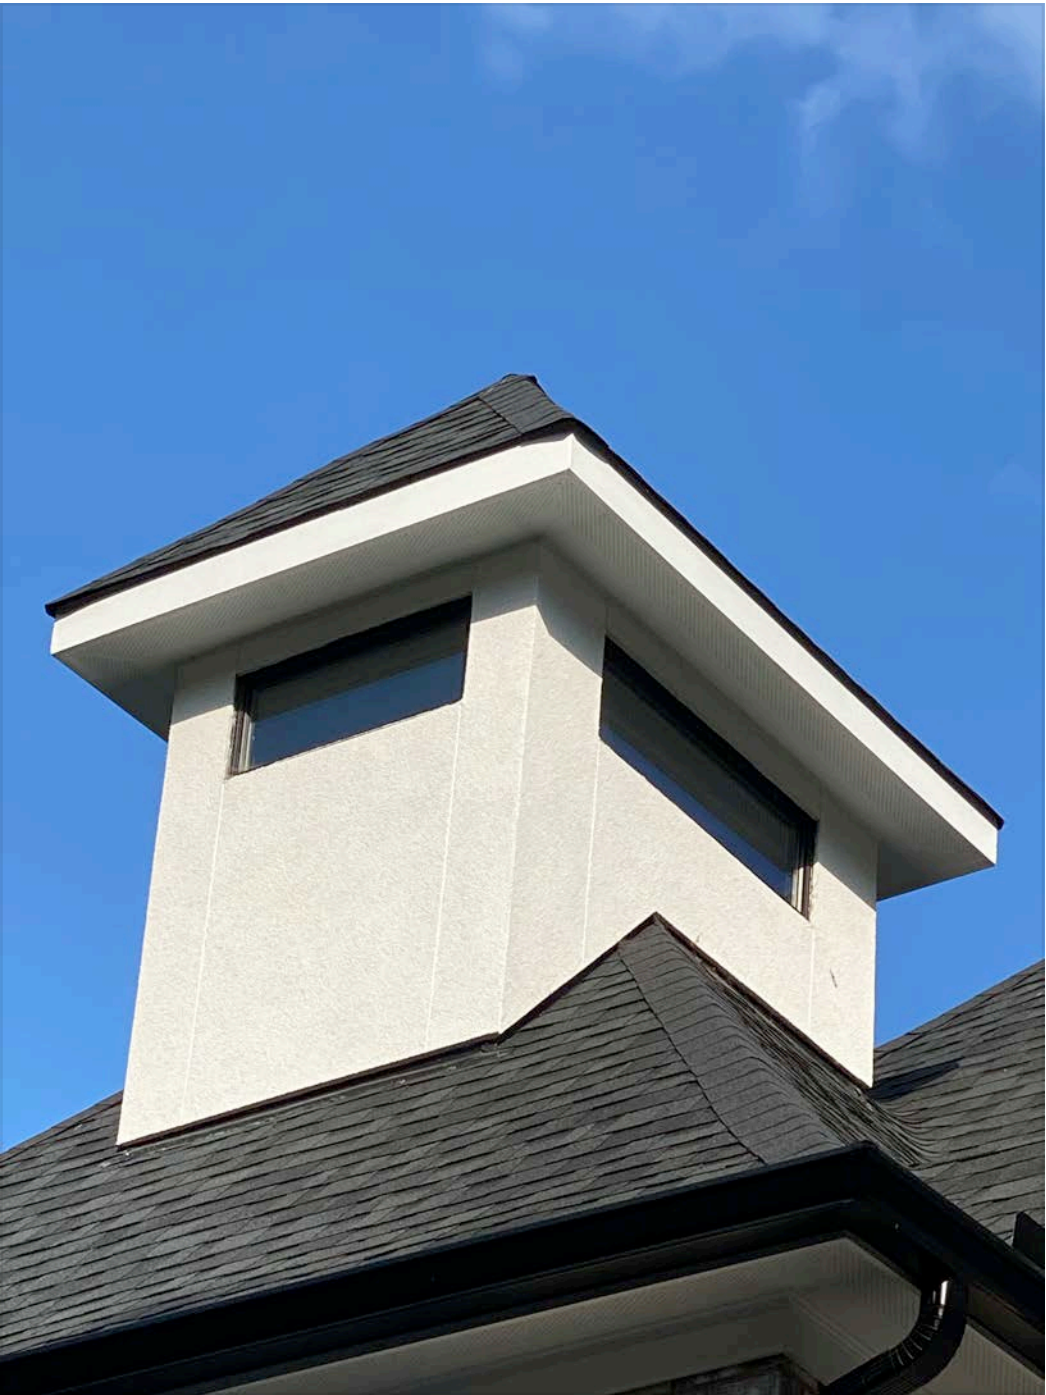
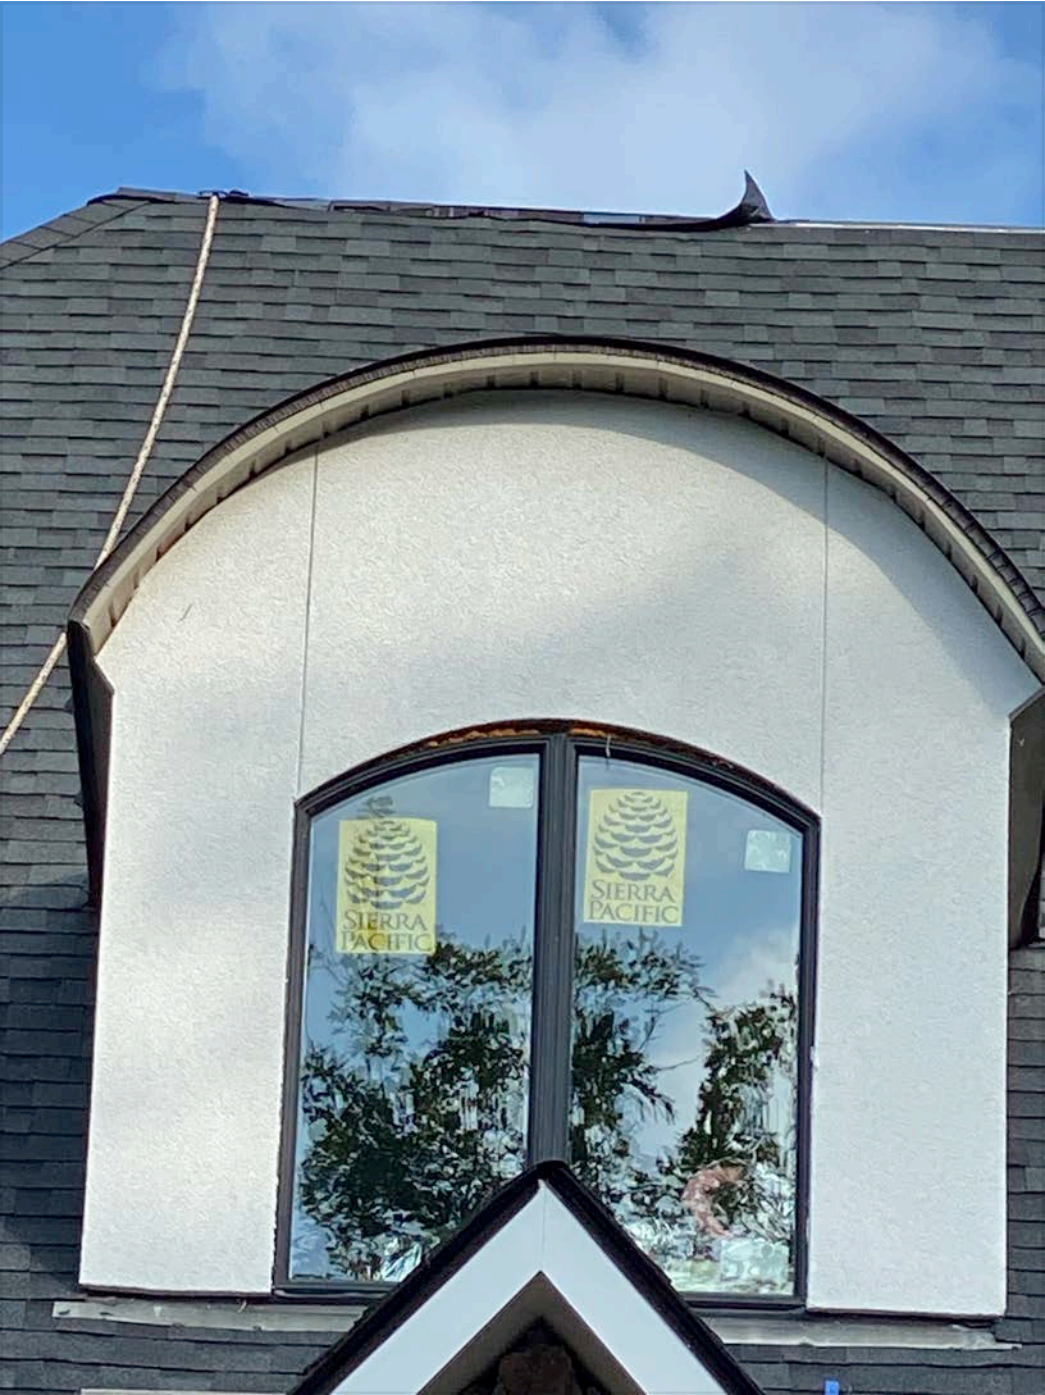
Difficult to see in this particular photo, however caulk separated

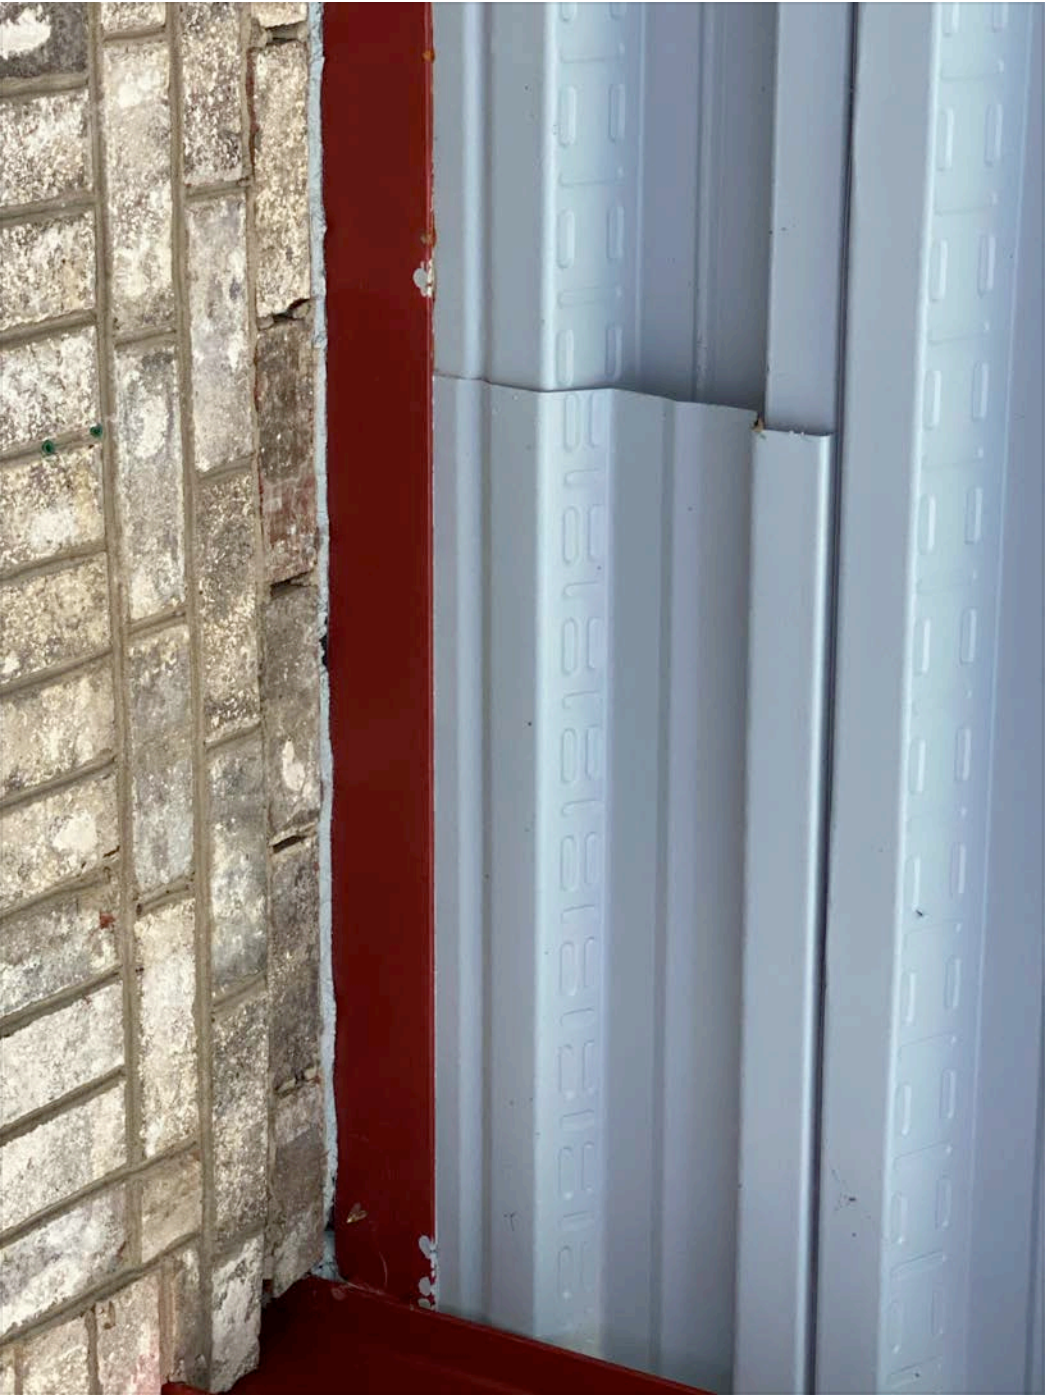
Lanai sandblast work to clean, mortar removal, plus the paint job:

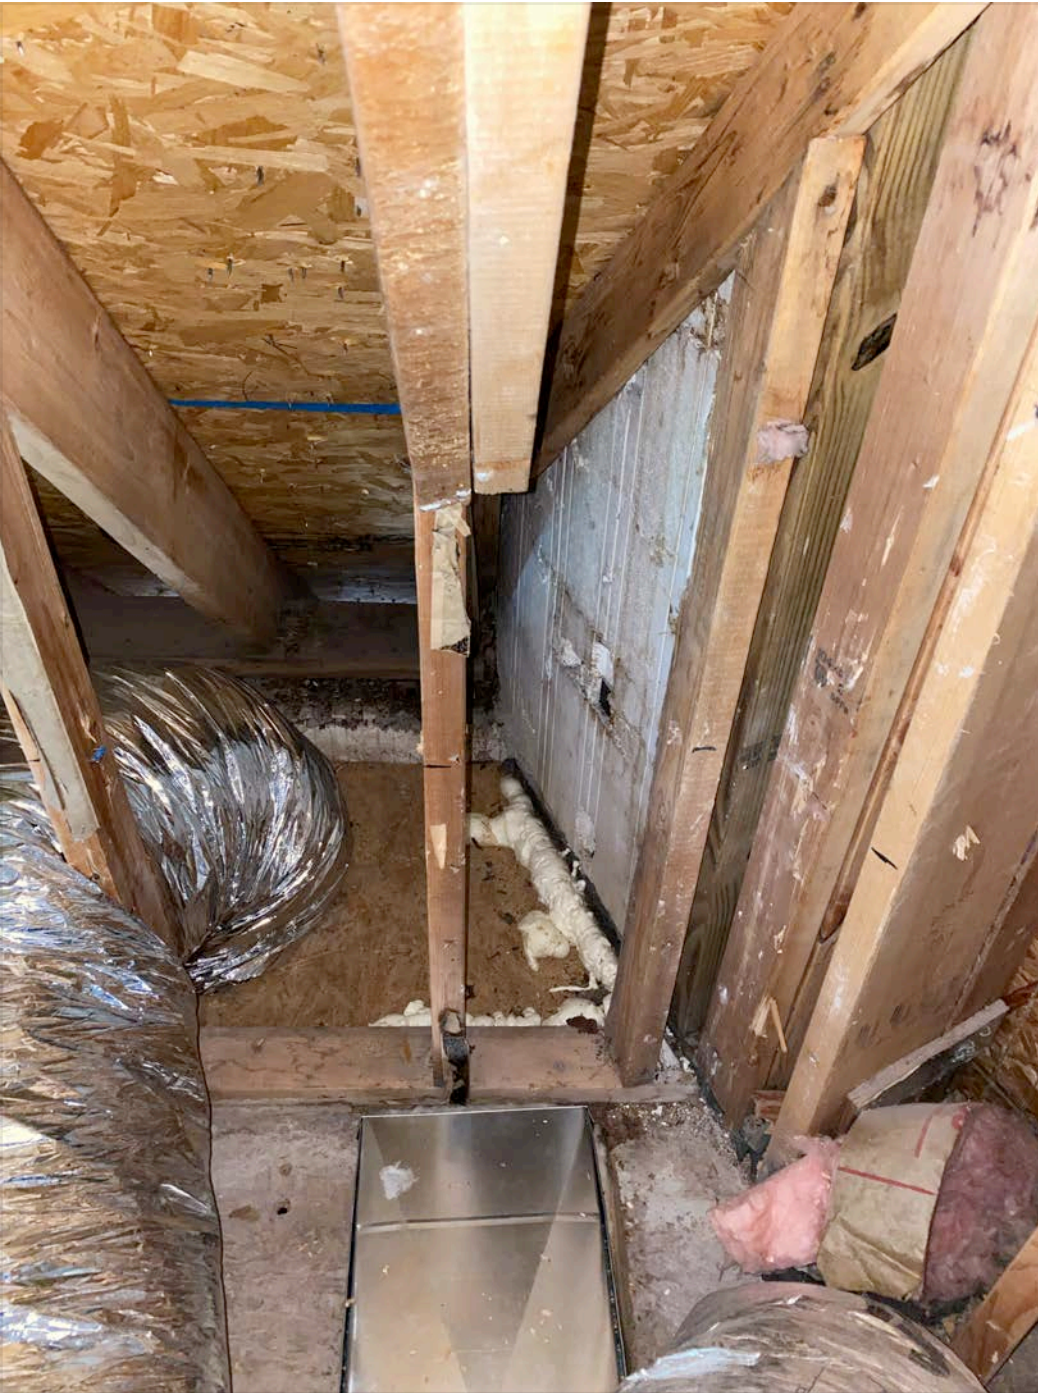
Multiple areas of home still evidence mold which must be fully remediated prior to drywall.

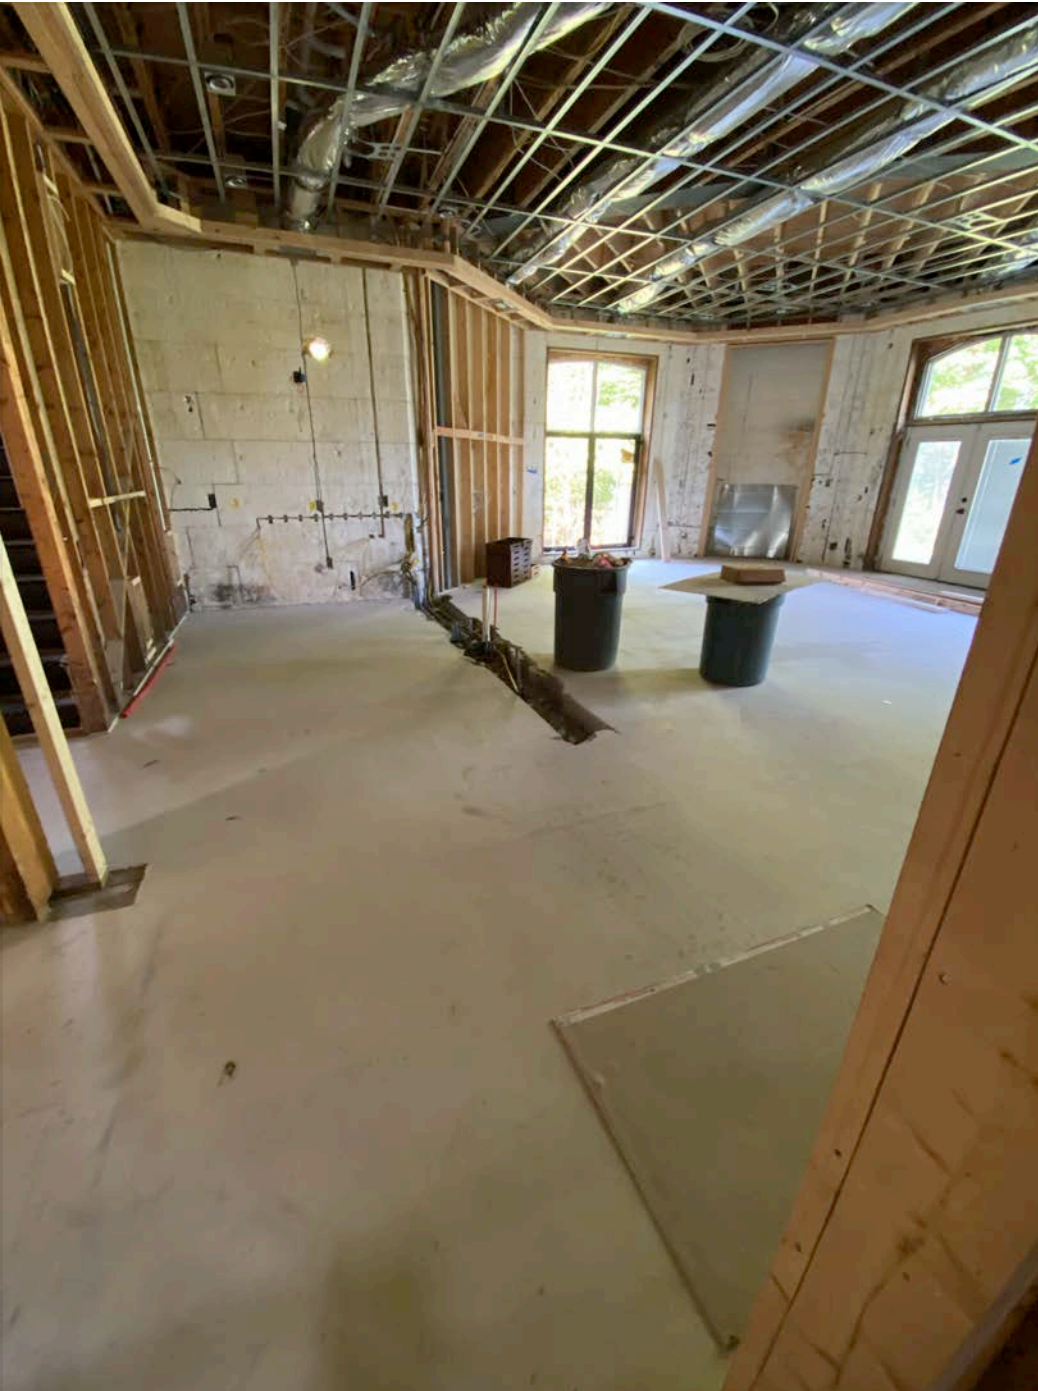
Kitchen trough recut with accompanying fixes to radiant flooring and other MANY times due to poor project management. WH had the opportunity to do it correctly back in early 2022 when the hole was first cut, however after Angela got assurance from both Jim B and Barbie that paths for, with extra, electrical would be run before the hole was filled, Angela walked in to see the hole filled woutout paths run. Barbie told Angela it was a mistake, that they didnt expect it to be filled yet but WH would take care of it.

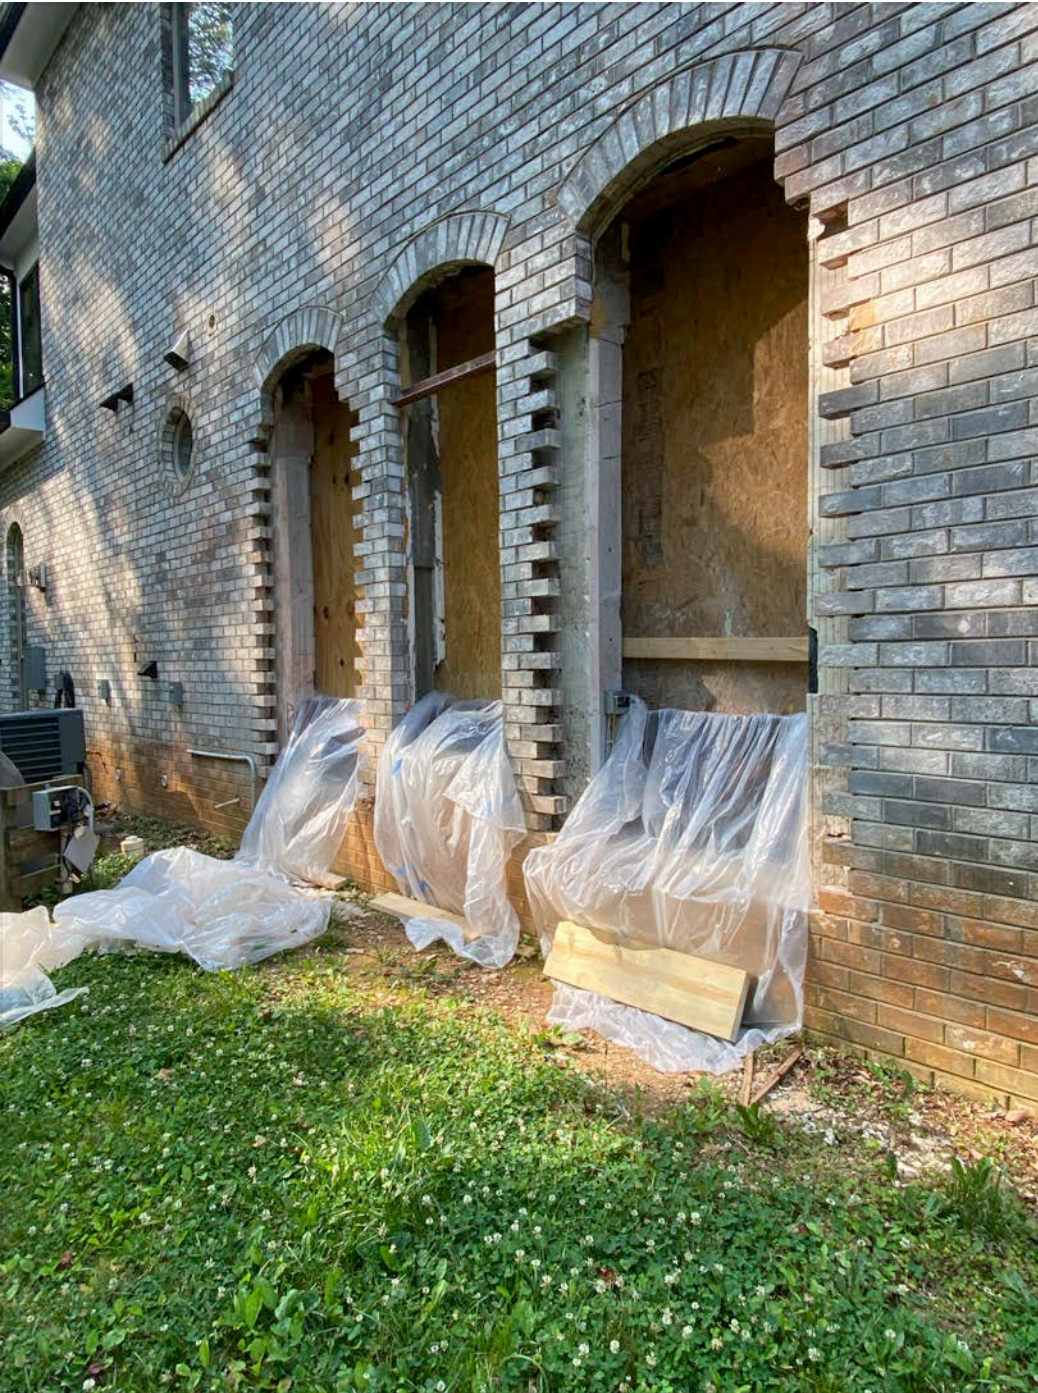
Window holes in primary bathroom cut too large due to poor communication by project manager to sub —will also cost extra masonry and other work. Angela met with James B prior to this work being done and told him to cut only what was needed for the size of the windows going in, and even reminded that the middle window would need to be brought up higher and a vanity would run along that wall as shown in pdf submitted December 2021. Instead, team was told to cut to match center window opening (preexisting) that happened to run very near the floor. This means several feet worth of additional unnecessary cutting and related masonry work to repair:

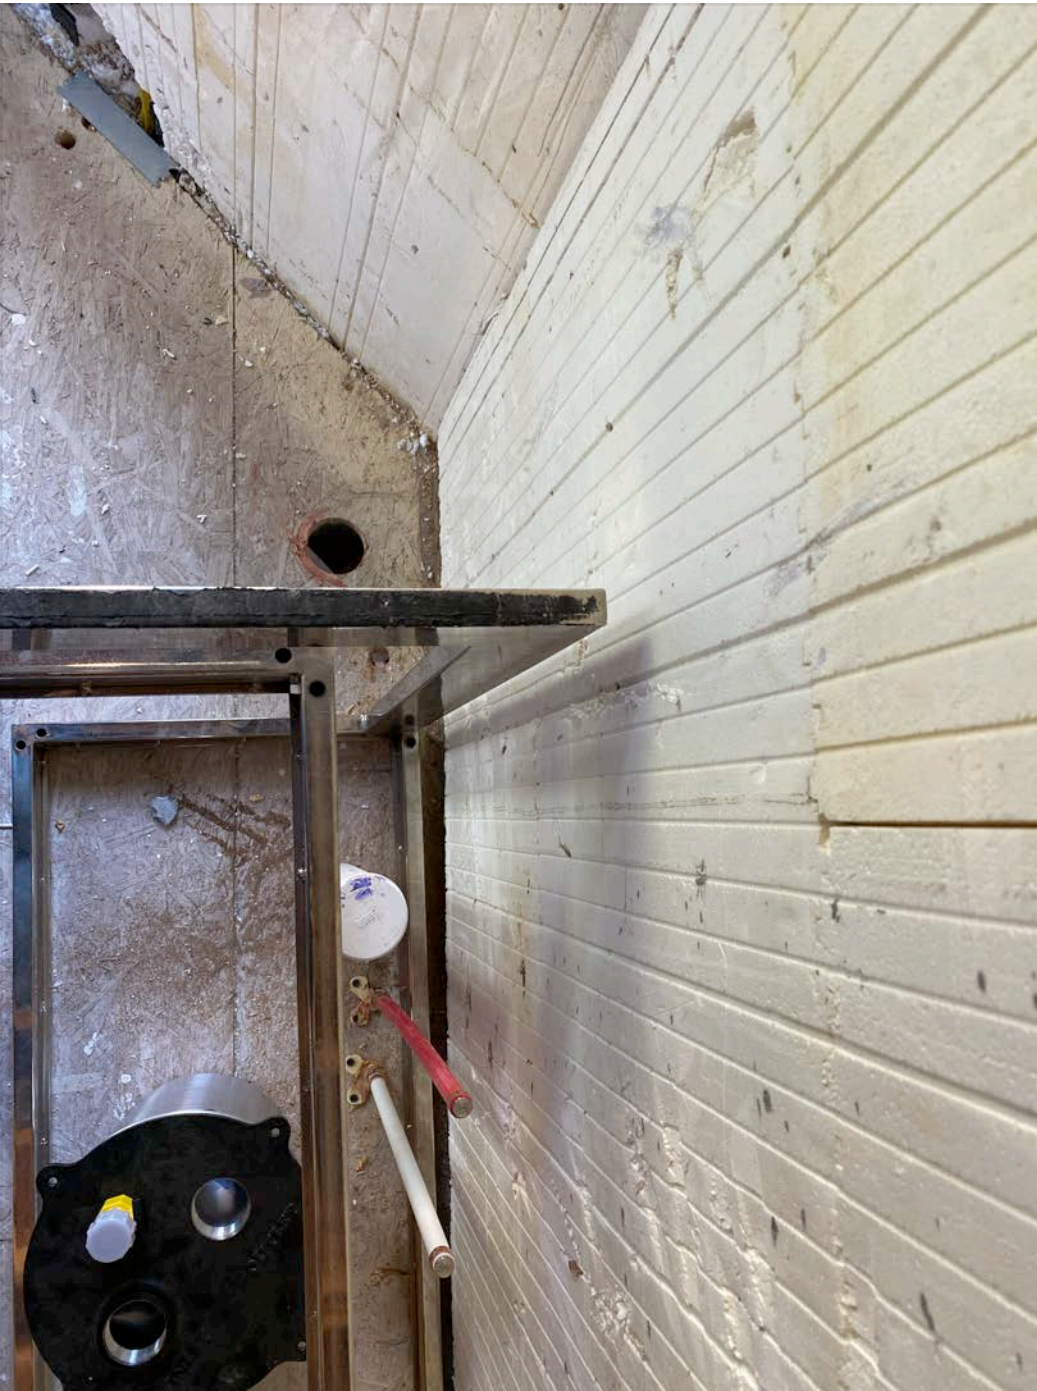
Art room sink plumbing installed too close to end of wall due to miscommunication by project manager to sub:
