Property Inspection Report

Report Number: 24175

5407 Eastern Shores Dr
Greensboro, North Carolina 27455

Date of Inspection: Monday, July 29, 2024

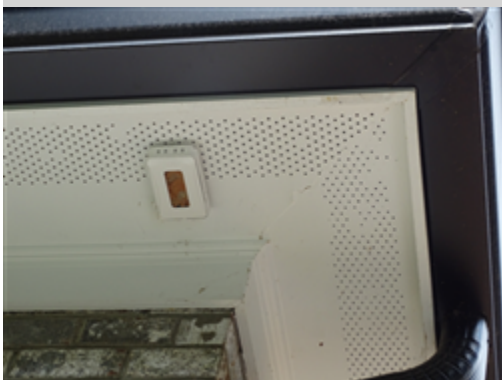
(B1 - 1.3) Main House

See item #2 in the comment above

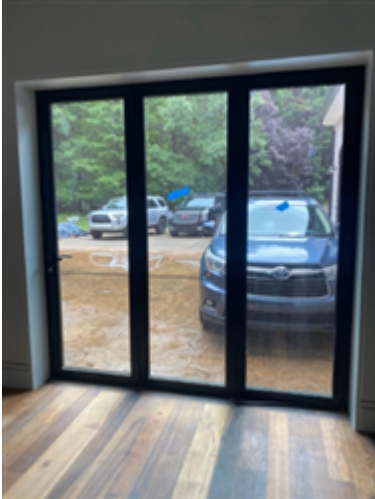
(B2 - 1.1) Doors

When inspecting the exterior doors the following concerns were observed:

1 - The triple panel door in the formal dining room:

A licensed general contractor should be contacted for further evaluation and repair to ensure that the doors function as intended.

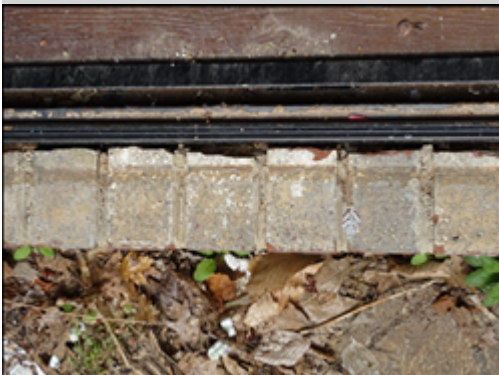
(B2 - 1.2) Doors

See item #1-B in the comment above - lower rail below the brick sill

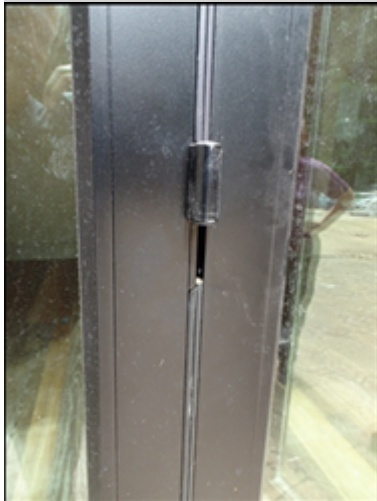
(B2 - 1.4) Doors

See item #1-C in the comment above

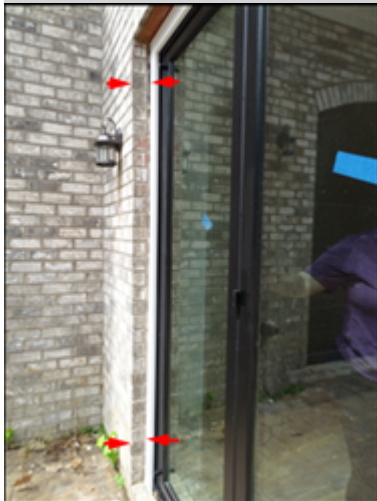
(B2 - 1.5) Doors

See item #1-D in the comment above

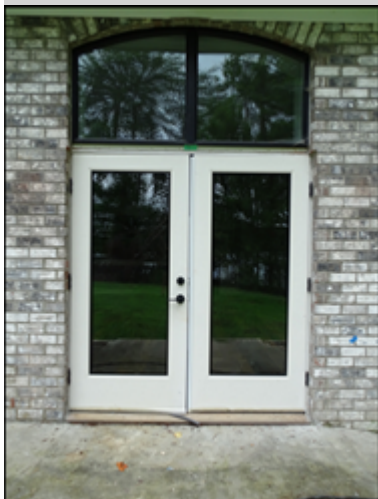
(B2 - 1.6) Doors

See item #2-A in the comment above - den door

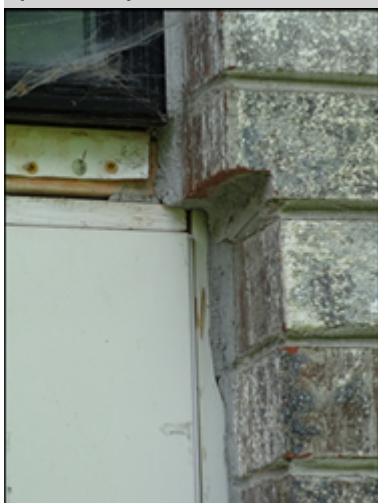
(B2 - 1.7) Doors

See item #2-A in the comment above - step in brick between door and transom.

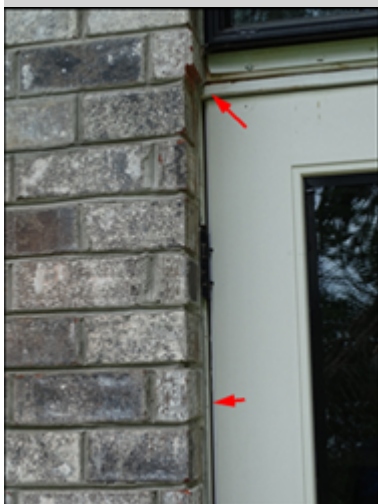
(B2 - 1.8) Doors

See item #2-A in the comment above - step in brick between door and transom.

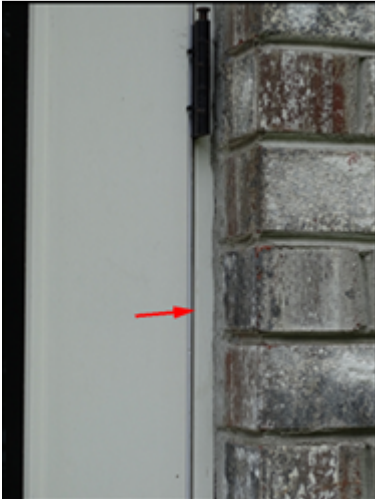
(B2 - 1.9) Doors

See item #2-B in the comment above - den door fit, right side

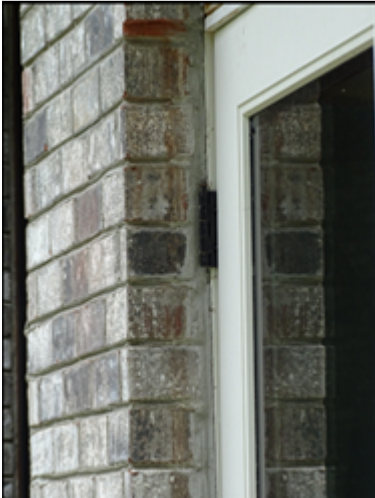
(B2 - 1.10) Doors

See item #2-B in the comment above - den door fit, left side

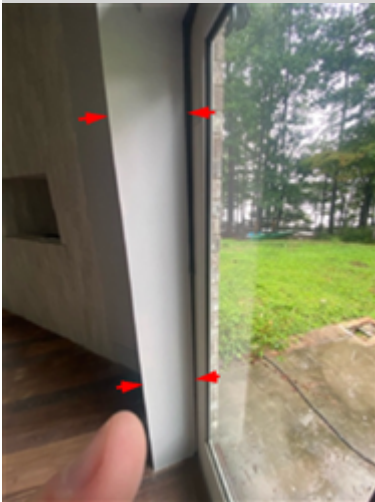
(B2 - 1.11) Doors

See item #2-B in the comment above - den door, margin at top vs. bottom

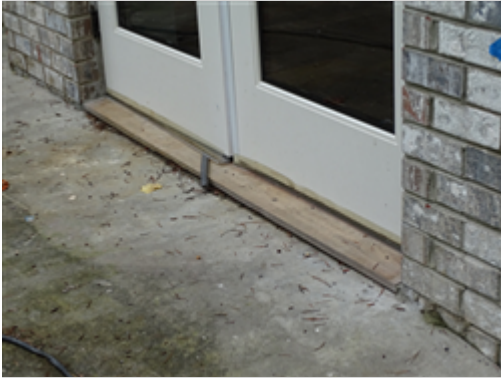
(B2 - 1.12) Doors

See item #2-C in the comment above - den door - weather stripping at threshold

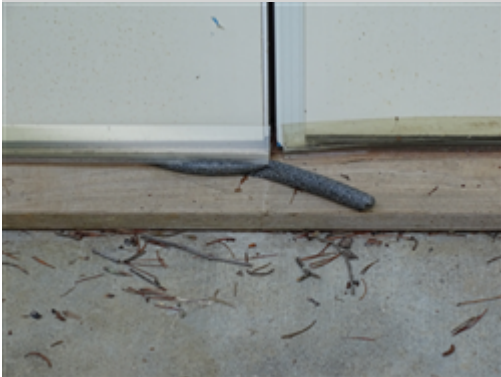
(B2 - 1.13) Doors

See item #2-C in the comment above - den doors not aligned

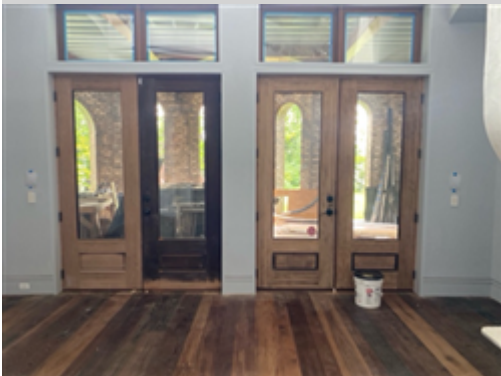
(B2 - 1.14) Doors

See item #3 in the comment above - great room

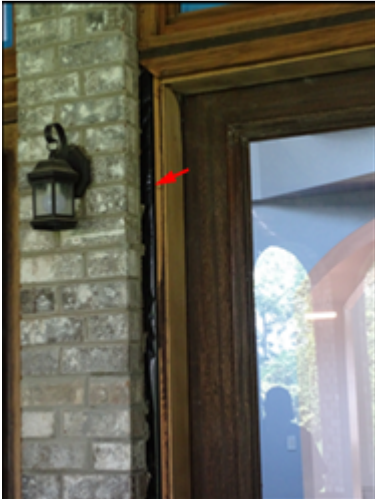
(B2 - 1.16) Doors

See item #3 in the comment above - exterior trim missing

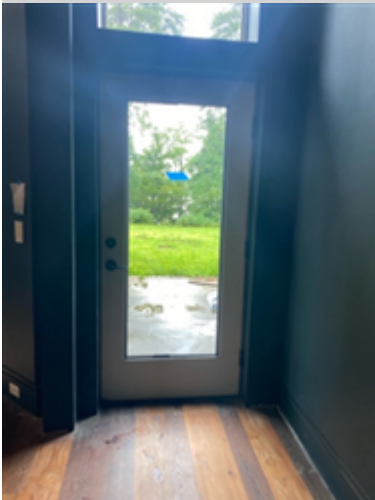
(B2 - 1.17) Doors

See item #4 in the comment above - master bedroom

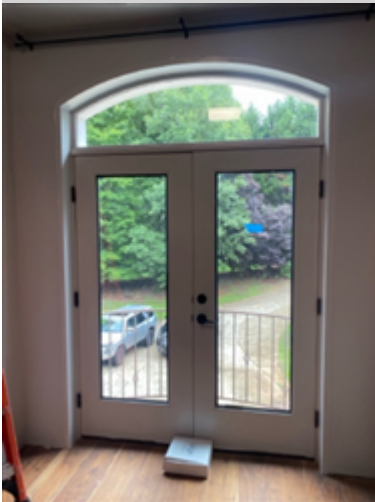
(B2 - 1.18) Doors

See item #5 in the comment above - front center bedroom (2nd level)

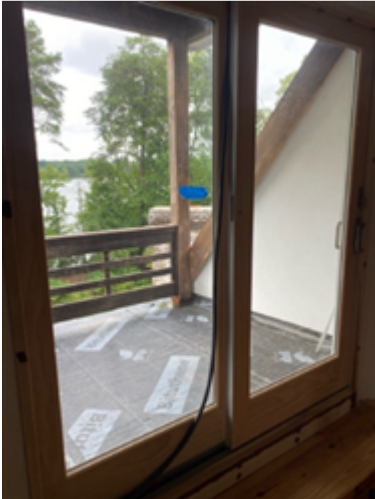
(B2 - 1.22) Doors

See item #7-A in the comment above - 3rd level balcony, installation incomplete

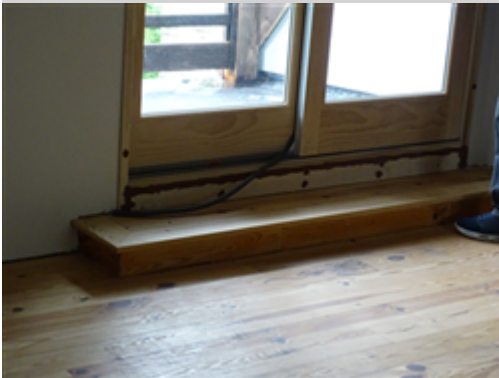
(B2 - 1.23) Doors

See item #7-A in the comment above - interior trim installation incomplete

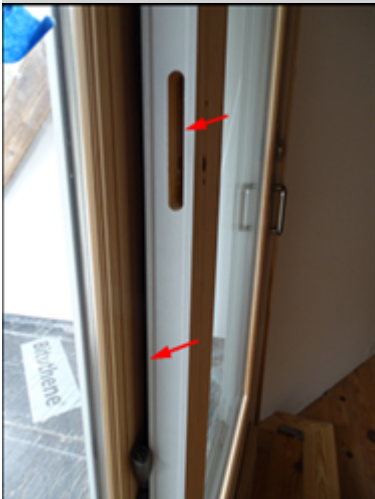
(B2 - 1.24) Doors

See item #7-B in the comment above - hardware installation incomplete - gap between door panels (lower red arrow), no weather stripping and hardware not installed (upper red arrow)

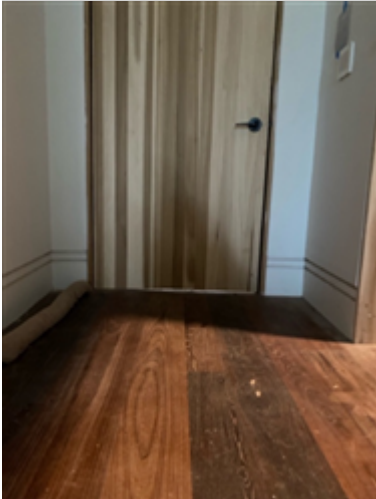
(B2 - 1.25) Doors

See item #8 in the comment above - garage door

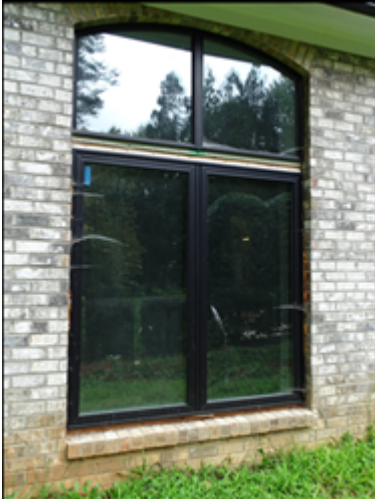
(B2 - 2.1) Windows

When inspecting the windows that have been replaced, it was noted that the window installation is not uniform or consistent. Materials used to fill gaps around the windows consist of aluminum or caulking and in some cases the gap is left exposed - photos below are an example and should not be considered a complete list. In addition to these general concerns, the following items were noted:

A licensed general contractor and/or the manufactures representative should be contacted for further evaluation, along with repairs to ensure that the windows function as intended.

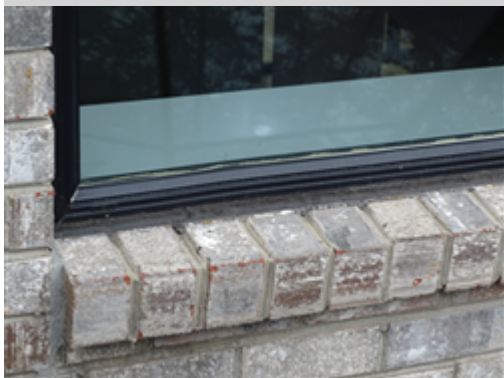
(B2 - 2.3) Windows

See general comment above - heavy caulking at bottom of windows

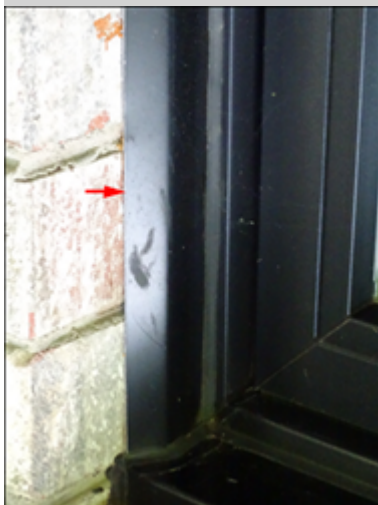
(B2 - 2.4) Windows

See general comment above - inconsistent window trim, some have aluminum flashing on sides and bottom, (main level rear)

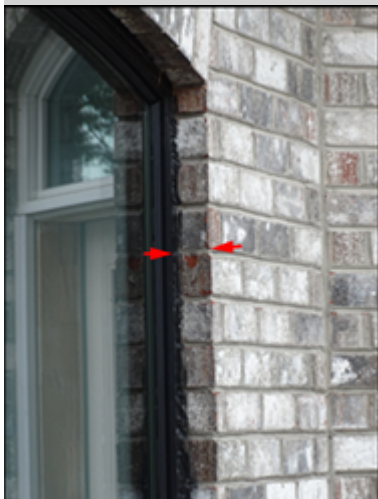
(B2 - 2.5) Windows

See general comment above - inconsistent depth and heavy caulk on sides of windows

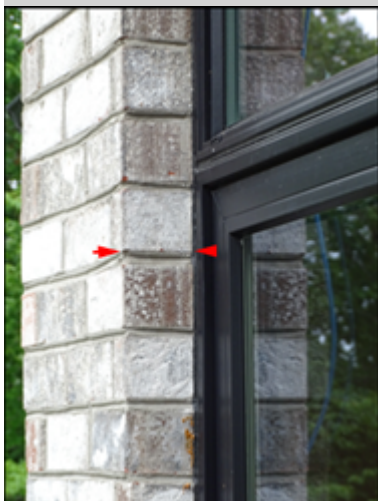
(B2 - 2.6) Windows

See general comment above - No aluminum trim or heavy caulking

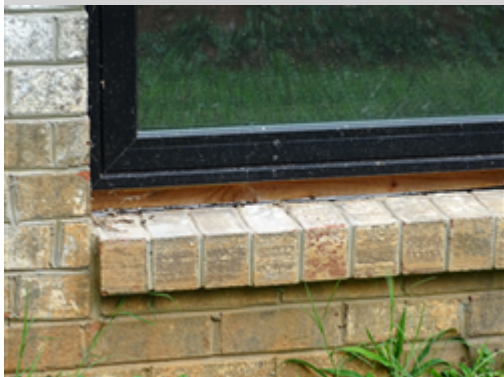
(B2 - 2.7) Windows

See item #1-A in the comment above - den

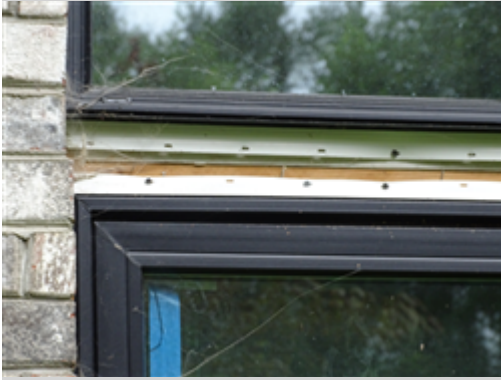
(B2 - 2.8) Windows

See item #1-B in the comment above - den

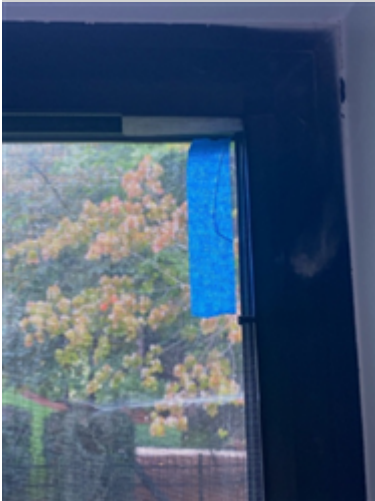
(B2 - 2.9) Windows

D - Also at the left rear den window, there is a crack in the glass at the upper corner of the right side sash.

See item #1-D in the comment above - den

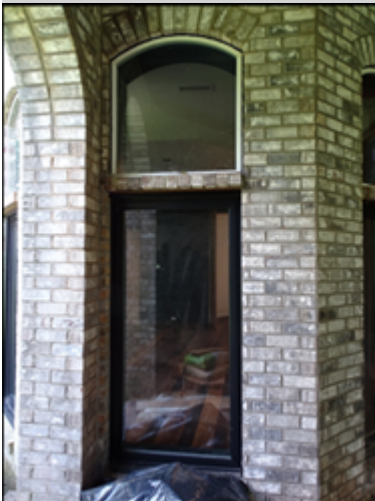
(B2 - 2.10) Windows

2 - Several of the transom windows across the rear have been replaced with white vinyl frame windows. (all other replacements are black)

See item #2 in the comment above - white transoms

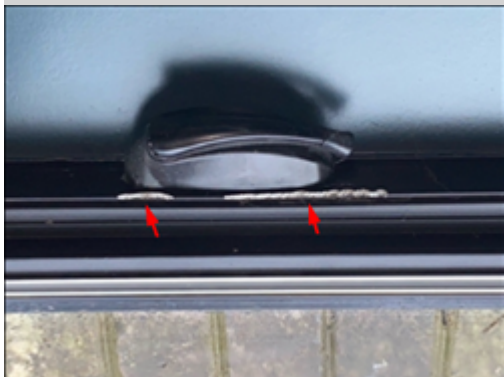
(B2 - 2.11) Windows

3 - The master bedroom window frame is damaged along the bottom.

See item #3 in the comment above - master bedroom

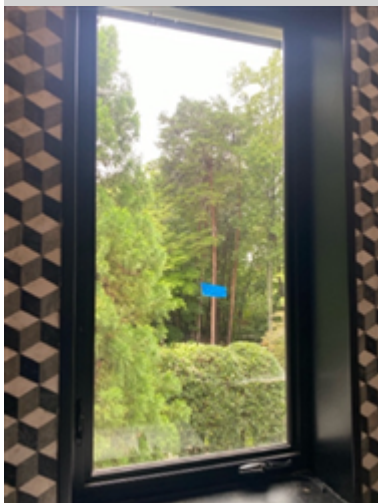
(B2 - 2.12) Windows

See item #4 in the comment above - private bath left front

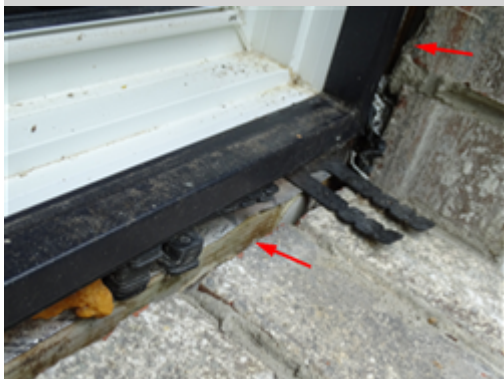
(B2 - 2.13) Windows

See item #4-A in the comment above - private bath left front

Note stack of plastic shims under window frame - incorrectly sized for opening - #4-A

Also note that the window is recessed beyond the brick sill - #4-C

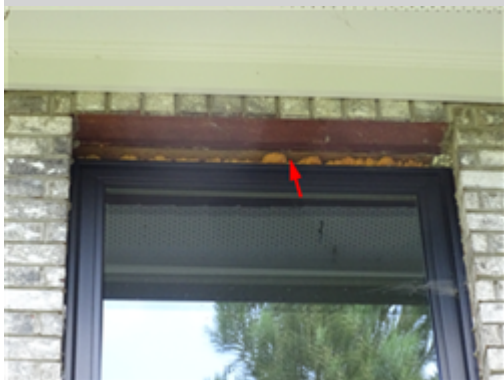
(B2 - 2.14) Windows

See item #4-A in the comment above - private bath left front, gap above window

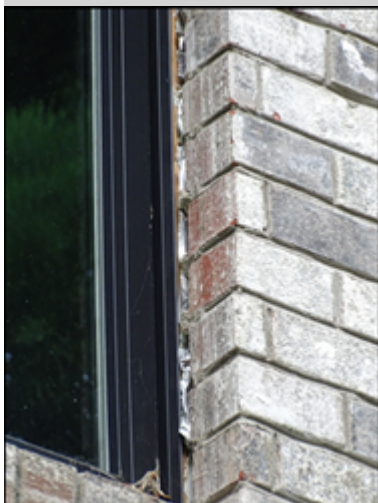
(B2 - 2.16) Windows

See item #4-C in the comment above - private bath left front, gap along sides of window

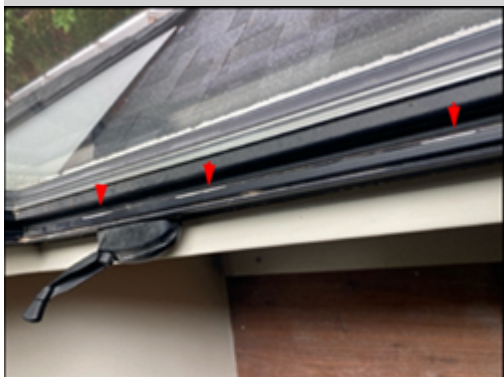
(B2 - 2.17) Windows

See item #5 in the comment above - left front bedroom

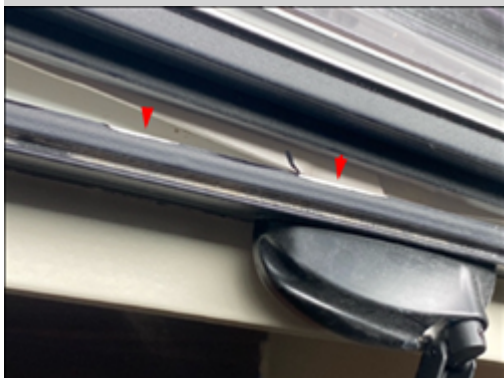
(B2 - 2.18) Windows

See item #5 in the comment above - left front bedroom, additional photo

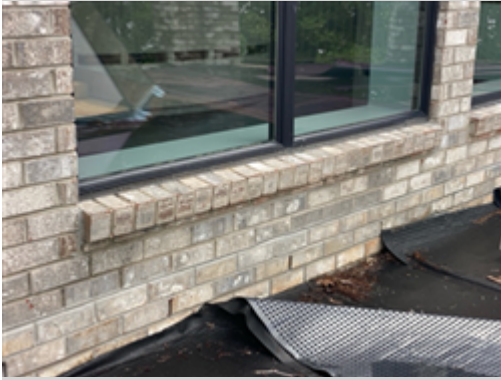
(B2 - 2.19) Windows

See item #6 in the comment above - rear window second level

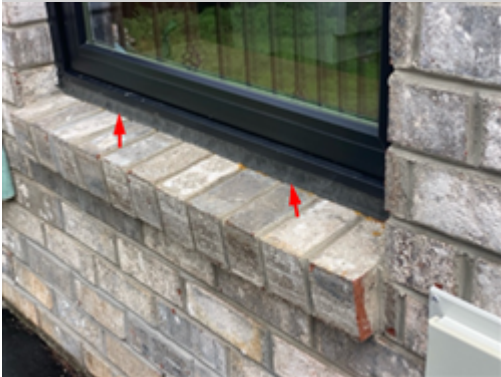
(B2 - 2.20) Windows

See item #6 in the comment above - Additional photo

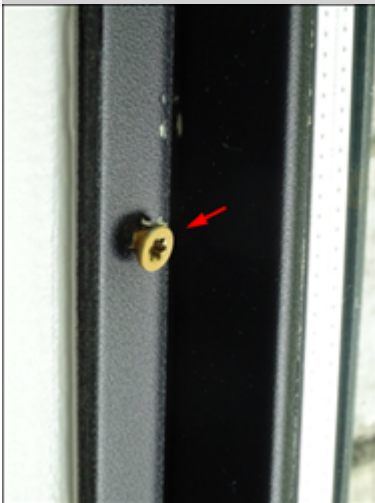
(B2 - 2.21) Windows

See item #7 in the comment above - Fixed windows, exposed deck screw

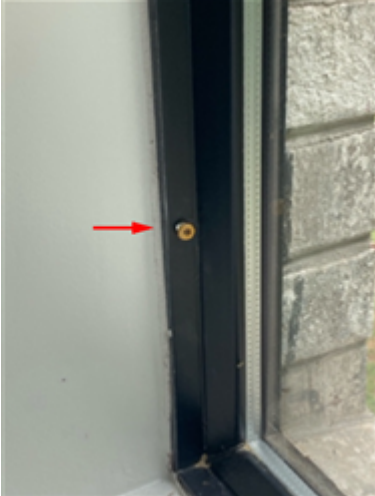
(B2 - 2.22) Windows

See item #7 in the comment above - Fixed windows, exposed deck screw

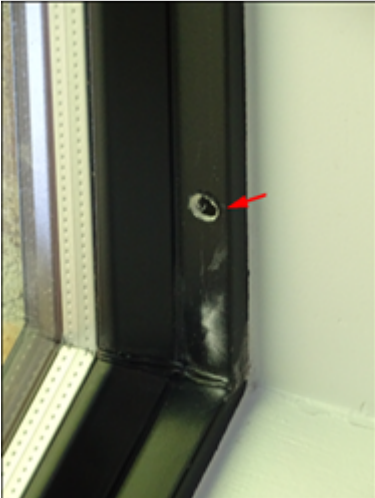
(B2 - 2.23) Windows

See item #7 in the comment above - Fixed windows, open holes

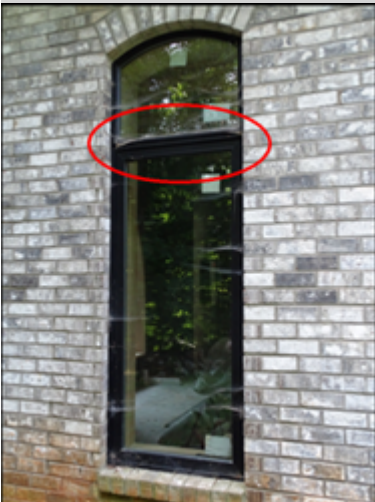
(B2 - 2.24) Windows

See item #8 in the comment above - transom at garage windows

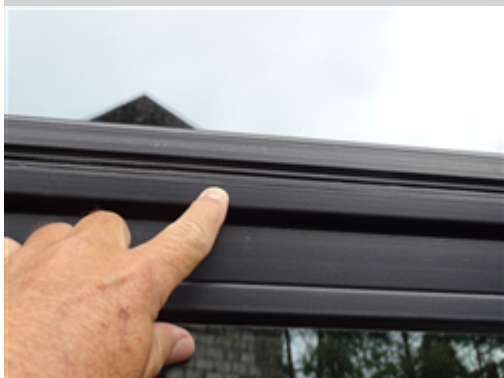
(B2 - 2.26) Windows

See item #8 in the comment above - transom transition (no gap)

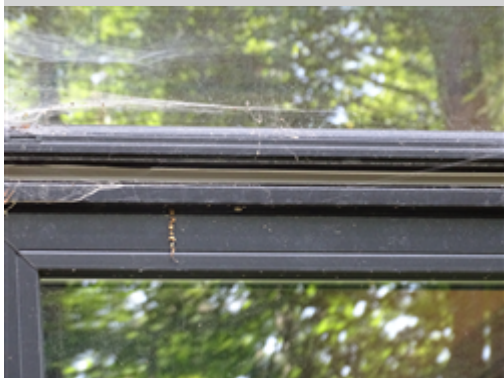
(B2 - 2.27) Windows

See item #8 in the comment above - transom transition (gap)

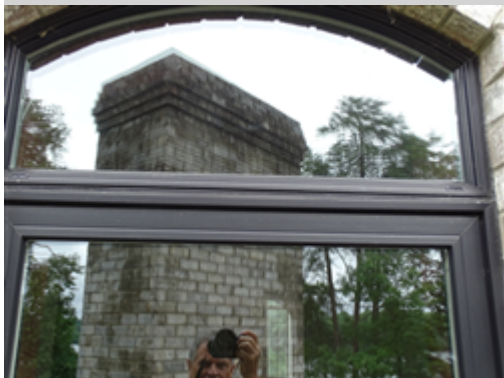
(B2 - 2.28) Windows

See item #8 in the comment above - transom transition

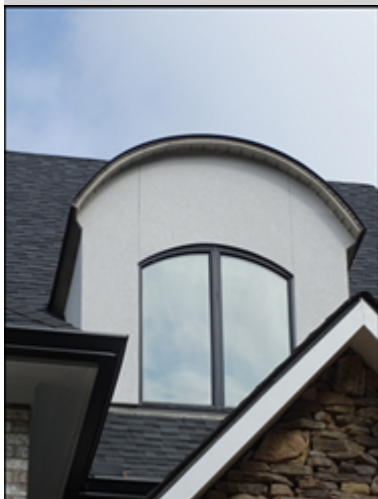
(B2 - 2.29) Windows

See item #9 in the comment above - front dormer window

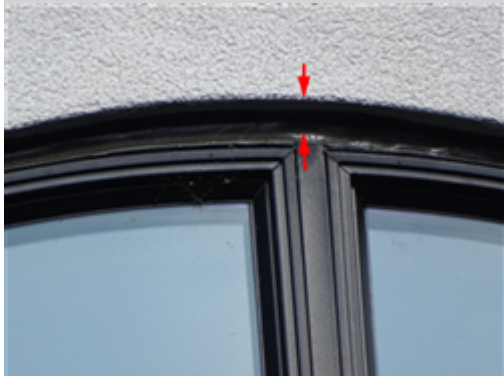
(B2 - 2.30) Windows

See item #9 in the comment above - caulked gap

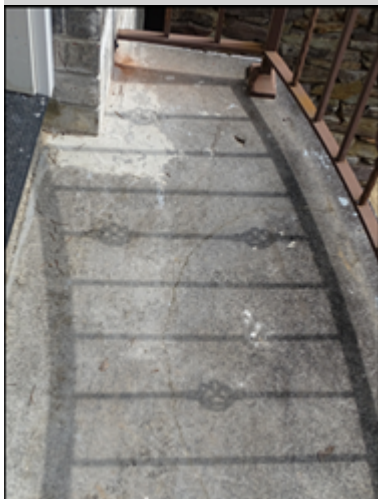
(B4 - 1.2) Balcony - 2nd Level - Front

See item #2 in the comment above

A licensed general contractor should be contacted for further evaluation along with completion of work to the patio.

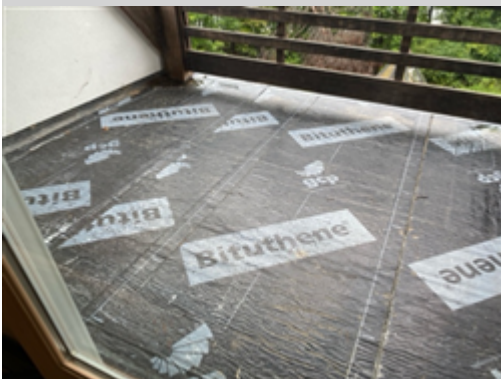
(B4 - 3.2) Patio - 3rd Level

- 1 - The slope of the surface is greater than what is comfortable to walk on.
- 2 - The surface materials have not yet been installed - installation incomplete.
- 3 - Some of the underlayment moves when walked on - needs to be secured.
- 4 - Water stands on the floor surface around both post.
- 5 - There are cracks in the stucco wall finish.

See items #1, #2 & #3 in the comment above

A licensed general contractor should be contacted for further evaluation along with completion of work to the patio.

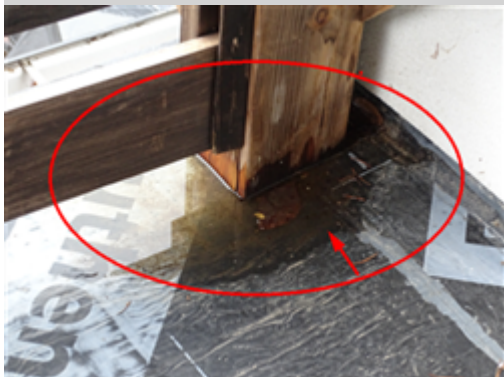
(B4 - 3.3) Patio - 3rd Level

See item #4 in the comment above - standing water

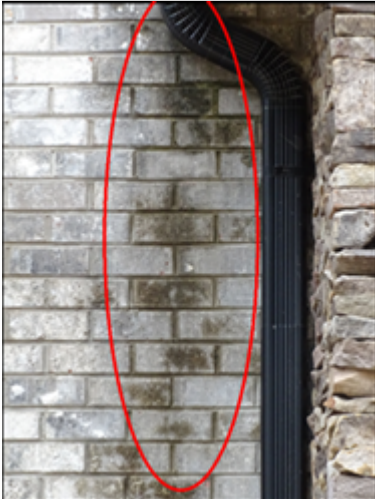
(C2 - 1.3) Main House

- 1 - Evidence suggest that the gutters are leaking (kick-out flashing not visible) in several locations across the front of the home.
- 2 - Evidence suggest that the drainpipe attached to the downspouts across the front of the home are clogged and not functional. It was raining during the inspection - water was overflowing at the connection at the base of the downspout.
- 3 - At the left side of the home, a downspout is not piped away allowing storm water to drain next to the foundation.
- 4 - The gutters are full of leaves and debris that is keeping them from functioning as intended. Cleaning is needed.

See item #1 in the comment above - left side of front entrance

A general contractor should be contacted for further evaluation and repair to avoid further damage.

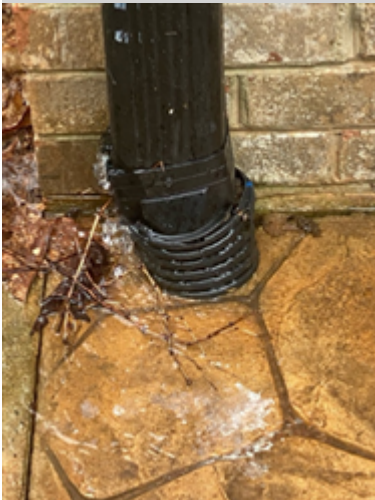
(C2 - 1.4) Main House

See item #2 in the comment above - front of home

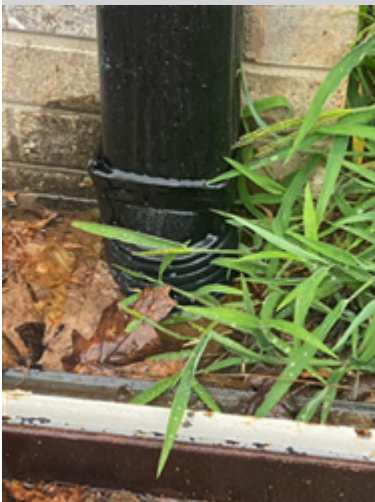
(C2 - 1.5) Main House

See item #2 in the comment above - front of home

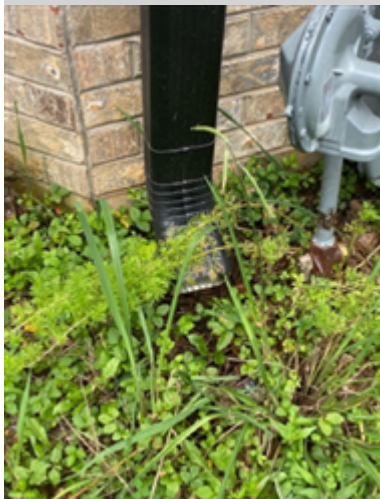
(C2 - 1.6) Main House

See item #3 in the comment above - front of home

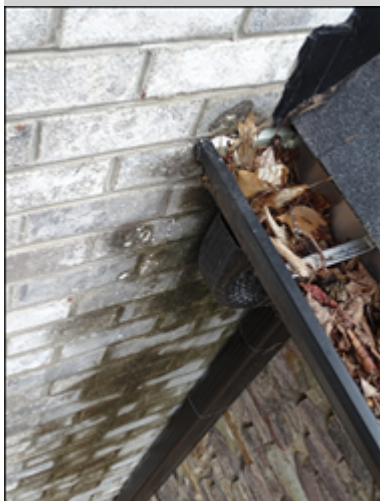
(C2 - 1.7) Main House

See item #4 in the comment above - leaves and debris

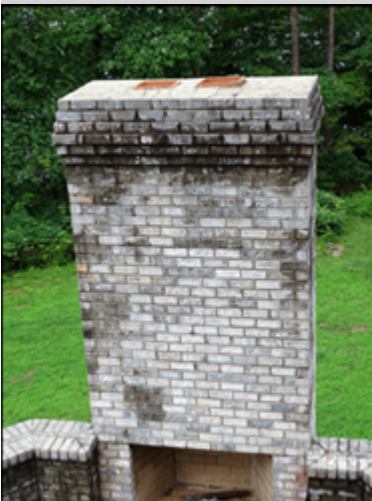
(C4 - 1.1) Outdoor Fireplace - Rear Patio

When inspecting the exterior fireplaces and chimney the following was noted:

1 - The mortar crown is deteriorated and cracked. When the mortar crown is damaged water can enter between the chimney body and the flue liner resulting in leaks and deterioration.

2 - At the lower level fireplace, evidence suggest that moisture is entering the chimney from the top.

A chimney specialist should be consulted for a complete evaluation of the chimney, the flue liner and the masonry crown and to make necessary repairs.

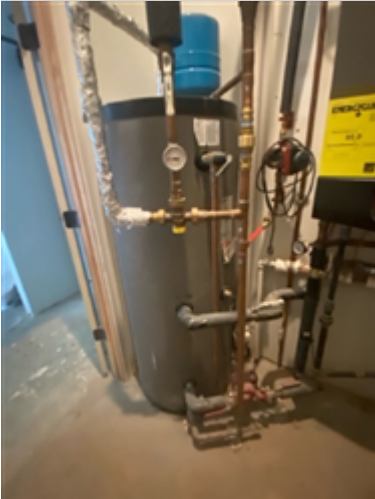
(D3 - 1.1) Unit #1

The water heater system was not producing hot water at the time of the inspection. This limited the inspection of the plumbing fixtures. Further evaluation and repair by a licensed plumbing contractor is needed.

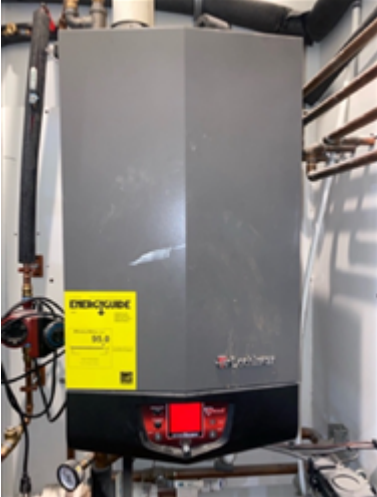
(D3 - 2.1) Unit #2

See comment in Unit #1 above... not functioning.

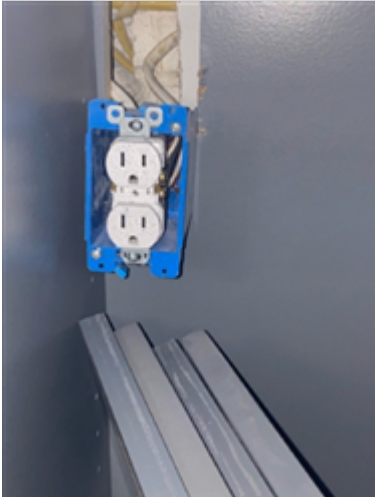
(E5 - 1.2) Miscellaneous Electrical

- 1 - The receptacles are missing in the kitchen.
- 2 - The electrical light switches for all of the main level were not functional - did not operate any of the overhead lights.
- 3 - A receptacle under the sink cabinet is missing the cover plate.
- 4 - A receptacle at the bar sink in the kitchen installation incomplete.

See item #3 in the comment above - under kitchen cabinet

A licensed electrical contractor should be consulted for a complete evaluation of the electrical system of this home to determine the significance of these concerns and make necessary repairs to correct defects and prevent safety hazards.

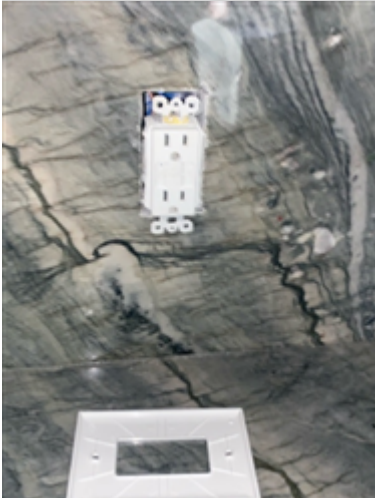
(E5 - 1.3) Miscellaneous Electrical

See item #4 in the comment above - bar sink

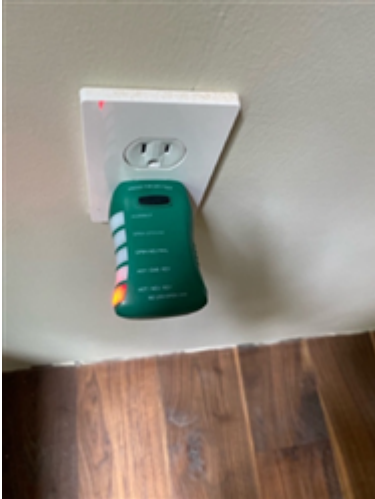
(E5 - 1.4) Miscellaneous Electrical

See item #5 in the comment above - left front bedroom

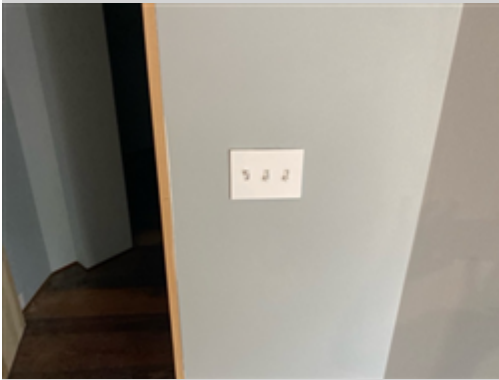
(E5 - 1.5) Miscellaneous Electrical

See item #6 in the comment above - left rear bedroom/ downstairs hall light

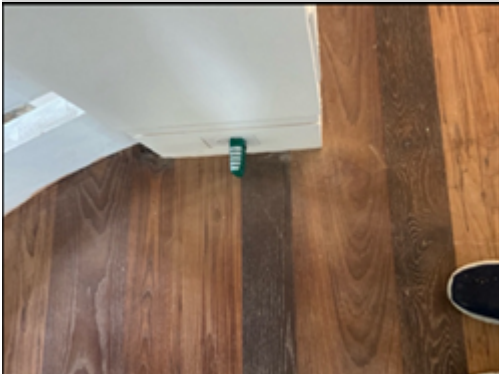
(E5 - 1.6) Miscellaneous Electrical

See item #7 in the comment above - right side stairwell

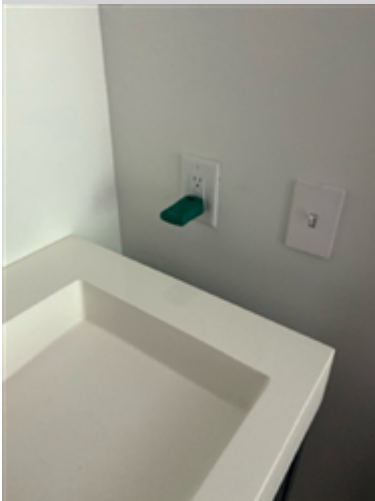
(E5 - 1.7) Miscellaneous Electrical

See item #8 in the comment above - Hall Bathroom

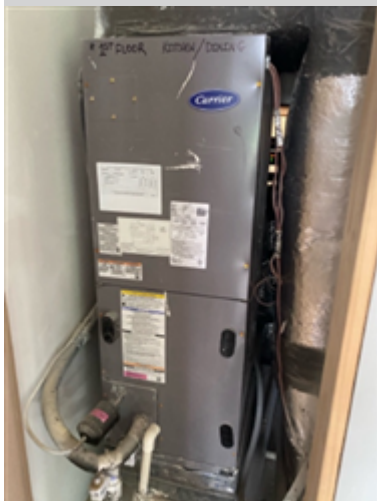
(F1 - 1.1) Heating and Cooling Unit #1

Photo - Heating and Cooling (interior) Unit #1

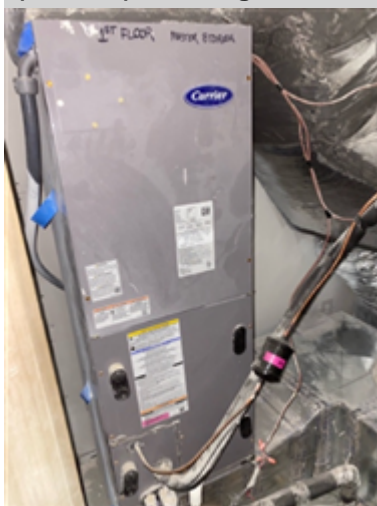
(F1 - 2.1) Heating and Cooling Unit #2

Photo - Heating and Cooling (interior) Unit #2

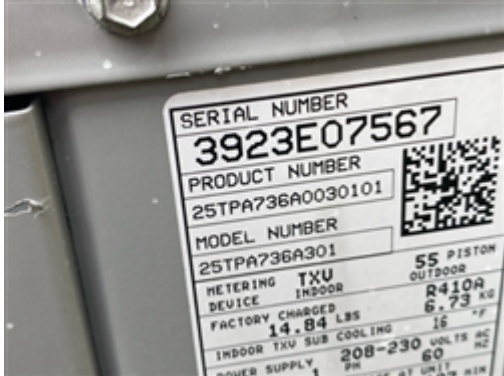
(G1 - 1.2) Heating and Cooling Unit #1

Data plate Mfg. date: 2023

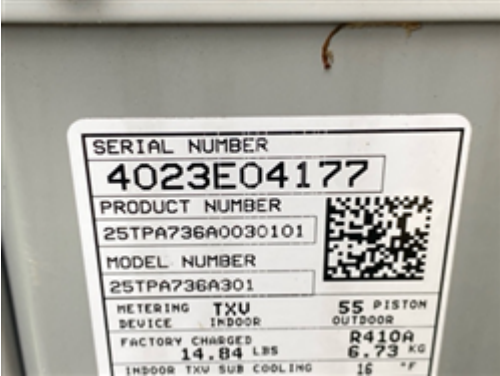
(G1 - 2.2) Heating and Cooling Unit #2

Data plate Mfg. date: 2023

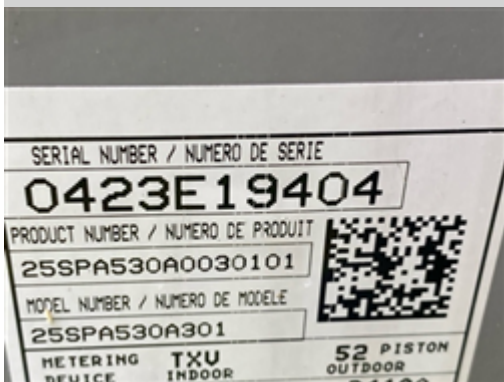
(G1 - 3.2) Heating and Cooling Unit #3

Data plate Mfg. date: 2023

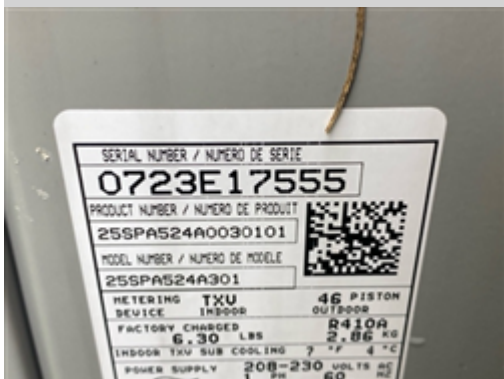
(G1 - 4.2) Heating and Cooling Unit #4

Data plate Mfg. date: 2023

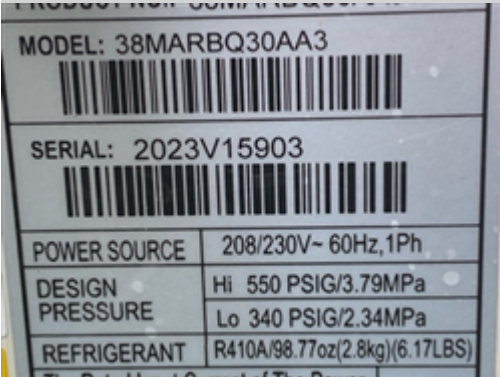
(G1 - 5.2) Heating and Cooling Unit #5

Data plate Mfg. date: 2023

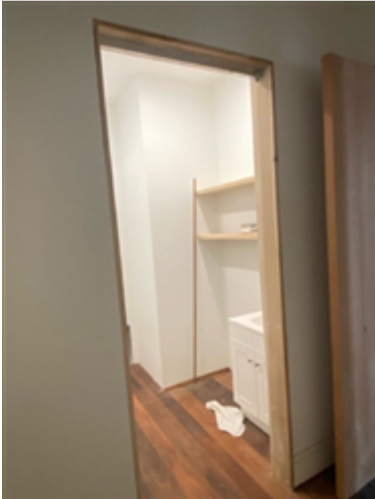
(H1 - 1.5) Interior Doors

- 3 - The left rear bedroom door has a broken glass.
- 4 - The laundry room pocket door installation is incomplete.
- 5 - The left front bedroom closet doors are warped.
- 6 - The utility closet door is damaged.
- 7 - The right side office door has surface damage.
- 8 - The right side office door installation is incomplete - missing trim.
- 9 - The left front bathroom pocket door installation is incomplete.
- 10 - The front right private bathroom doors installation is incomplete.

See item #4 in the comment above - laundry

A general contractor should be contacted for further evaluation along with repairs and completion.

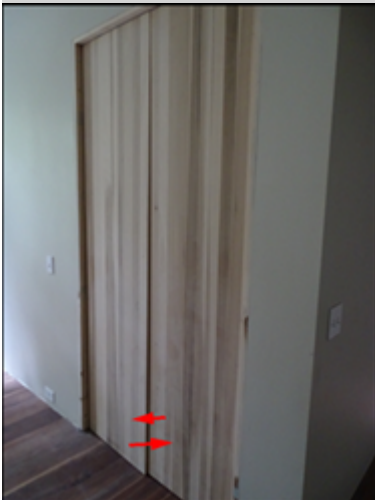
(H1 - 1.6) Interior Doors

See item #5 in the comment above - left front bedroom

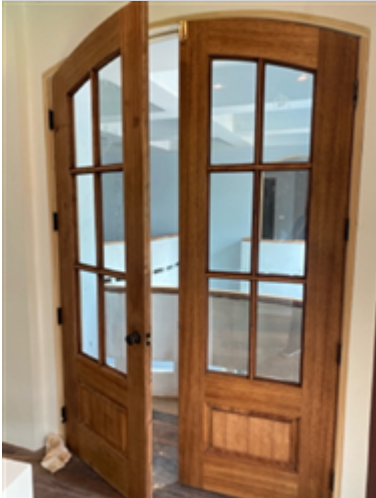
(H1 - 1.9) Interior Doors

See item #8 in the comment above - office

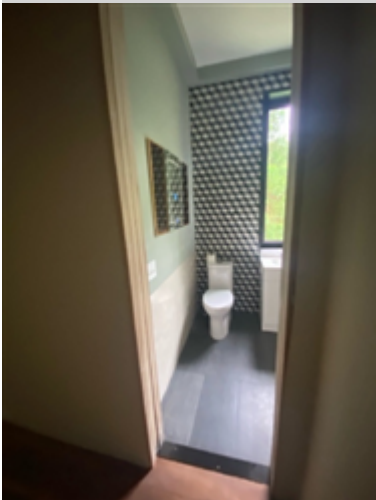
(H1 - 1.10) Interior Doors

See item #9 in the comment above - Pocket door incomplete
Bathroom: Private 2nd Left Front

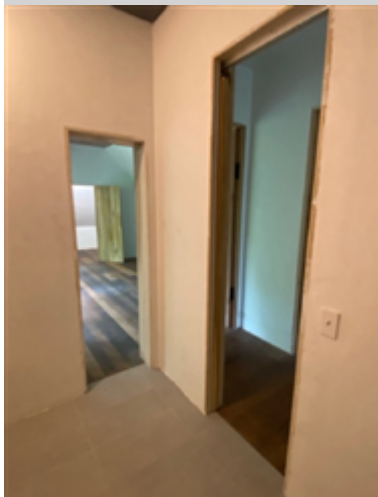
(H1 - 1.11) Interior Doors

See item #10 in the comment above - front right bathroom doors

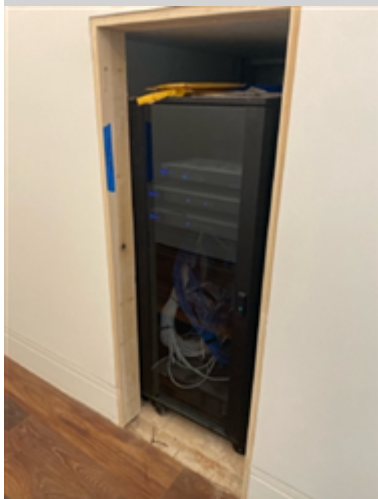
(H1 - 1.12) Interior Doors

See item #11 in the comment above - upper level HVAC closet door

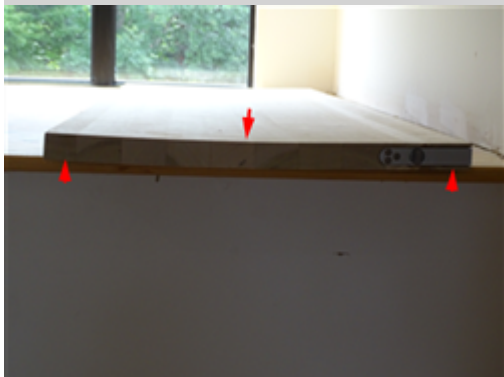
(H1 - 1.13) Interior Doors

See item #11 in the comment above - upper level HVAC closet door warped

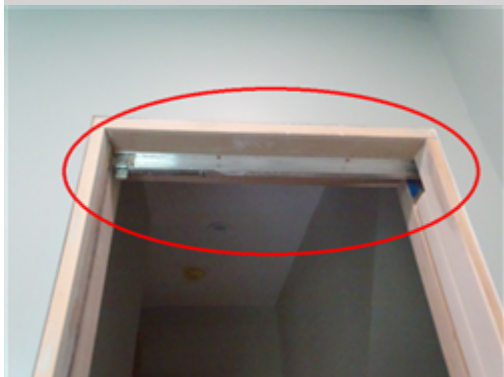
(H1 - 1.14) Interior Doors

See item #12 in the comment above - pocket door headers

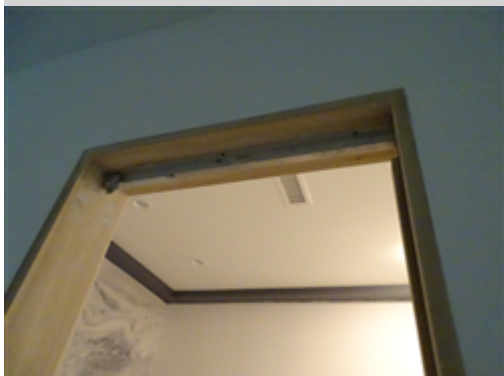
(H1 - 1.15) Interior Doors

See item #12 in the comment above - pocket door header, private bath

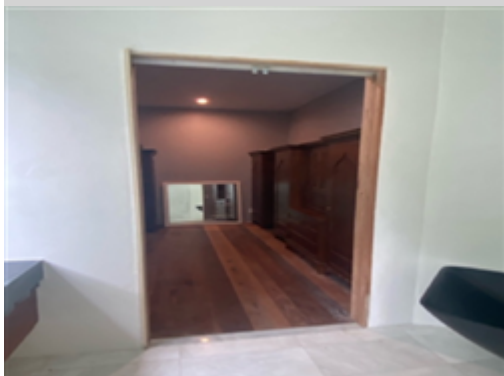
(H1 - 1.16) Interior Doors

See item #12 in the comment above - pocket door header, master bathroom to closet

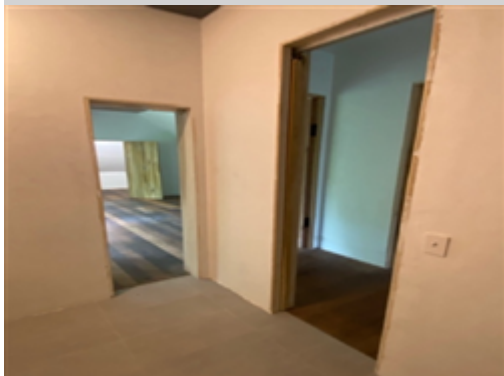
(H1 - 1.17) Interior Doors

See item #12 in the comment above - pocket door header, private bath

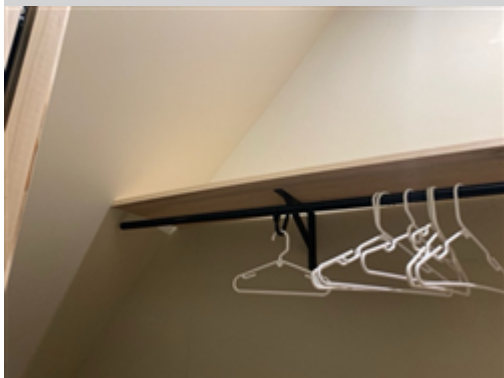
(H1 - 2.3) Miscellaneous

Note: Also at the left front bedroom, the closet shelving is bowed & poorly cut. left front bedroom

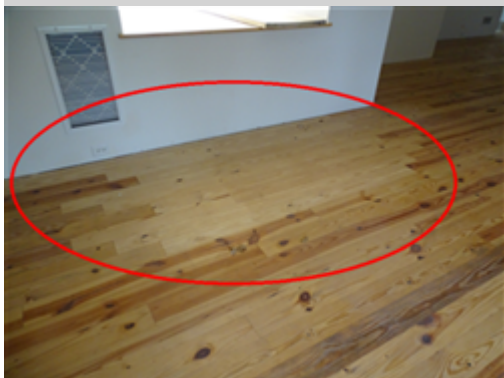
(H1 - 2.4) Miscellaneous

3rd level flooring - poorly patched, does not match... existing flooring is heart pine and new flooring white pine?

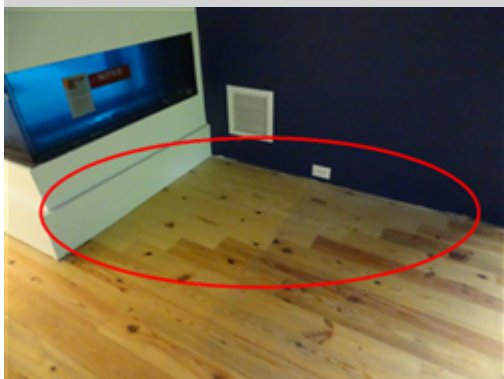
(H1 - 2.5) Miscellaneous

See comment above - 3rd level flooring

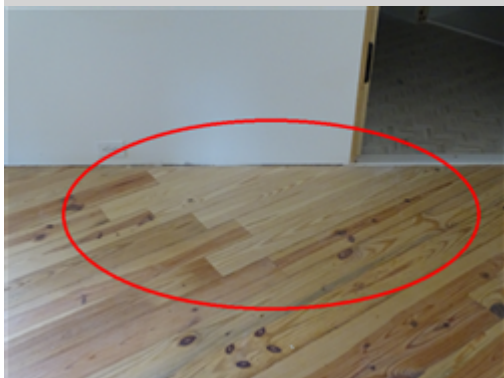
(H1 - 2.6) Miscellaneous

See comment above - 3rd level flooring

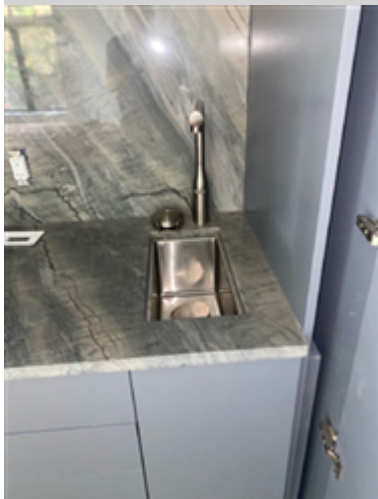
(H2 - 1.3) Kitchen

- 1 - The cabinet doors and drawers need to be adjusted.
- 2 - There was no water at the kitchen sink.
- 3 - There was no water at the bar sink.
- 4 - The bar sink faucet is loose.

See item #3 & #4 in the comment above - bar sink

A general contractor should be contacted to complete the installation and make all needed repairs.

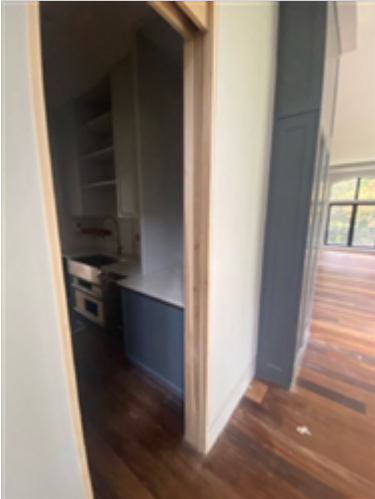
(H2 - 2.3) Butlers Pantry

At the butlers pantry the following was noted:
1 - The cabinet doors and drawers need to be adjusted.
2 - Drawer fronts missing.
3 - Pocket door hardware missing.
A general contractor should be contacted to complete the installation.

See item #2 in the comment above - pocket door

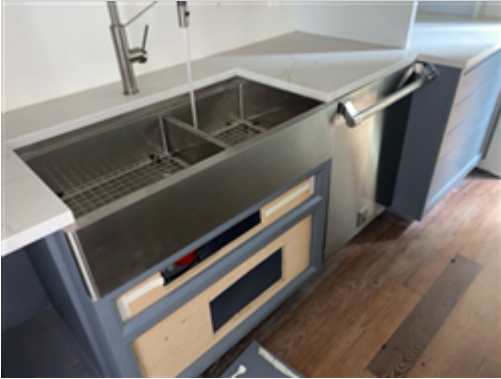
(H2 - 2.4) Butlers Pantry

Appliances not inspected...

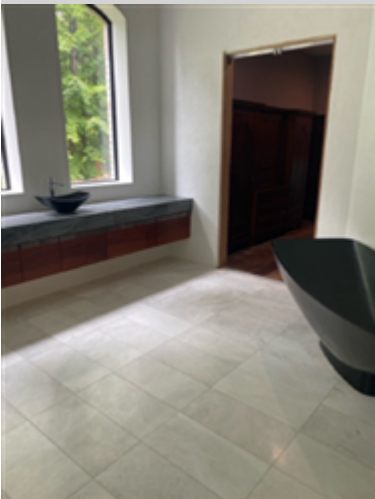
(H3 - 1.1) Bathroom: Master

At the master bathroom the following was noted:

- 1 - The left side sink faucet is loose.
 - 2 - The sink installation is not in line with the countertop.
 - 3 - The shower faucet valve is not aligned to center.
 - 4 - The top shower jet is at female face level.
 - 5 - The shower head is too high to reach the center control button.
 - 6 - The repair to the wall finish around the tub control is incomplete.
 - 7 - The toilet is not square to the wall & residue on floor around base.
- A licensed general contractor should be contacted to repair and complete as needed.

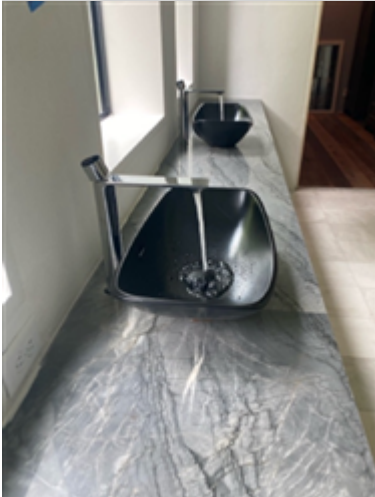
(H3 - 1.2) Bathroom: Master

See item #1 in the comment above - left side sink

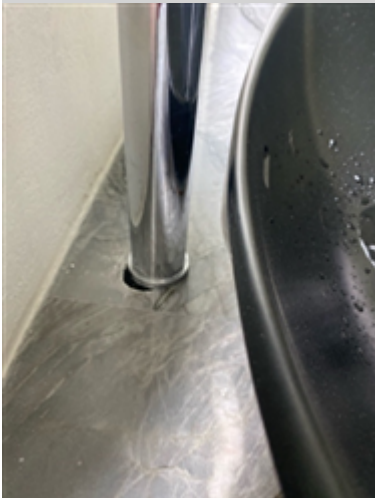
(H3 - 1.3) Bathroom: Master

See item #1 in the comment above - Additional photo

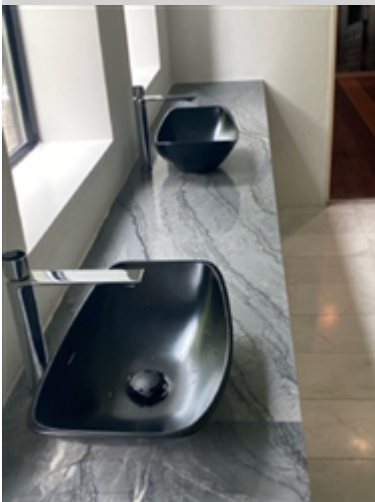
(H3 - 1.4) Bathroom: Master

See item #2 in the comment above - Sinks are misaligned

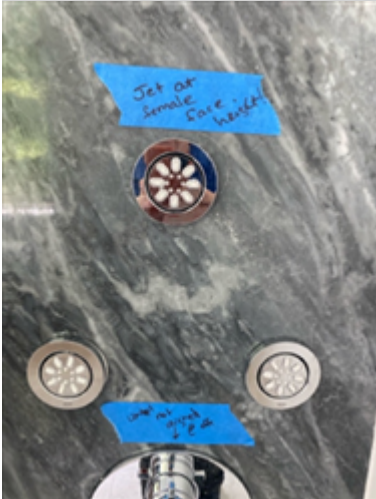
(H3 - 1.5) Bathroom: Master

See item #3 and #4 in the comment above - jet height

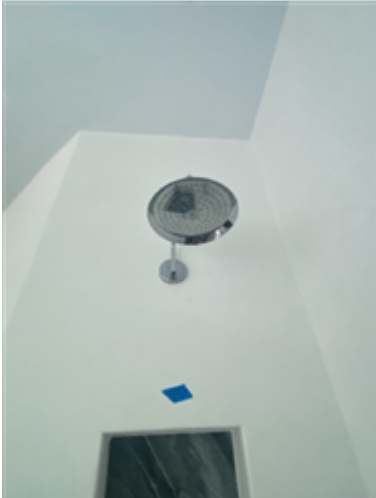
(H3 - 1.6) Bathroom: Master

See item #5 in the comment above - Shower head center button too high to reach

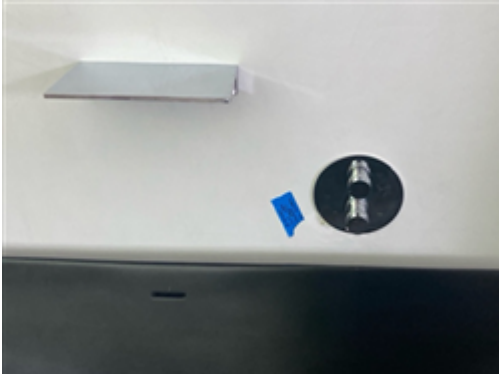
(H3 - 1.7) Bathroom: Master

See item #6 in the comment above - wall above tub

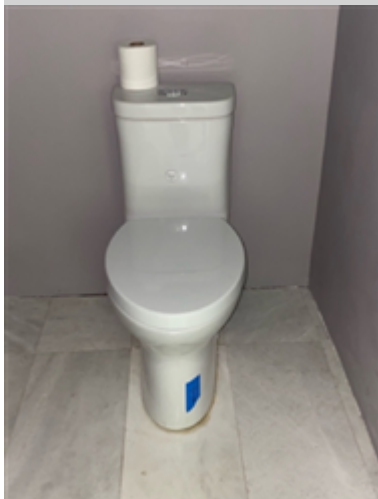
(H3 - 1.8) Bathroom: Master

See item #7 in the comment above - toilet

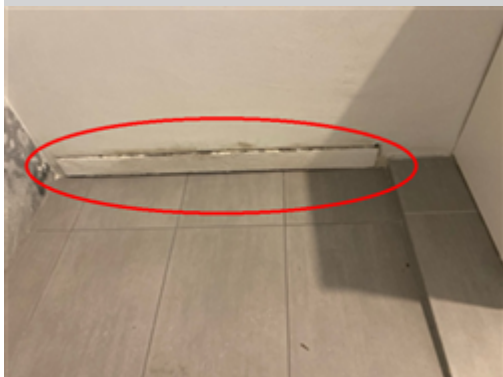
(H3 - 5.3) Bathroom: Private 2nd Right Front

- 1 - The shower faucet valve is not flush to the shower wall.
 - 2 - The shower drain is not recessed into the shower wall.
 - 3 - The drywall is damaged at the side of the vanity.
- A licensed general contractor should be contacted to repair and complete as needed.

See item #2 in the comment above - Shower drain

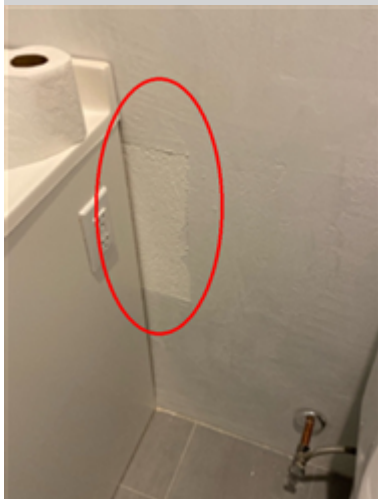
(H3 - 5.4) Bathroom: Private 2nd Right Front

See item #3 in the comment above - drywall
