Property Inspection Report

Report Number: 24175

5407 Eastern Shores Dr
Greensboro, North Carolina 27455

Date of Inspection: Monday, July 29, 2024

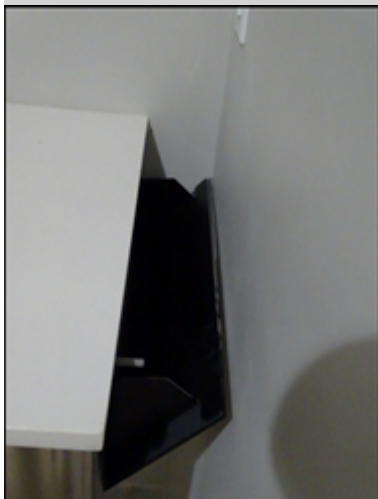
(H3 - 6.3) Bathroom: 3rd Level

At the 3rd level bathroom:
1 - The left side of the vanity is damaged.
2 - The right side tilt drawer hits the wall when opened.
3 - The sink drain installation is incomplete.
A general contractor should be contacted to repair.

See item #2 in the comment above - Vanity

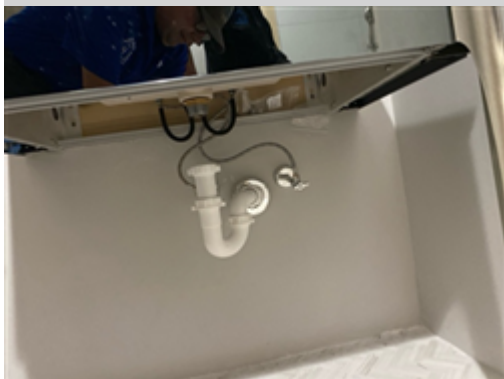
(H3 - 6.4) Bathroom: 3rd Level

See item #3 in the comment above - Drain disconnected

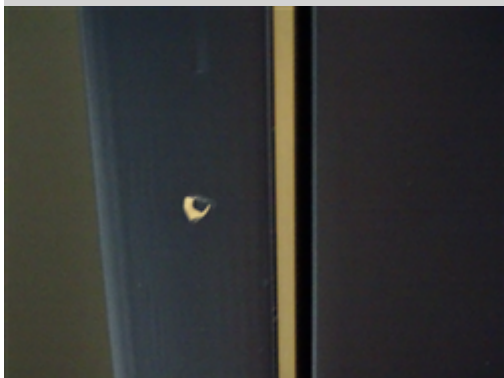
(H3 - 7.3) Hall Sink: 2nd Level

The vanity cabinet in the 2nd level right end hall:
1 - Cabinet is damaged.
2 - The sink surface is damaged.
3 - The drain stop is mismatched.
A general contractor should be contacted to repair.

See item #1 in the comment above

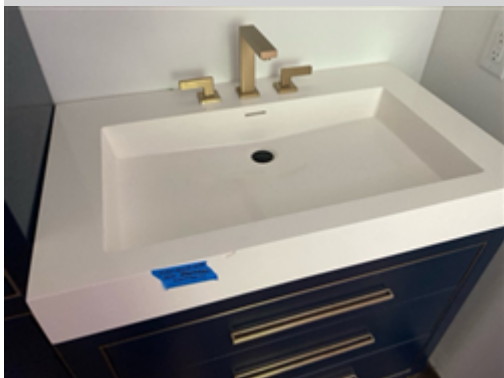
(H3 - 7.4) Hall Sink: 2nd Level

See item #2 in the comment above

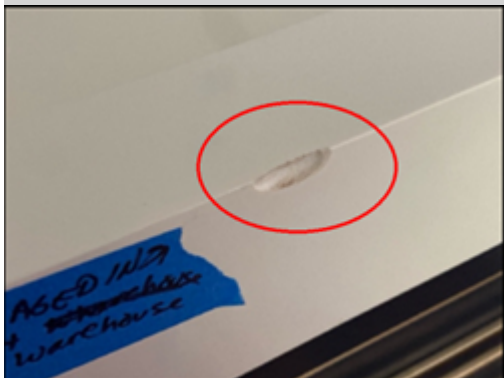
(H3 - 7.5) Hall Sink: 2nd Level

See item #2 in the comment above

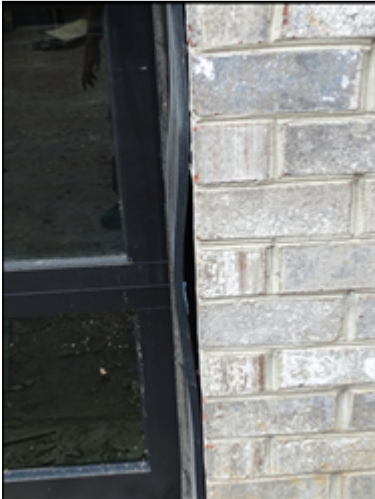
(H4 - 1.3) Garage #1

At the left side garage:
1 - The trim around both garage doors is defective.
2 - Bolts have been left protruding from the floor near utility room door - trip hazard and need to be removed.
A general contractor should be contacted to repair or replace.

See item #1 in the comment above - left rear door

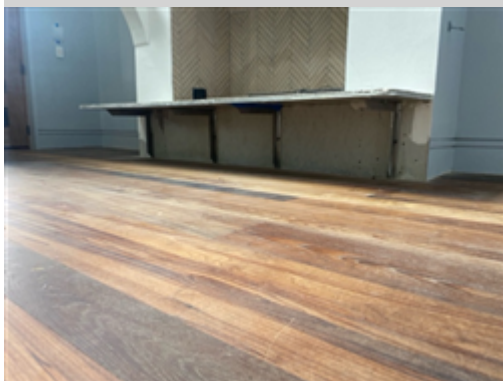
(H6 - 1.2) Fireplace: Masonry

The family room fireplace hearth installation is incomplete. A general contractor should be contacted.

See comment above - supports exposed under hearth...

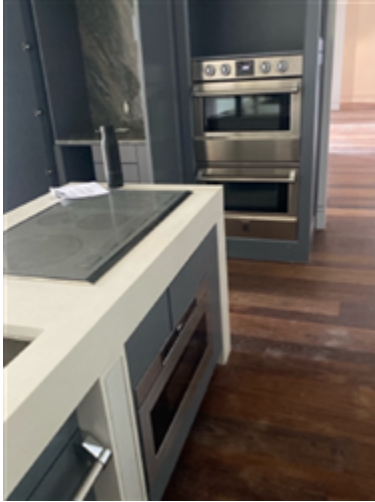
(J1 - 1.1) Appliances Not Inspected - per client

Appliances not operated...
